UNITED STATES COAST GUARD

INVESTIGATION INTO THE CIRCUMSTANCES
SURROUNDING THE COLLISION BETWEEN THE

M/V BALSA 37

ON AUGUST 10, 1993, WITH NO LOSS OF LIFE

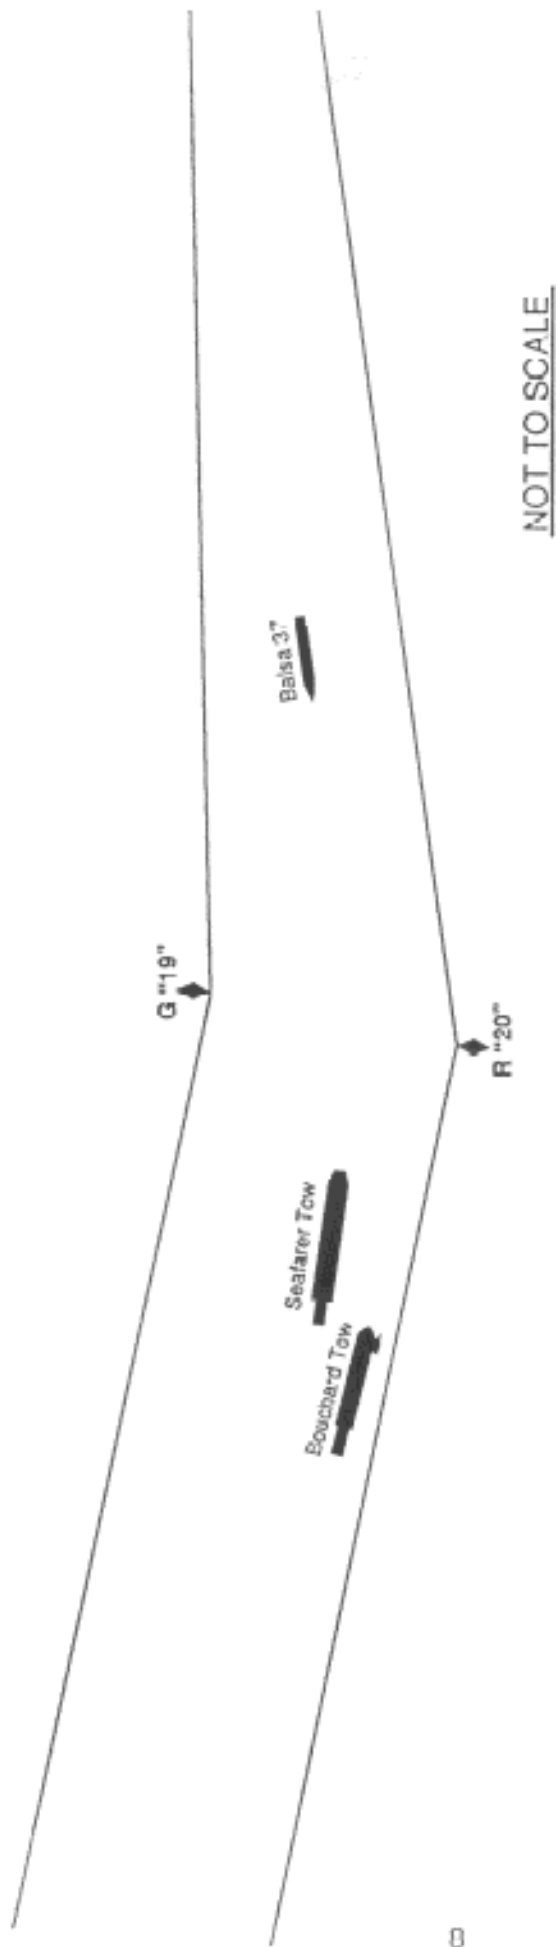
Figure 2

APPROXIMATE POSITIONS AS
VESSELS APPROACHED TURN
