INVESTIGATION INTO THE CIRCUMSTANCES  
SURROUNDING THE SINKING OF THE  
UNINSPECTED FISHING VESSEL

## ARCTIC ROSE

OFFICIAL NUMBER 931446, IN THE BERING SEA ON  
APRIL 2, 2001, WITH ONE PERSON DECEASED AND  
FOURTEEN PERSONS MISSING AND PRESUMED DEAD

Amended 05/20/2004

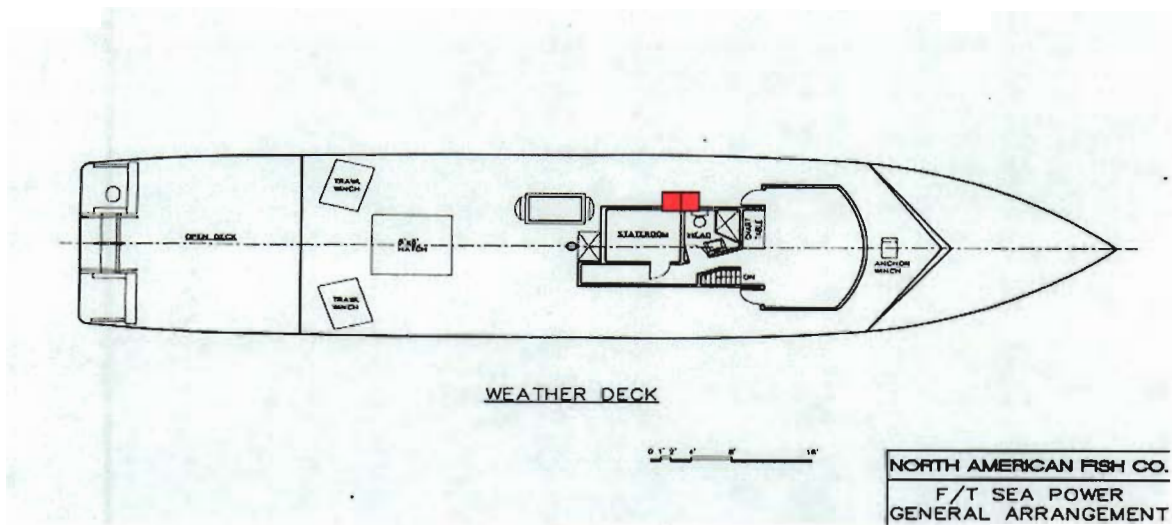
Figure 6  
 Drawing of weather deck  
 The red boxes are the proximate location of the wooden boxes

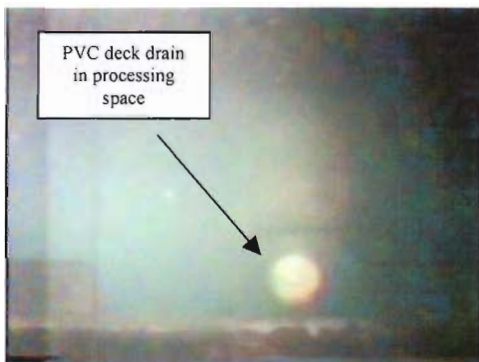
- g. Processing Space Sideshell Openings. There were a total of six sideshell penetrations in the processing space. Four of these openings (2 port and 2 starboard) were approximately 2-3 inches above the deck. These openings were closed by a threaded PVC cap that could be removed (unscrewed) from inside the processing space to allow excess water to drain overboard. Two rectangular shaped openings (1 port and 1 starboard) were overboard discharge chutes to discard by-catch (starboard) and to discharge waste (port) from fish processing.

Figure 8  
Photo of PVC deck drain  
cap (2001)

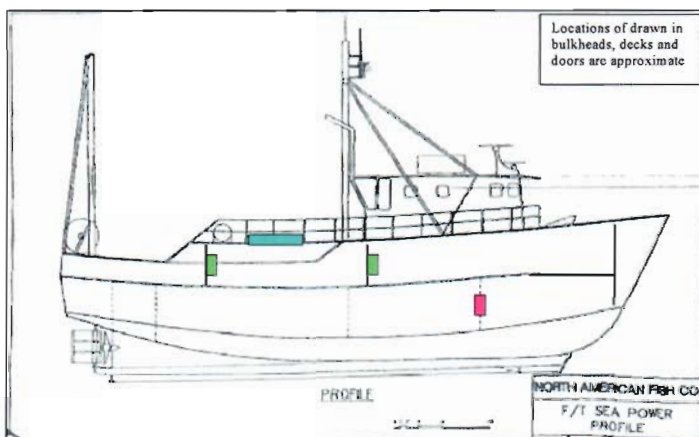
facilitated the movement of the catch from the dump box to the processing space. The overhead of the processing space had a weathertight hatch used to offload product. The processing space had six sideshell openings. A small manhole with a raised coaming was located in the top of the deck hatch, which was fitted with a non-watertight or weathertight plywood cover. A weathertight door provided access from the processing space to the mudroom. Access to the engine room was via a flush deck trunk. A hatch cover was not fitted over the engine room trunk. There was a watertight door between the engine room and auxiliary machinery space and a non-watertight hatch between the engineer's stateroom and the auxiliary machinery space. The Jensen Marine Consultants (JMC) issued stability booklet required this watertight door to remain shut at all times except when used for passage. This same book required all openings for scrap and fish chutes in the processing space bulkhead to be kept closed at all times except when used while processing fish.

Figure 11  
Drawing showing  
locations of the  
weathertight or watertight  
doors and hatches

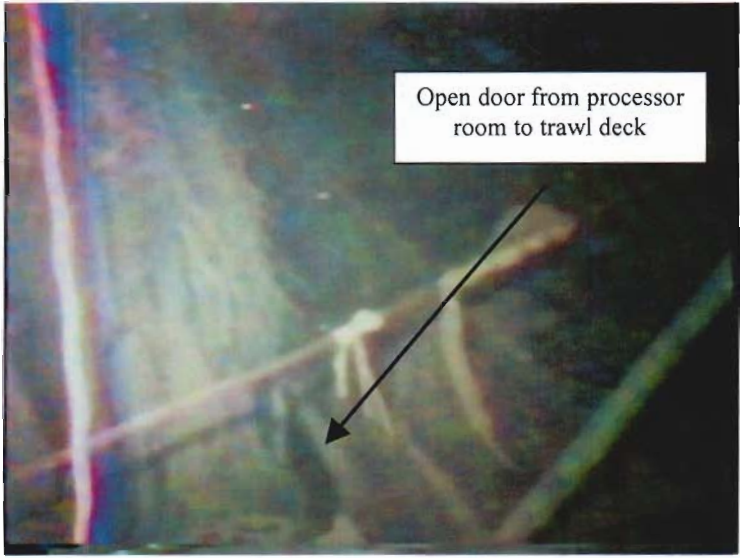
Figure 30  
Photo of open  
weathertight  
door on aft  
bulkhead of  
processing  
space taken  
from ROV  
video (2001)
