UNITED STATES COAST GUARD

INVESTIGATION INTO THE CIRCUMSTANCES
SURROUNDING THE SINKING OF THE
UNINSPECTED FISH PROCESSING VESSEL

ALASKA RANGER

OFFICIAL NUMBER 550138, IN THE BERING SEA ON
23 MARCH 2008 WITH THE LOSS OF FOUR LIVES AND
ONE PERSON MISSING AND PRESUMED DEAD

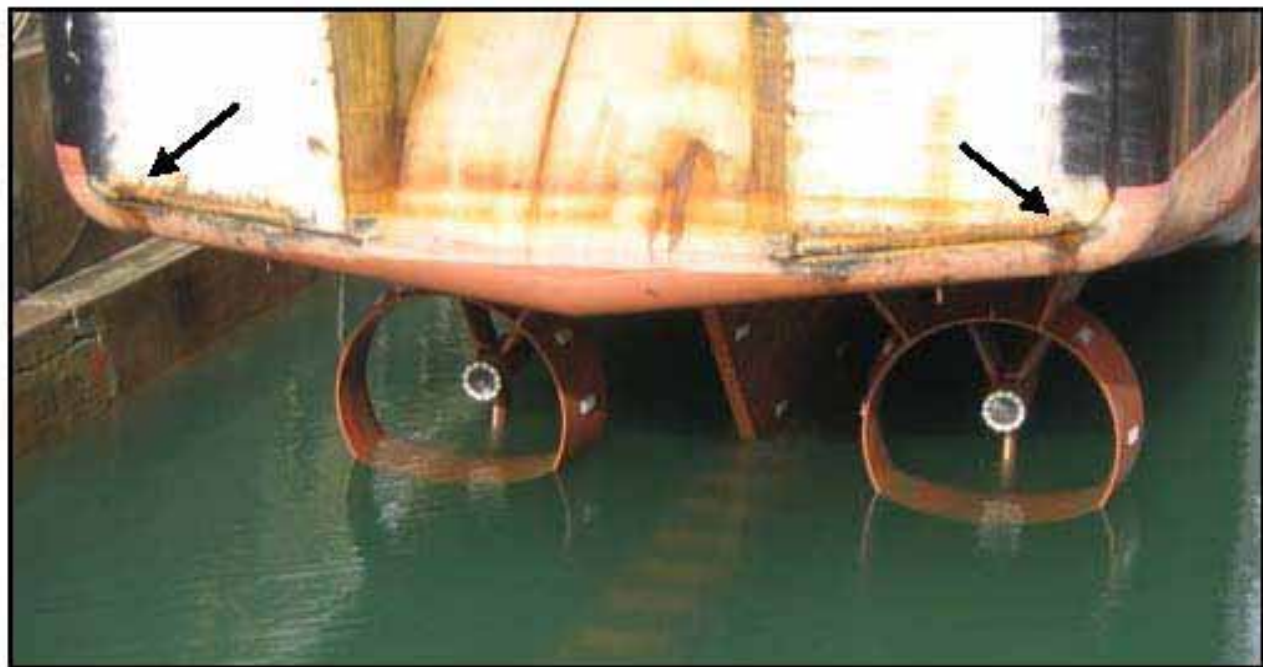
Figure 17: Photograph of the stern taken in 2005 showing water draining from outer transom

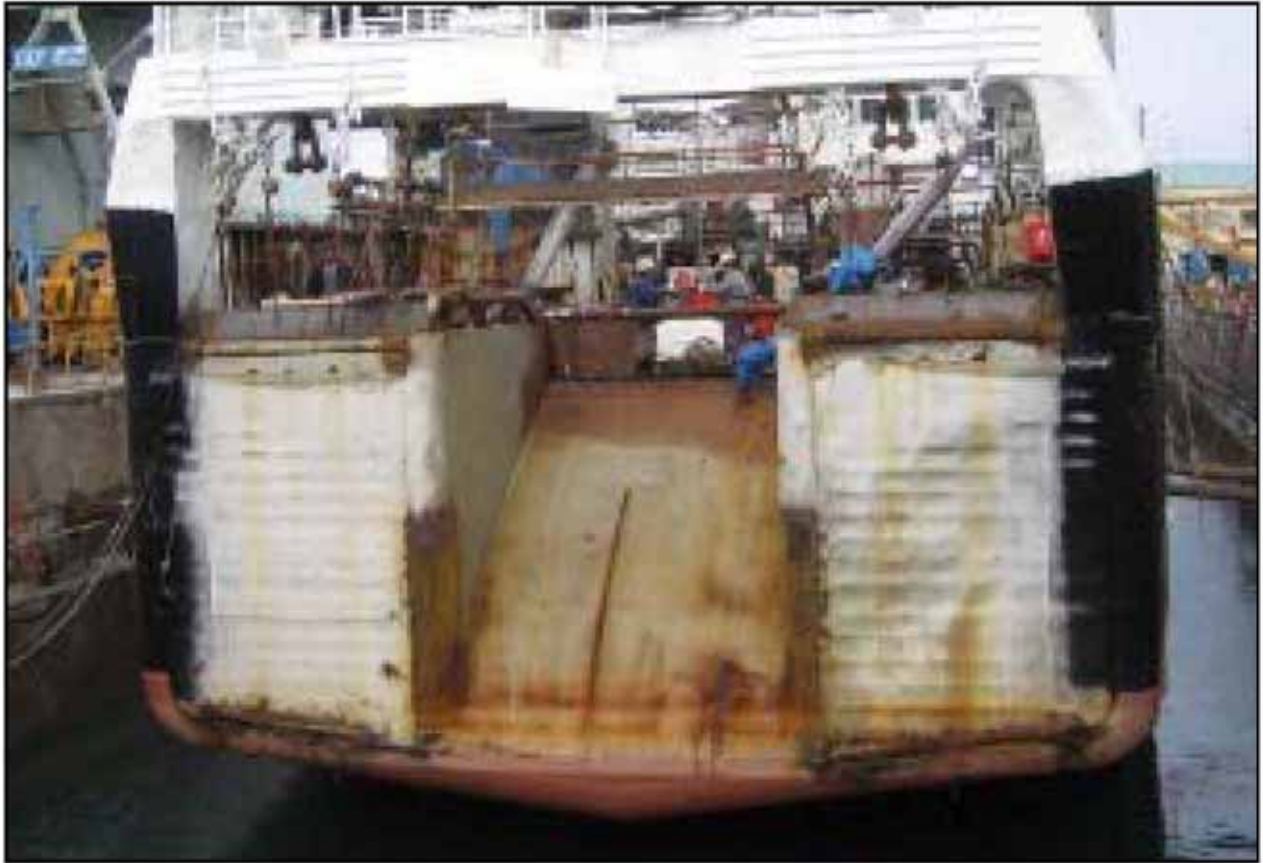
Figure 18: Photograph of the outer transom.

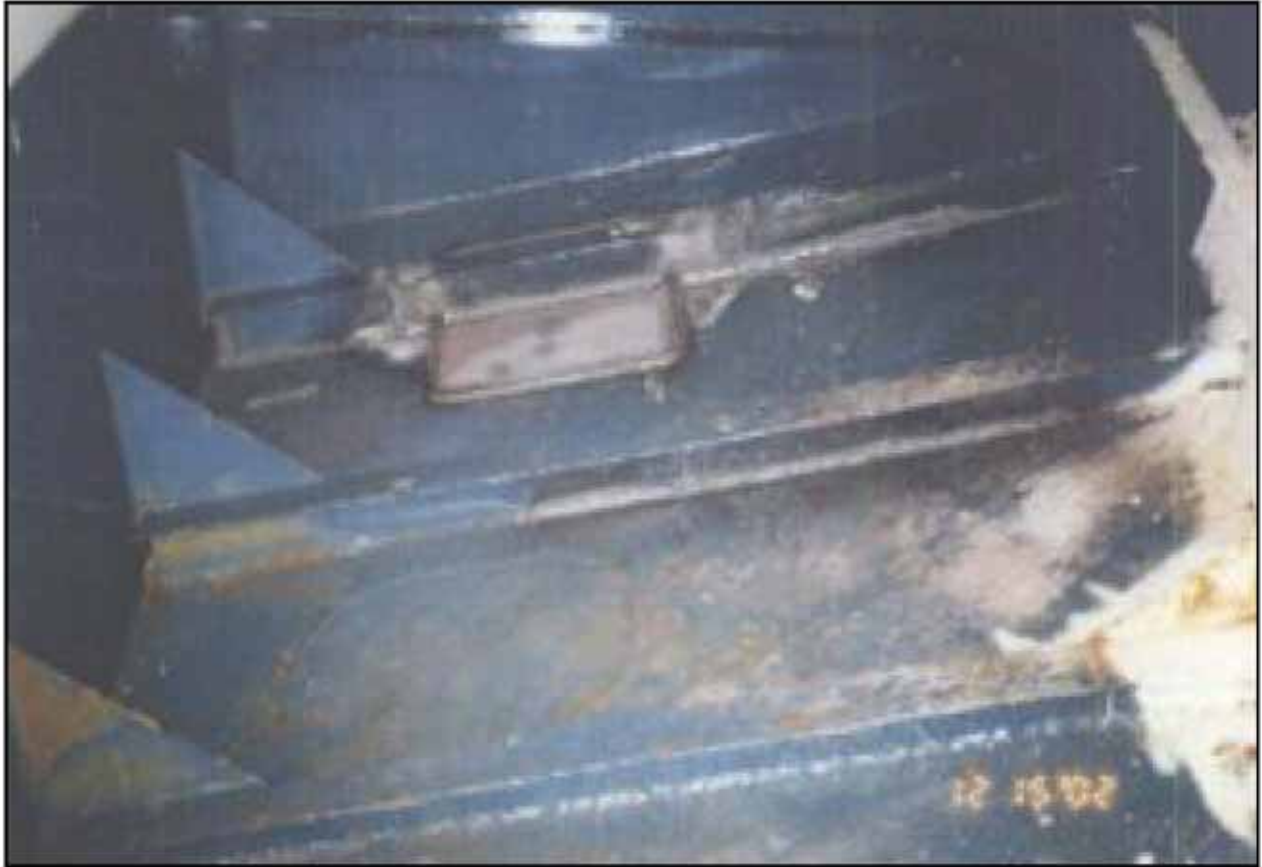
Figure 21: Photograph taken inside of potable water tank showing doubler.

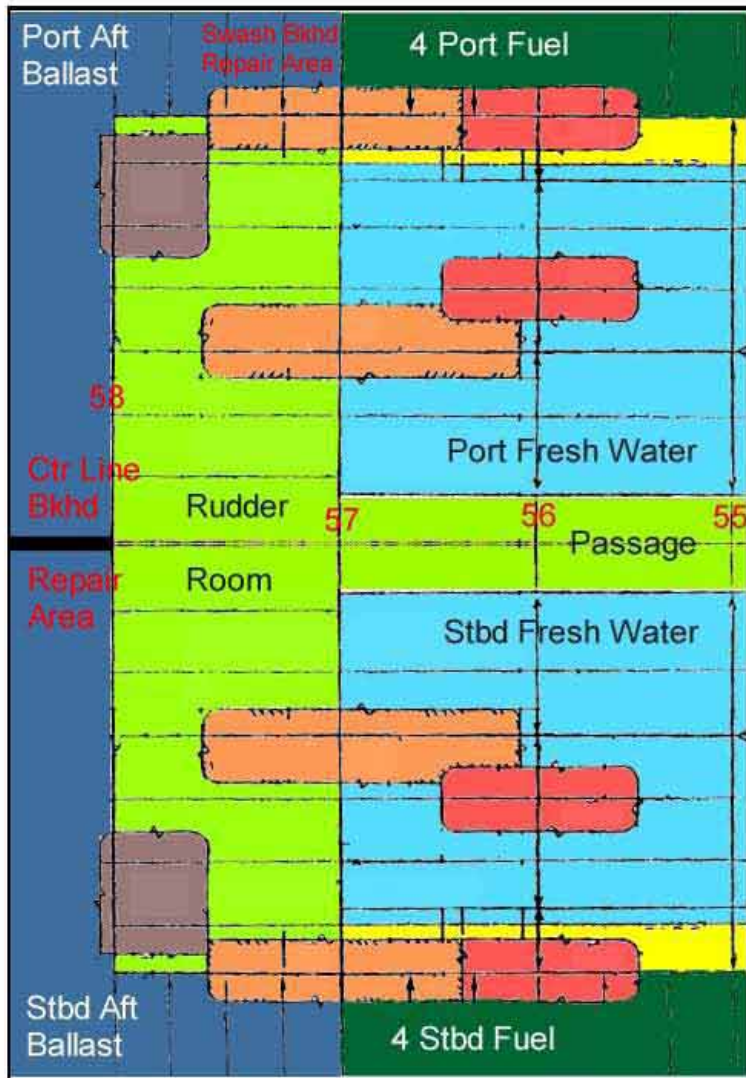
Figure 24: Portion of drawing developed by shipyard for Kort nozzle installation

The detailed shipyard drawings specified a 24 mm hull plating insert (orange at top and bottom of Figure 24) installed directly aft of the existing insert (shown in red) to which the outboard shaft bearing housing strut were attached. This insert was directly under the longitudinal bulkhead that separated the #4 fuel oil tank (shown in dark green) and the adjacent cofferdam (yellow) as well as the rudder room (light green) and the aft ballast tank (blue). The shipyard drawing indicated that the bottom 1.8 feet of this longitudinal bulkhead was to be replaced with 24 mm thick plate and additional brackets were to be installed to support the bulkhead.

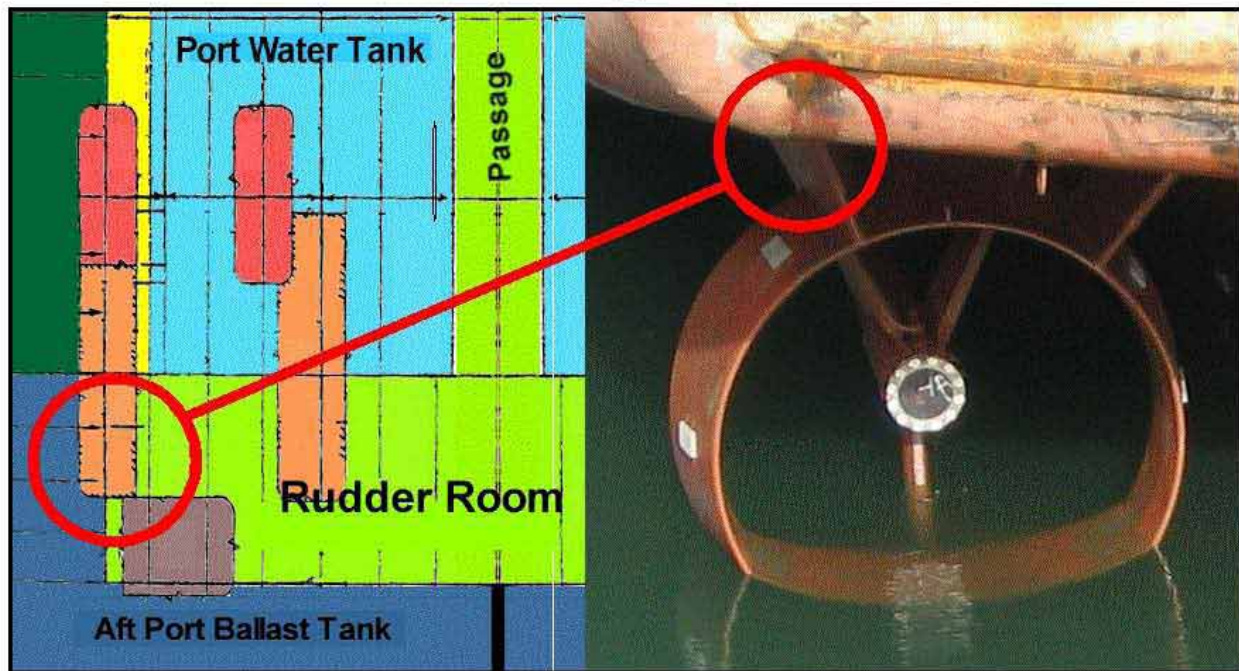
indicated that doubler plates were also located in the hull inside of the cofferdams, but no doubler plates were installed in the rudder room, #4 fuel oil tank, or potable water tanks. If so, the Kort nozzle strut landing areas located in way of the rudder room, aft ballast tanks, #4 fuel oil tanks, and potable water tanks were not reinforced. The load and stresses from the Kort nozzles were not properly distributed, and the struts experienced significant vibrations for which they were not properly reinforced.

Figure 25: Upper right red circle: Location of Kort nozzle strut fractures

Lower left red circle: Location of corroded frames in port aft ballast tank.

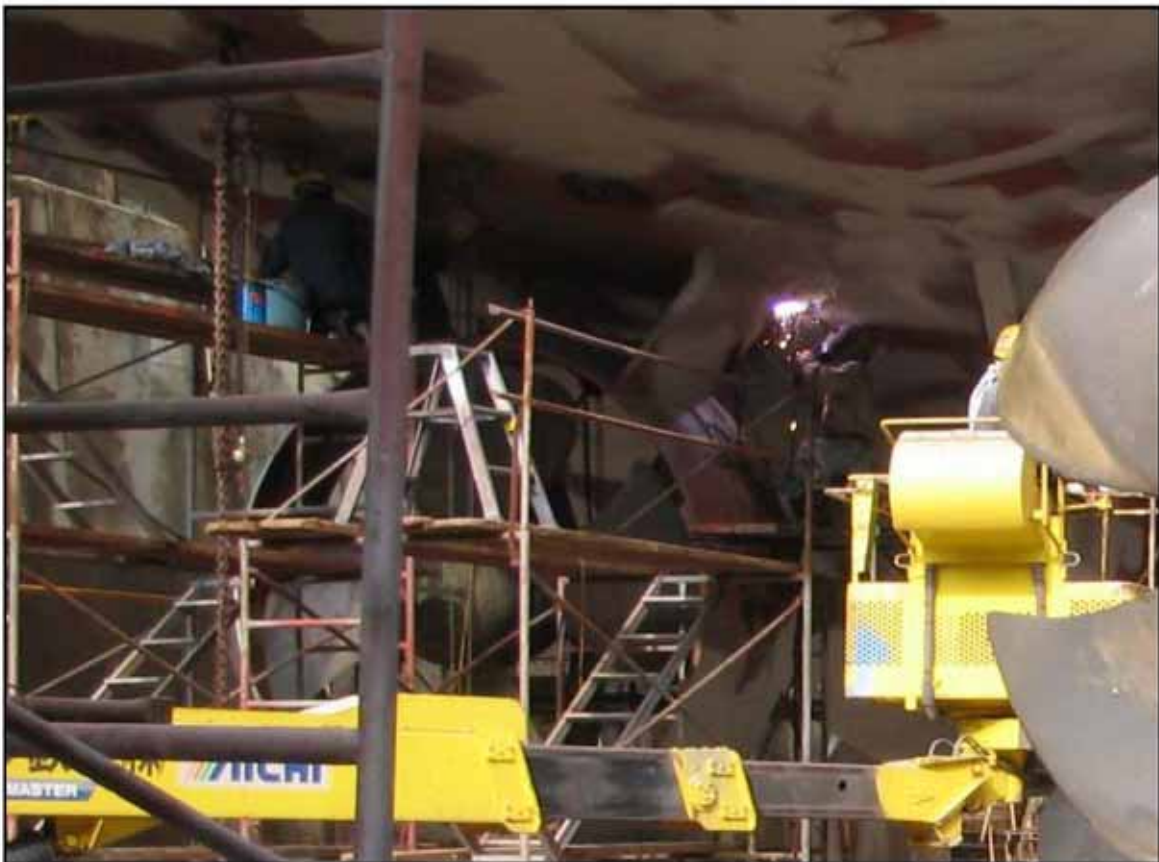
Figure 28: Photograph of worker repairing the inboard port Kort nozzle strut

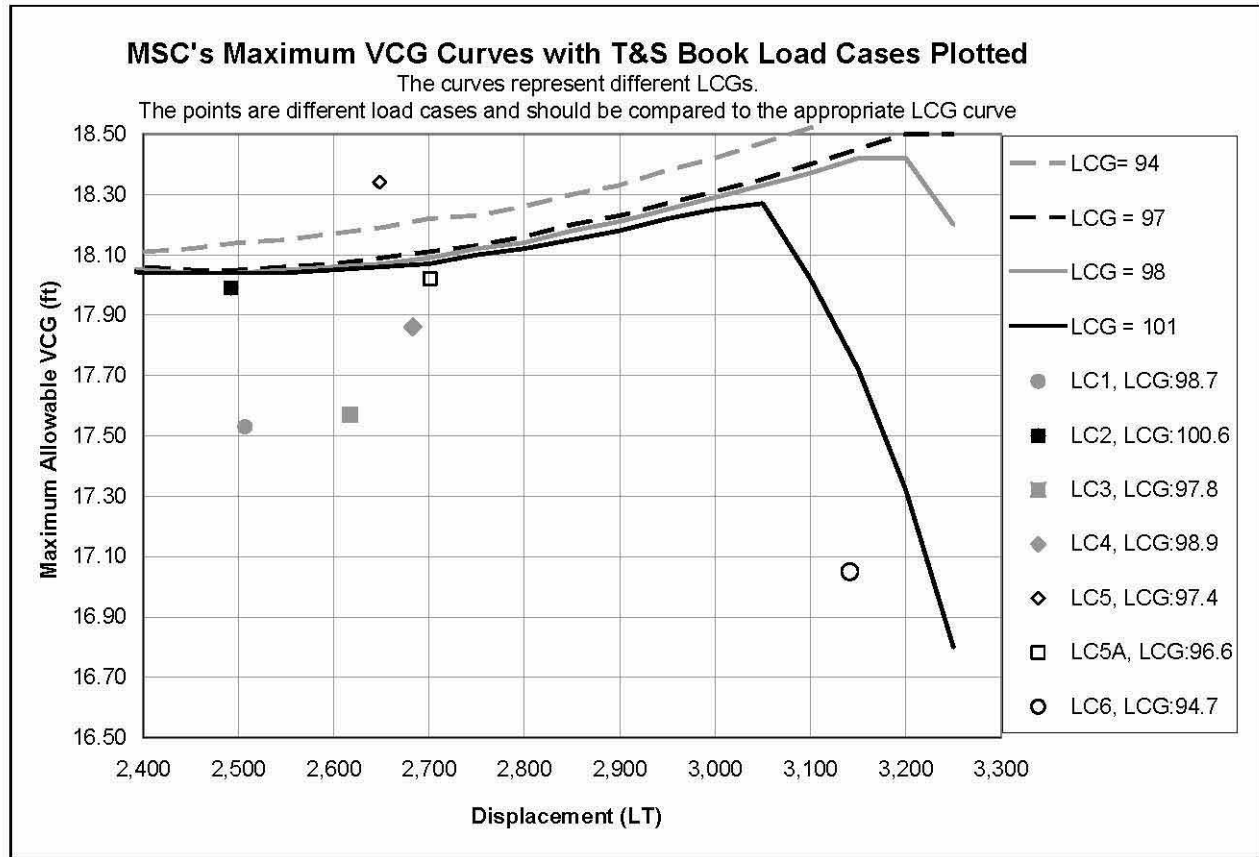
Figure 2: Load Case Evaluation

RANGER's T&S booklet included an illustrative load case #5 which failed to meet the criteria, as well as a modified version, load case #5A which passed.

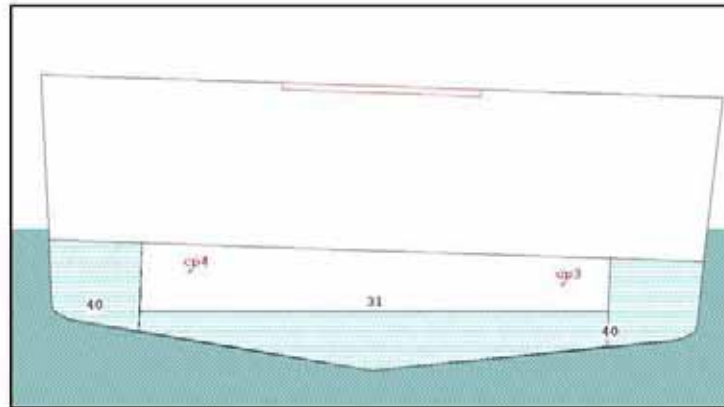
Figure 6: Example of Rudder Room Flooding at 50%

The initial rate of flooding into the Rudder Room was estimated by assuming that the flooding began through the rudder bearing, after the complete loss of one rudder and shaft. McDermott Shipyard Dwg. No. 54271-2101-1, Rev 2, dated October 25, 1973 shows that the upper rudder tube bearing is 9 inches in diameter. It also indicates that the longitudinal, transverse and vertical locations of the top of the rudder tube as being 178.59ft aft of frame 0, 10.75 ft outboard from centerline and 16.85 ft above baseline. Figure 6, shows the ALASKA RANGER's body plan at the location of the rudder posts. The points labeled "cp3" and "cp4" are the locations of the top of the rudder bearing and the assumed location of flooding.

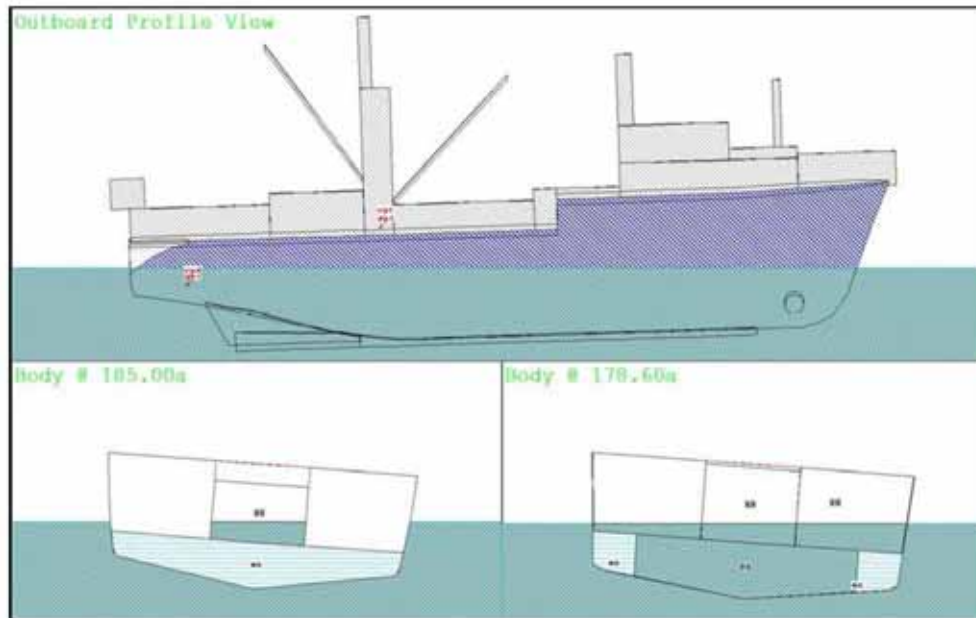
Figure 8: Step C in 1st Flooding Scenario

Reference (a) indicated that after the Rudder Room flooded, the next compartments to have reported flooding were the Ramp Room as well as the Harbor Generator Room, Workshop, and Aft Machinery Alley. The flooding of these compartments was modeled as step C in Table 3, and is depicted in Figure 8. In our model, these flooded compartments were allowed to flood to the waterline throughout the scenario so that as the flooding progressed, more water would flow in. It is not clear whether this floodwater came from a hull breach or upward from the rudder room below. However, our model suggested that with the rudder room flooded, the deck in the ramp room would have been 2 feet below the static water line, making a hull breach a reasonable source of flooding.

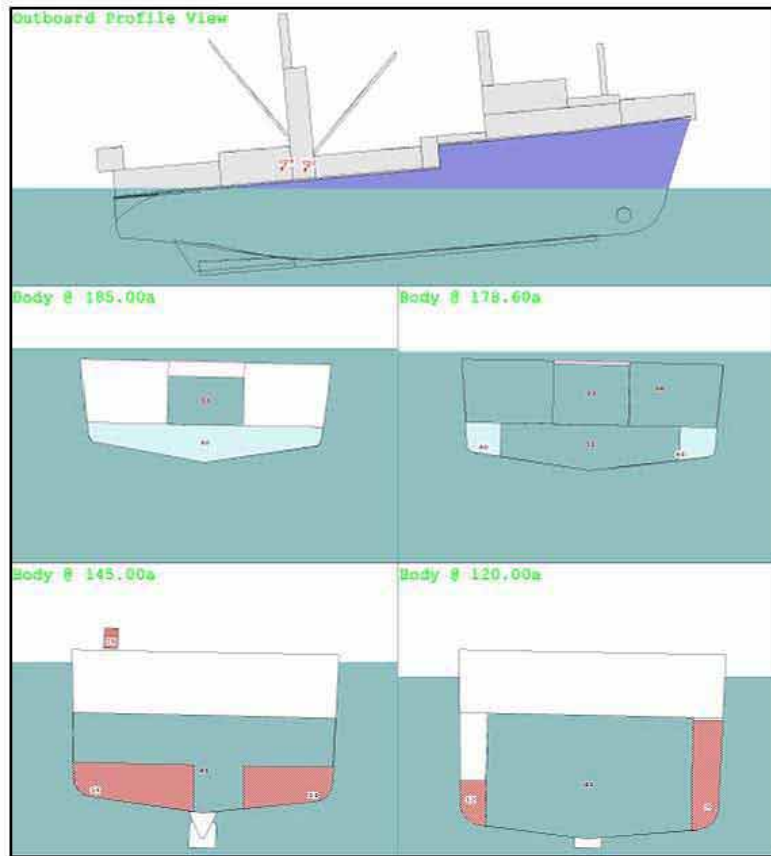
Figure 9: Step D in 1st Flooding Scenario

Reference (a) indicated that the Hydraulics Room was the next compartment to flood. The bulkhead at frame 50 was not watertight and so in step D, the entire engine room was allowed to flood. As seen in Figure 9, once the engine rooms were completely flooded, the aft portion of the trawl deck is awash increasing the likelihood that the #4 Hold and the Fish Bin would begin to downflood.

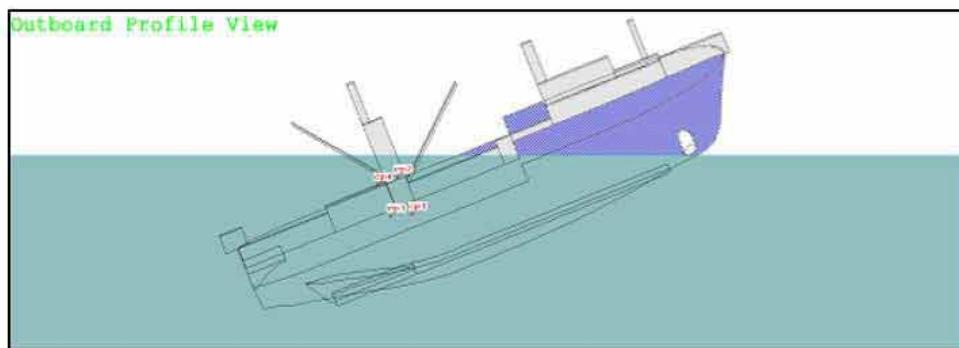
Figure 10: Step E in the 1st Flooding Scenario

Figure 10 shows the model's attitude with the Fish Bin and #4 Hold flooded. Although this analysis describes one potential sinking scenario, it doesn't predict any significant listing until the model had extreme trim by the stern. Please note that this sinking scenario neglects the effects of wind and sea conditions.

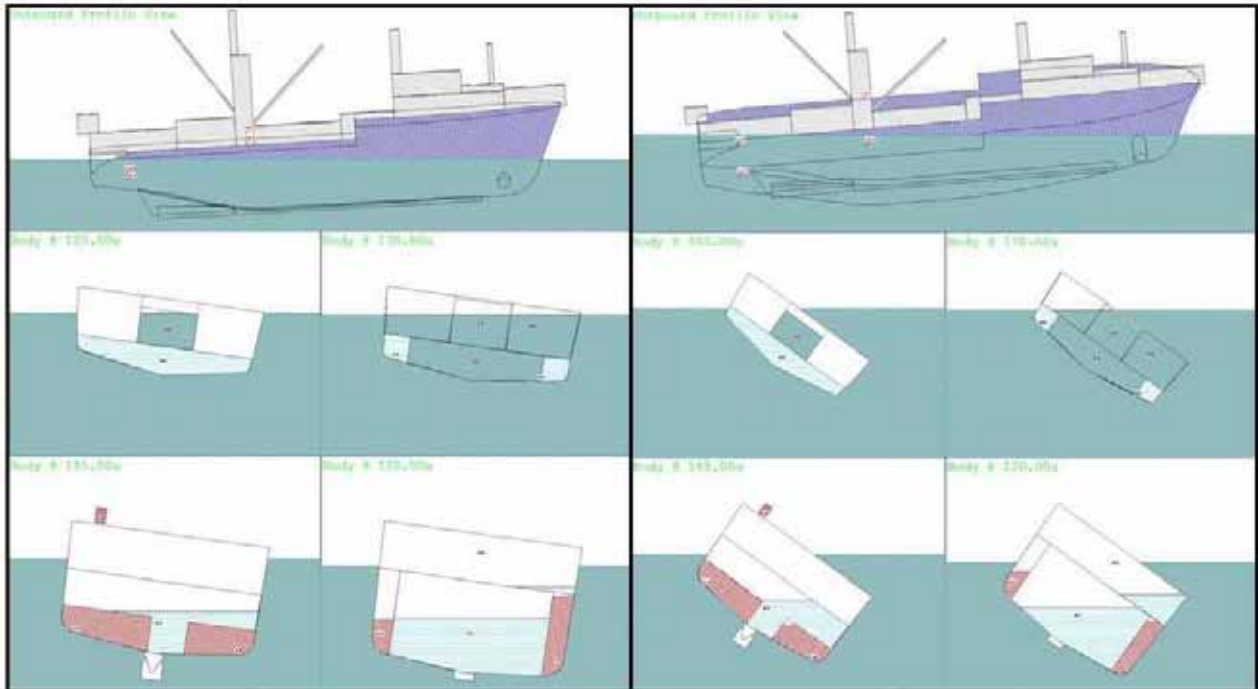
Figure 14: Step J in 2nd Flooding Scenario

As noted previously, the ALASKA RANGER reportedly listed hard to starboard after losing power (presumably due to flooding in the engine rooms). However, Table 4 shows only between 4° and 5° static starboard heel angle once the engine rooms are flooded. One plausible condition that would increase the free surface effect and create a greater heel angle is a small quantity of flood water on the processing deck. Limited flooding on the processing deck is a reasonable assumption considering the aft end of the trawl deck was nearly submerged in step I of the scenario. When only 15 LT of flood water was added to the processing deck, the model heeled sufficiently to put the starboard corner of the transom in the water as shown in Figure 14. With 50 LT of flood water on the processing deck, the heel angle doubled to 16°. At this point, our model indicated that the starboard side of the trawl deck was underwater from frame 47 to the transom.
