**FORMAL INVESTIGATION INTO THE ALLISION OF THE LIBERIAN TANK
VESSEL HYDE PARK WITH THE M/V HERMAN POTT AND TOW, AND THE
SUBSEQUENT ALLISION WITH THE DOMINO SUGAR FACILITY AND THE M/V
MISS LESLIE, AT MILE MARKER 90 ON THE MISSISSIPPI RIVER ON 26
FEBRUARY 1999, WITH SEVERE DAMAGE AND POLLUTION, AND NO KNOWN
INJURIES OR LOSS OF LIFE**

ACTION BY THE COMMANDANT

Subj: FORMAL INVESTIGATION INTO THE ALLISION OF THE LIBERIAN TANK VESSEL HYDE PARK WITH THE M/V HERMAN POTT AND TOW, AND THE SUBSEQUENT ALLISION WITH THE DOMINO SUGAR FACILITY AND M/V MISS LESLIE, AT MILE MARKER 90 ON THE MISSISSIPPI RIVER ON 26 FEBRUARY 1999, WITH SEVERE DAMAGE AND POLLUTION, AND NO KNOWN INJURIES OR LOSS OF LIFE

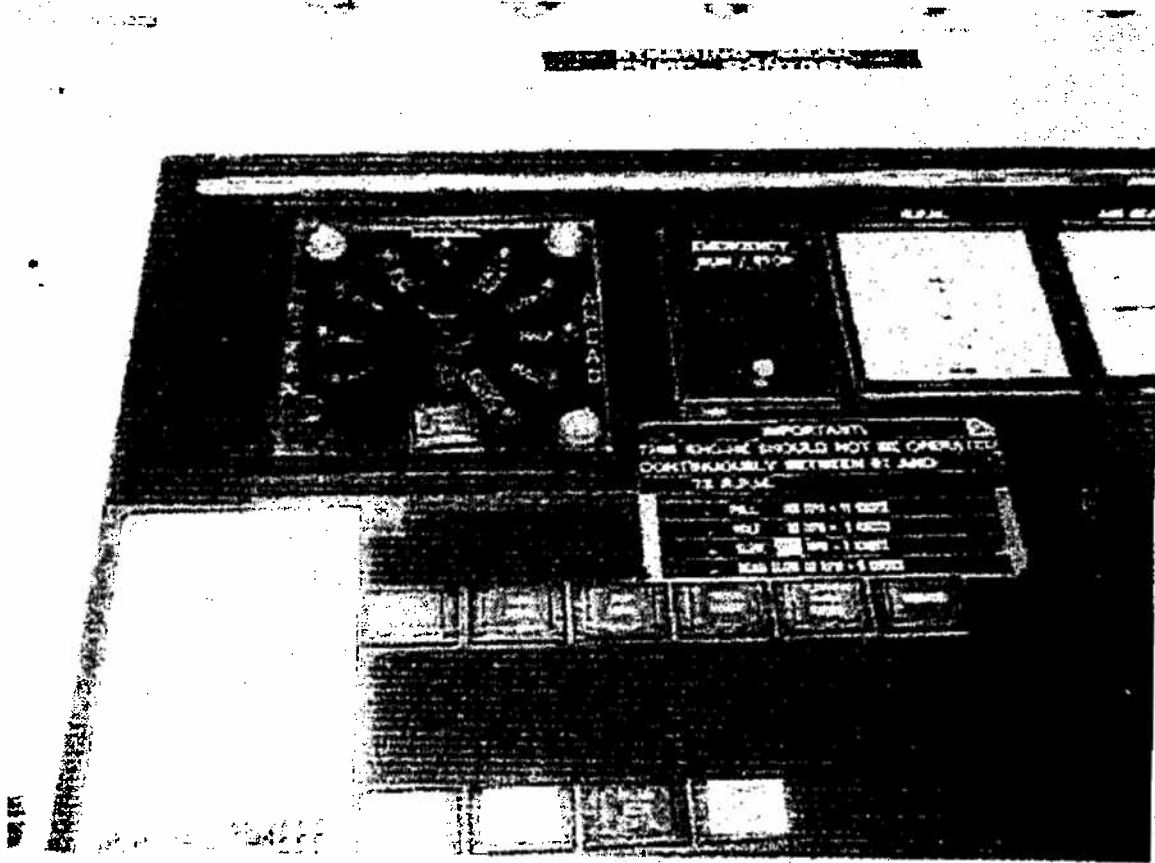
Photograph of Bridge Control Console

Though it is possible for the bridge to directly control the engine, in actual practice the ship always operates in engine room control mode – that is, the engineers always directly control the engine. Engine orders are transmitted from the bridge to the engineering control room by a telegraph system. The telegraph in the engineering control room has two arrows, one controlled by the bridge, one controlled by the engineering watchstanders, that lie one on top of another. When a bridge watchstander receives an engine command, he indicates this command to the engineering watchstander by dialing in the appropriate command on the bridge telegraph. Whenever a new engine command is indicated on the bridge telegraph, a buzzer sounds and a light that corresponds to the ordered engine position flashes on both the bridge and the engine

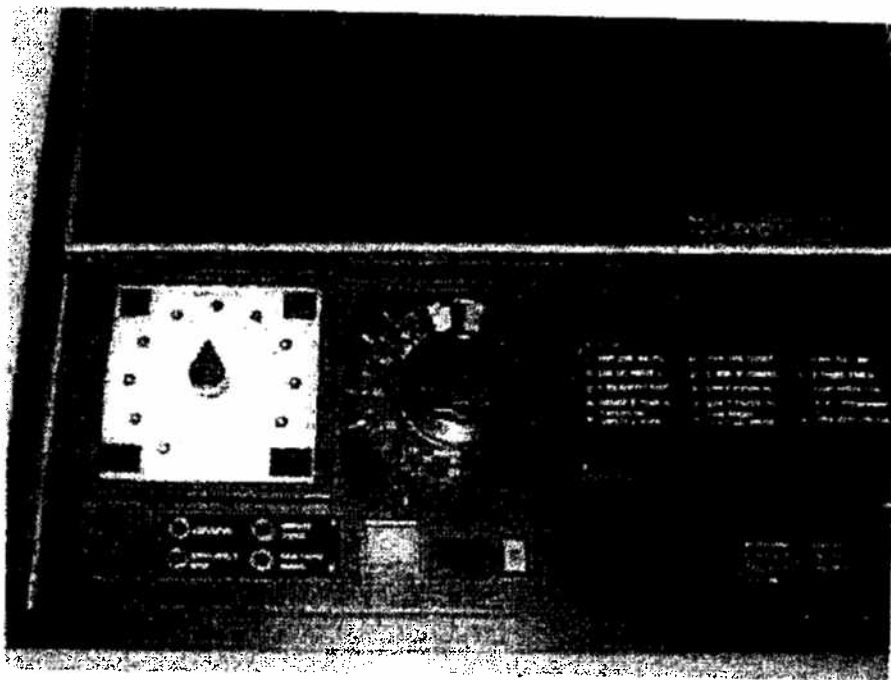
Photographs of Engineering Control Console

control room telegraphs. In addition, the bottom arrow on the engineering telegraph moves to the position that corresponds to the ordered command, and an audible alarm located on the bulkhead above the engine control console sounds. The engineering watchstander acknowledges the command by rotating the top arrow on the engineering telegraph to match the desired order indicated by the bottom arrow (see page 9). Once the engineering watchstander correctly matches the two arrows on the telegraph, the audible telegraph alarms extinguish and the light indicating the ordered engine command stops blinking (though it does stay on). If the engineering watchstander fails to correctly match the two arrows, the audible telegraph alarms continue to sound, the light indicating the ordered command continues to blink, and a light in the lower right hand corner of the engineering telegraph comes on and stays illuminated. On both the bridge and the engineering telegraphs, the "engine stop" position is in the top center of the telegraph. The telegraph knob on the bridge is rotated clockwise to indicate ahead, counter-clockwise to indicate astern. The telegraph knob in the engine control room is rotated clockwise to indicate astern, counter-clockwise to indicate ahead.

The engineer's response on the telegraph does not control the engine – it merely indicates to the bridge that the engineers have received and acknowledged the command. In order to actually cause the engine to respond to the command relayed on the telegraph, the engineers need to stop/start the engine, if necessary, and then turn a second dial (the engine control dial) located to the right of the telegraph to the requested engine command. The engine control dial does not actually start the engine; the engine is started and stopped by a separate button. The engine control dial has a black knob with a concentric circle around it, half green and half red, with the green half on the left corresponding to ahead and the red half to the right corresponding to astern. If the engine is at stop, turning the dial will shift the camshaft in the right direction and then, once the engine has been started, will bring RPMs up to the ordered speed. If the engine/shaft is operating in one direction (astern, for example), and the bridge orders an ahead command, turning the dial in the ahead direction will automatically shift the camshaft. The further the engine control dial is turned from the center position the greater the engine RPMs.
