## Key Techniques in the Integral Salvage of Ancient Sunken Vessel *Nanhai No 1*

Jiancheng Wu<sup>a</sup>, (co-author/speaker), Yongqiang Zhang, (co-author), Elva Ding, (speaker), Guangzhou Salvage, People's Republic of China

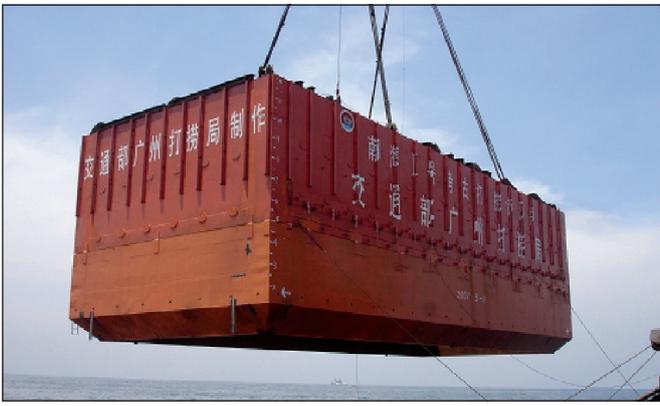
Figure 1: Steel open caisson.

The steel open caisson is not only the most important structure of the Integral Salvage Project, but also the carrier of all follow-up processes; almost all working procedures of the salvage project were carried out around it. Whether the design of the steel open caisson is reasonable or not will directly affect the success or failure of the whole archaeological salvage project. After numerous underwater inspections and measurements, we could confirm that the main particulars of the vessel were: 30.4m × 9.8m × 4.2m. Accordingly, we decided that the net length of the steel caisson inner side should be 33m long, leaving an extra 1.3m on each end. The net width of the inner side would be 12m, leaving an extra 1.1m on each side. The outer size of the caisson would be 33.3m×14.4m.

The steel open caisson is a combination, vertically, of upper and lower parts. There are two functions of the lower part:

The purpose of the upper part is to wrap around the ancient sunken vessel and there are reserve holes at the bottom for threading through the bottom-supporting steel beams. After the threading of these beams is completed, the upper and lower parts will be separated by hoisting up the upper part, leaving the lower part on the seabed. The height of the upper part was 7.2m while the effective height for carrying **Nanhai No 1** was 6.15m; the leeway in the vertical direction is 1.95m. The height of the lower part was determined based on Anti-rising Stability Analysis of mud at the bottom of the steel caisson<sup>[4]</sup>. After calculations, it was determined that the lower part was 5m high.

Due to the fact that most of the work was carried out underwater during the hoisting and sinking of the steel caisson, many traditional measuring instruments could not function. Therefore Ultra-short Baseline Equipment was mainly adopted to carry out its positioning. During the pressing-down process for the caisson, we adopted GAPS instrumentation to carry out 24-hour monitoring of its status in order to ensure that it could be sunk stably to its designed position.

At 13.00 on 17<sup>th</sup> May, 2007, the connection and testing of the positioning devices were completed. All the preparation of **Nan Tian Long** for the lifting and sinking of the steel caisson was finished. It was time to lift it. At 14.00, the water began to flood into the caisson, and at the same time the Ultra-short Baseline System and GAPS instrument started to carry out the positioning and monitoring for it. The sinking position, sinking depth and balance of the caisson were constantly monitored. At 16.30, it was about 50cm from the mud surface of the seabed. Two divers went underwater to confirm whether its position was correct or not by examining the position of the framework. At 17.10, the correct positioning of the steel open caisson was confirmed and it entered the mud smoothly.

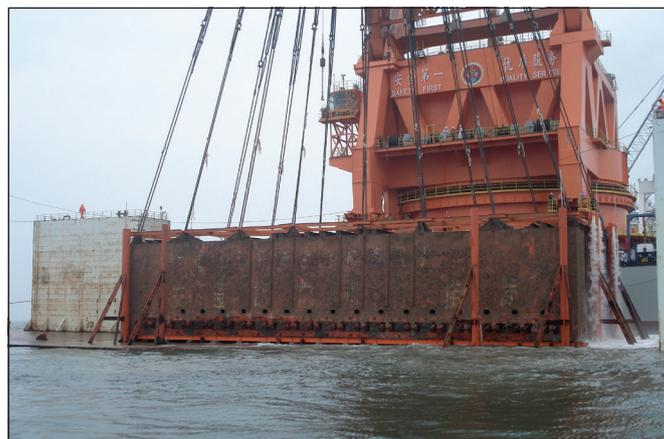
Figure 2: The protective container on the semi-submersible barge.

Solving the problem of insufficient lifting capacity was one of the critical issues for the salvage project. After plenty of calculations and research carried out by technical personnel, a semi-submersible barge was selected as a carrier to float the steel container<sup>[7]</sup>. Firstly, the floating crane was used to hoist the top of the container approximately 1m above the surface of the water and place it on to **Zhong Ren 1601**, the 15,000DWT semi-submersible barge which was submerged in advance. After the container was confirmed ready in accordance with requirements, **Zhong Ren 1601** would de-ballast to float, while simultaneously the main hook of **Hua Tian Long** would be still maintaining a certain load until the semi-submersible emerged to the design draft. The container was then fastened on the deck of the transport barge and taken to a temporary jetty at Zhapo in Yang Jiang City for the purpose of rolling it ashore and then moving it to Crystal Palace in the Maritime Silk Road Museum.

From 17<sup>th</sup> December, when the 4,000-tonne floating crane **Hua Tian Long** arrived at site, to 22<sup>nd</sup> December when **Zhong Ren 1601**, the semi-submersible barge, floated from the water, the whole hoisting operation had lasted for six days. The Integral Salvage Project for the sunken ship **Nanhai No 1** has been successfully achieved (see Figure 2, below).

- For hoisting requirements, 16 x 300-tonne lifting points were pre-designed on top of the container; as far as possible, these kept every lifting point in balance at an even level of force, thus maintaining a horizontal floating condition. The 16 lifting points were divided into four groups, ie four sets of wire ropes were grouped together at each side by four equalizer pulleys.
- The lifting wire ropes needed to be connected by divers underwater, and there were numbers of wire ropes, totalling 16 groups of slings. It was

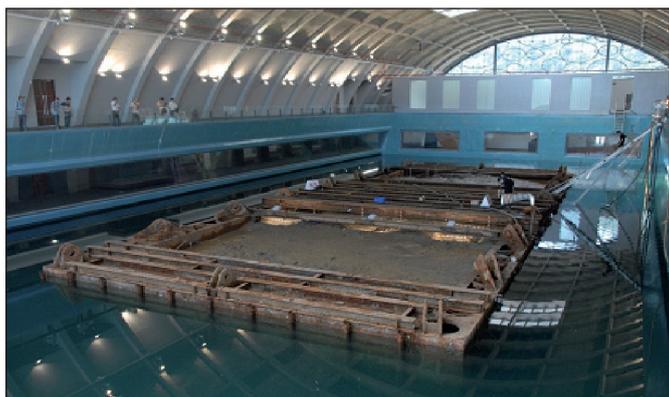
Figure 3: The protective container inside Crystal Palace.

The rolling process of the container was the last part of the whole project. The gross weight of the container and bottom tray was about 5,500 tonnes. The airbag rolling operation was finally selected after the comparison of many options<sup>[9-10]</sup>. On 24<sup>th</sup> December, **Zhong Ren 1601** berthed alongside the front of the temporary pier. On 27<sup>th</sup> December, the container was successfully rolled off the barge to the shore. The next day, **Nanhai No 1**, enclosed in its protective container, was safely moved into the Crystal Palace (see Figure 3). In this airbag rolling operation, the weight of 5,500 tonnes created a new record in China, of rolling a single heavy object; the linear distance of the rolling operation was about 450m.

The final step was to roll the container ashore and move it into Crystal Palace using airbags. For the airbag rolling operation it was necessary for the bottom of the container to be flat. Therefore we designed a bottom rolling tray to meet the needs of the operation. Based on the shape of the caisson structure, the rolling tray was designed as a  $\square$  shape, whose higher plane was in contact with steel beams and lower plane was in contact with the bottom of the container, so that the weight of the whole container could be evenly spread to the tray via the contact surface. In addition, the tray should be pre-fixed on to the deck of barge prior to the submerging of the semi-submersible barge. Furthermore, six limit piles would be set at both sides of the tray for the purpose of accurate location of the container.
