INVESTIGATION INTO THE CIRCUMSTANCES  
SURROUNDING THE SINKING OF THE  
UNINSPECTED FISHING VESSEL

## ARCTIC ROSE

OFFICIAL NUMBER 931446, IN THE BERING SEA ON  
APRIL 2, 2001, WITH ONE PERSON DECEASED AND  
FOURTEEN PERSONS MISSING AND PRESUMED DEAD

Amended 05/20/2004

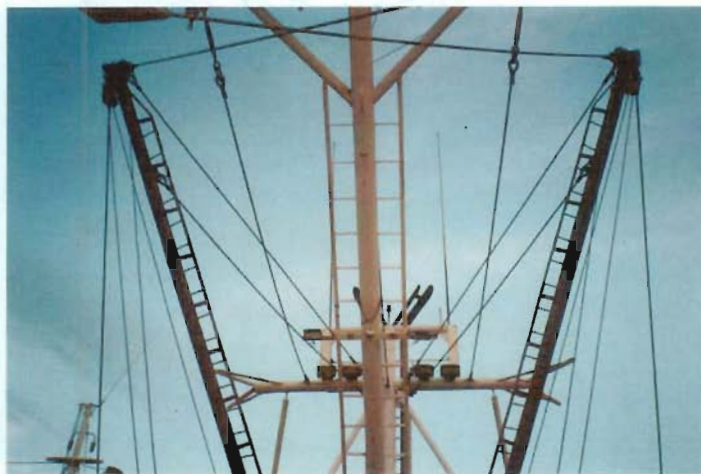
Figure 16  
Photo of “Stability  
Vanes (1995)

The existing stability vanes (see Figure 16), were removed.

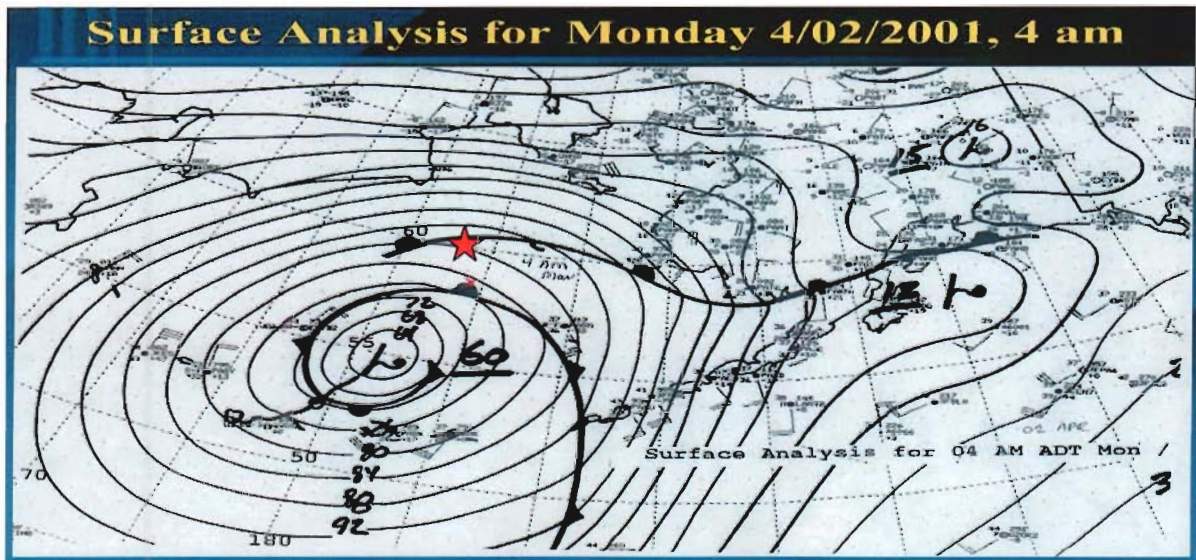
Figure 19  
National Weather Service Surface Analysis for 4am April 2, 2001  
The red star marks the approximate position of the ARCTIC ROSE

The generated forecast by the NWS covers a large area and unfortunately leads to ambiguous forecasts. This is due to the lack of data buoys and weather stations in the Bering Sea region. The NWS attempts to compensate for the lack of information by generating forecasts which tend to be conservative in nature. Many times these forecasts call for more severe weather than actually occurs and as a result the fishermen do not always trust these forecasts.

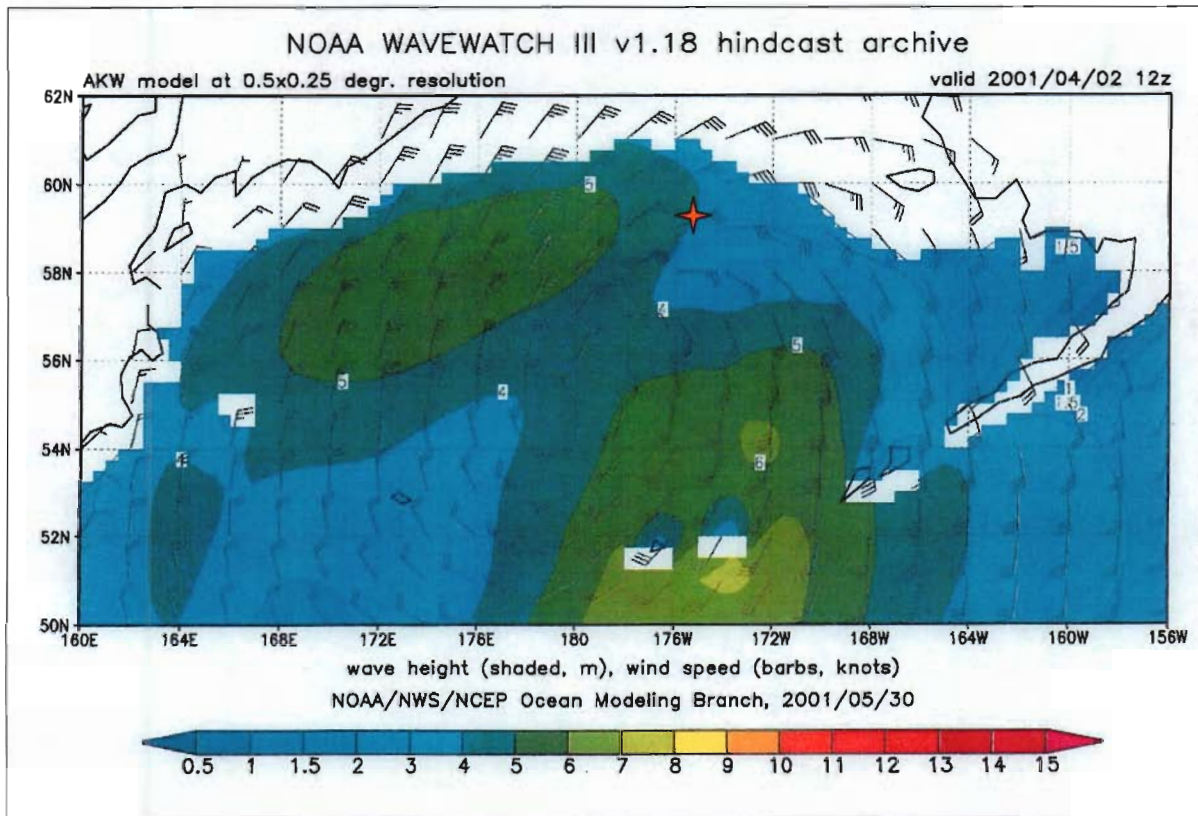
Figure 20  
 National Weather Service Hindcast for 4am April 2, 2001.  
 The orange star is the approximate position of the ARCTIC

The NWS generated a hindcast (Figure 20) of the weather in the vicinity of the sinking based on weather reports from Coast Guard and other commercial sources operating in the vicinity of the sinking. Their analysis indicates a significant weather event occurred at the ARCTIC ROSE's last known position. A weather phenomenon known as a Triple Point, which is an area of a frontal system where a cold, warm and occluded front join together and is usually associated with severe weather, passed over the ARCTIC ROSE's position. It is highly probable, based on the Triple Point, the vessel experienced three distinct weather patterns within a brief period of

The NWS hindcast shows the weather was worse than forecasted. In testimony provided to the Marine Board, Dr. [REDACTED] of the NWS indicated that waves could reach significant heights of 24 feet and could be accompanied by sustained winds of up to 45 knots.

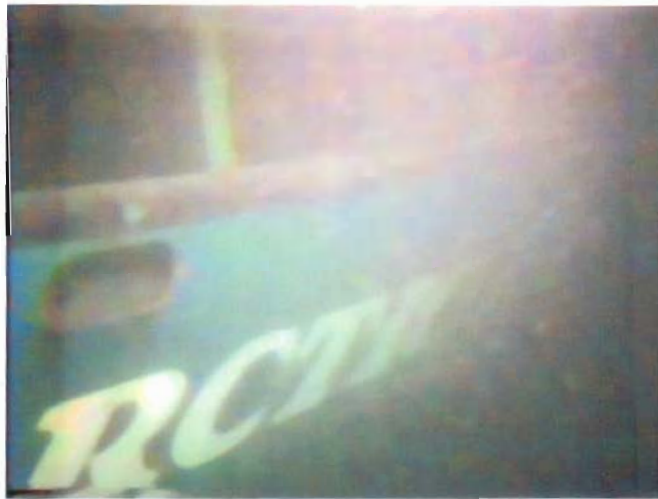
Figure 28  
Photo of  
Arctic Rose  
(2001)

made several passes along the port bow and port side of the pilothouse. Multicolored polypropylene lines used to mend the trawl net had unraveled from their cardboard spools and were floating above the wreck. As the ROV maneuvered around the wreck, several lines were sucked into the ROV's impellers and entangled it. Efforts to free the ROV resulted in the ROV's umbilical cord parting and the loss of the ROV.

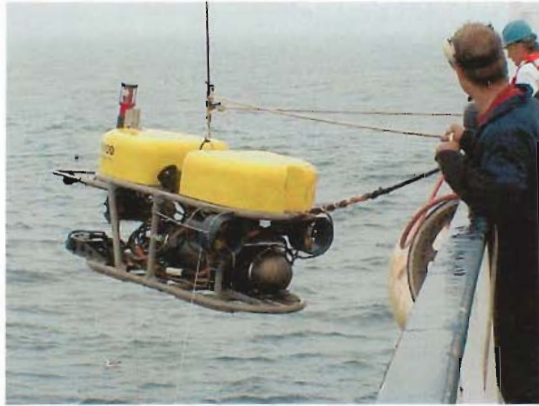
Figure 29  
Photo of MAXROVER  
deployed during second  
expedition (2001).

large majority of the work left unfinished by the first mission. The expedition video discovered many facts concerning the condition of the ARCTIC ROSE. The ROV surveyed a large majority of the hull above and below the waterline, port side of the pilothouse, and the aft deck area. The following was observed:

- The vessel's hull was intact.
- The vessel's pilothouse was undamaged with all windows visibly examined found intact.
- The aft weathertight door to the processing space from the trawl deck was open.
- The vessel's rudder was over to port.
- The trawl net was on the reel and the cod end was in the dump box.
- The trawl doors were missing.
- There was no evidence of fire or explosion to the vessel.
- The starboard overboard discharge chute was partially open.
- The wires were spooled on the trawl winches as indicated by the tattle tale marks.
- Trawl gear, mud lines and wires had shifted to the starboard side of the vessel.
- The vessel landed on the sea floor stern first as shown by the plow marks aft where the vessel's kort nozzle made its initial impact.

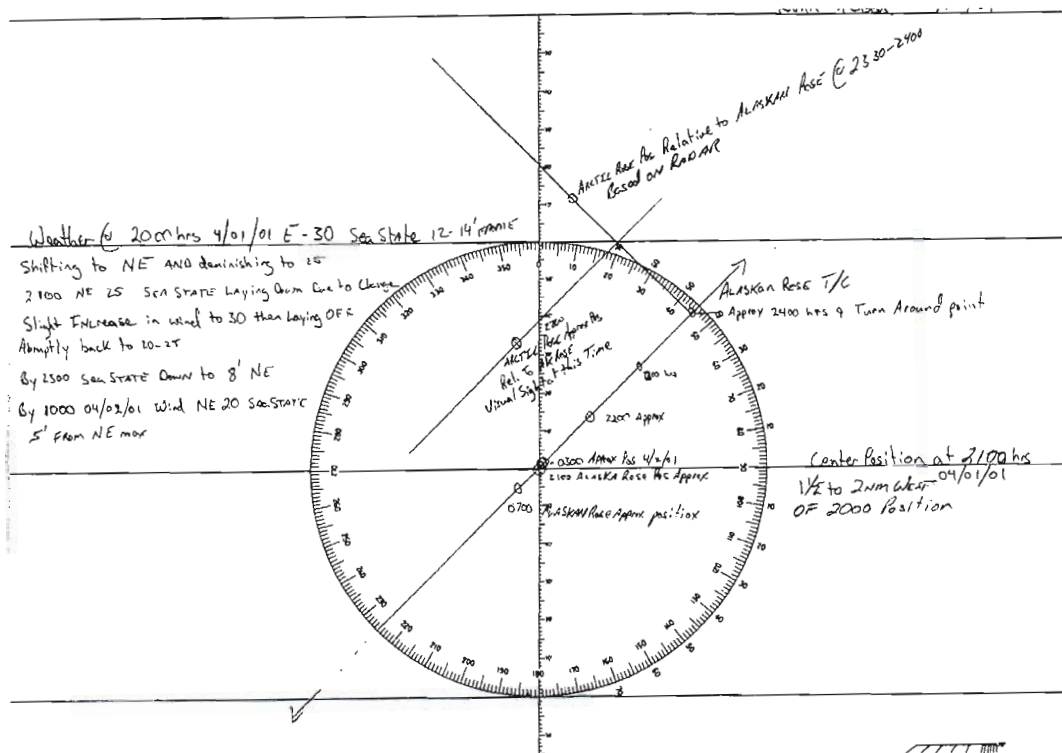
Figure 31  
 Universal plotting sheet depicting relative position and heading of ARCTIC ROSE on April 1 and 2

The Marine Board conducted an analysis of the ARCTIC ROSE's position based on testimony provided by Mr. [REDACTED], the EPIRB position and Captain Rundall's stated intent to remain in the area to begin fishing on the morning of April 2<sup>nd</sup>. Trawling vessels will give each other a wide berth to prevent their tow wires or nets from becoming entangled. The ARCTIC ROSE was maintaining a position to the northwest of the ALASKAN ROSE. At the time of the last sighting, the ARCTIC ROSE was moving away from the ALASKAN ROSE. The ALASKAN ROSE was running on a track line from Northeast to Southwest to maintain their position to fish at first light.

The Marine Board established a vessel heading of 315° T with a relative position of twelve miles northwest of the ALASKAN ROSE and making a turn to port at the approximate time of the casualty.

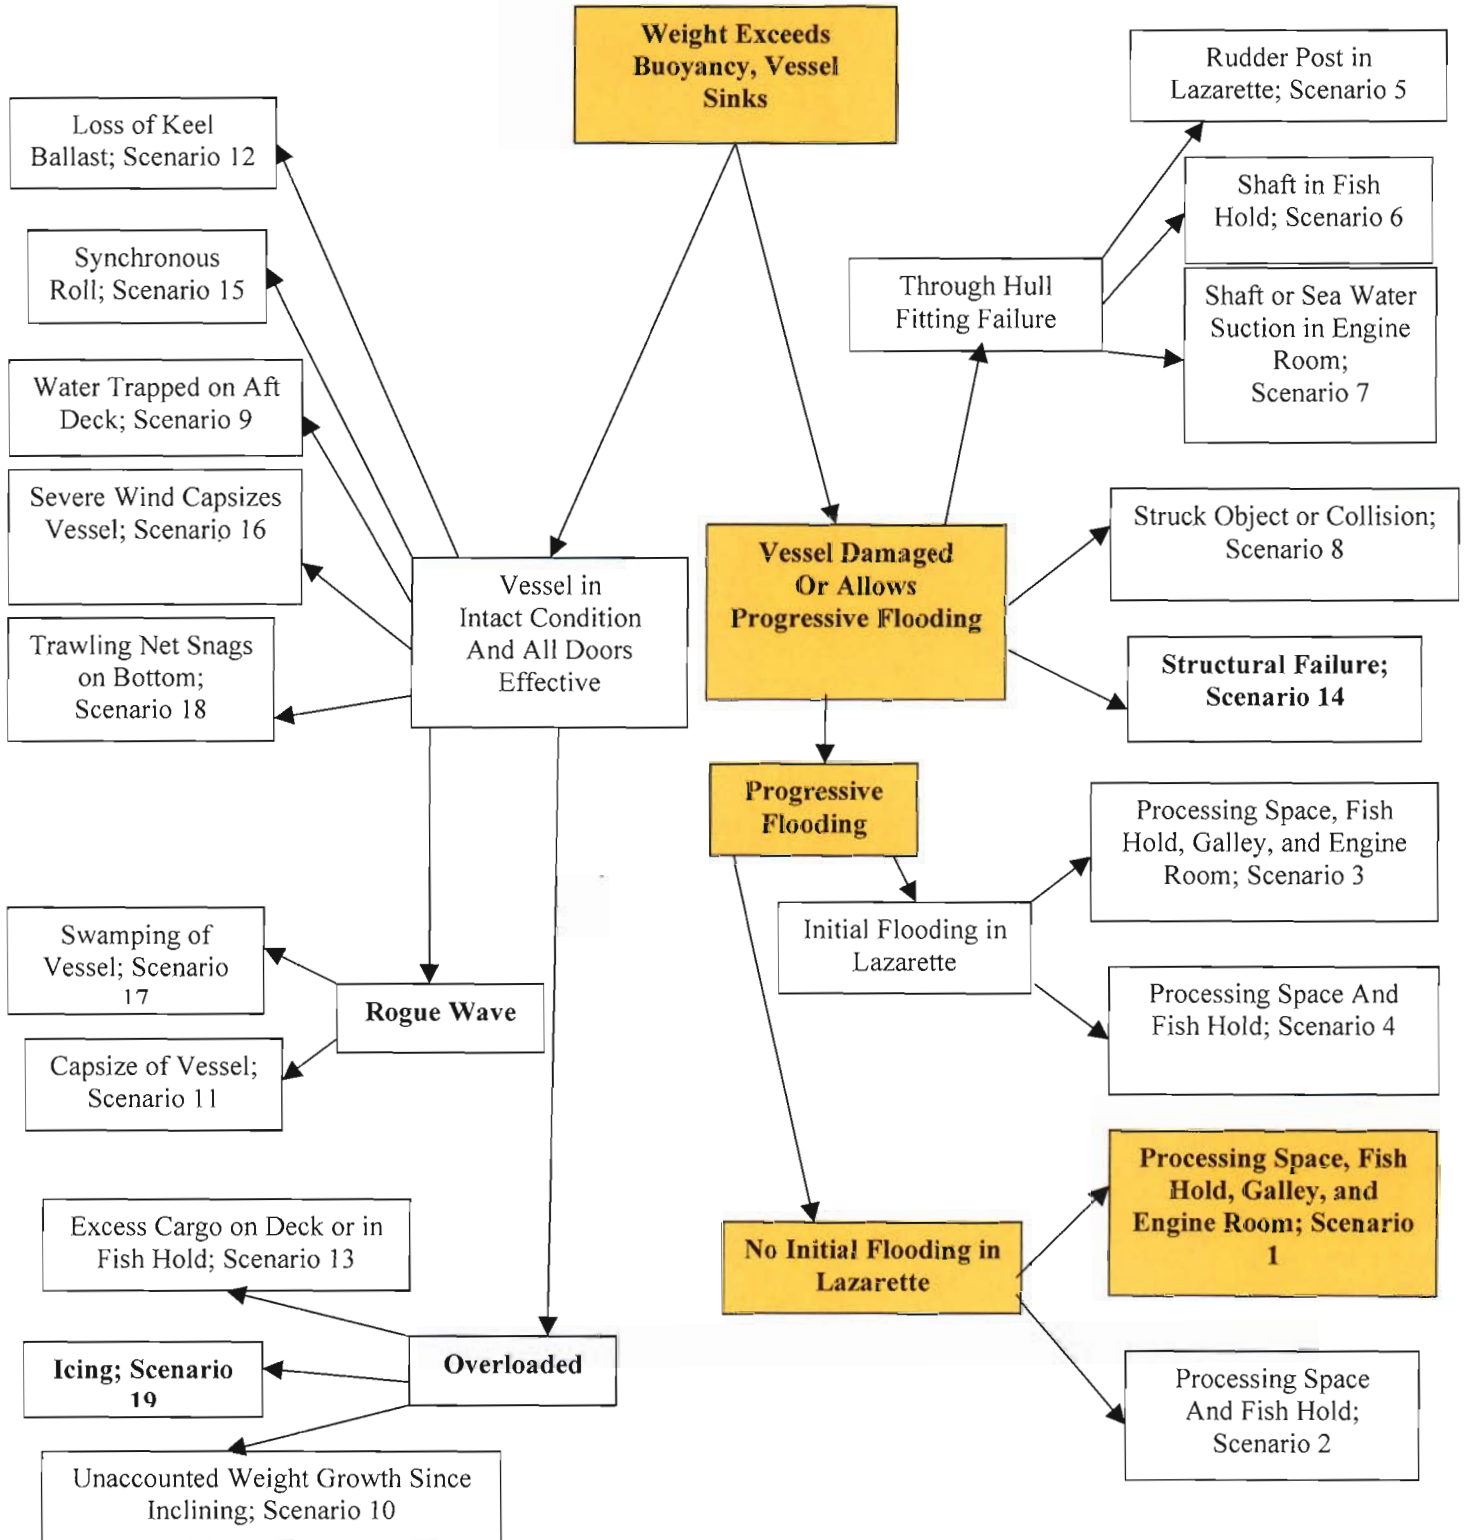
## SCENARIO 1

### PROGRESSIVE FLOODING INTO PROCESSING SPACE, FISH HOLD, GALLEY, AND ENGINE ROOM

7. Based on the ARCTIC ROSE's rapid loss of positive stability and reserve buoyancy, the ROV video showing the aft door to the processing space open, testimony on the lack of watertight integrity above the main deck, and the arrangement of the vessel, it is most likely that progressive flooding of the processing space, fish hold, engine room, and galley was the cause of the loss of the ARCTIC ROSE.

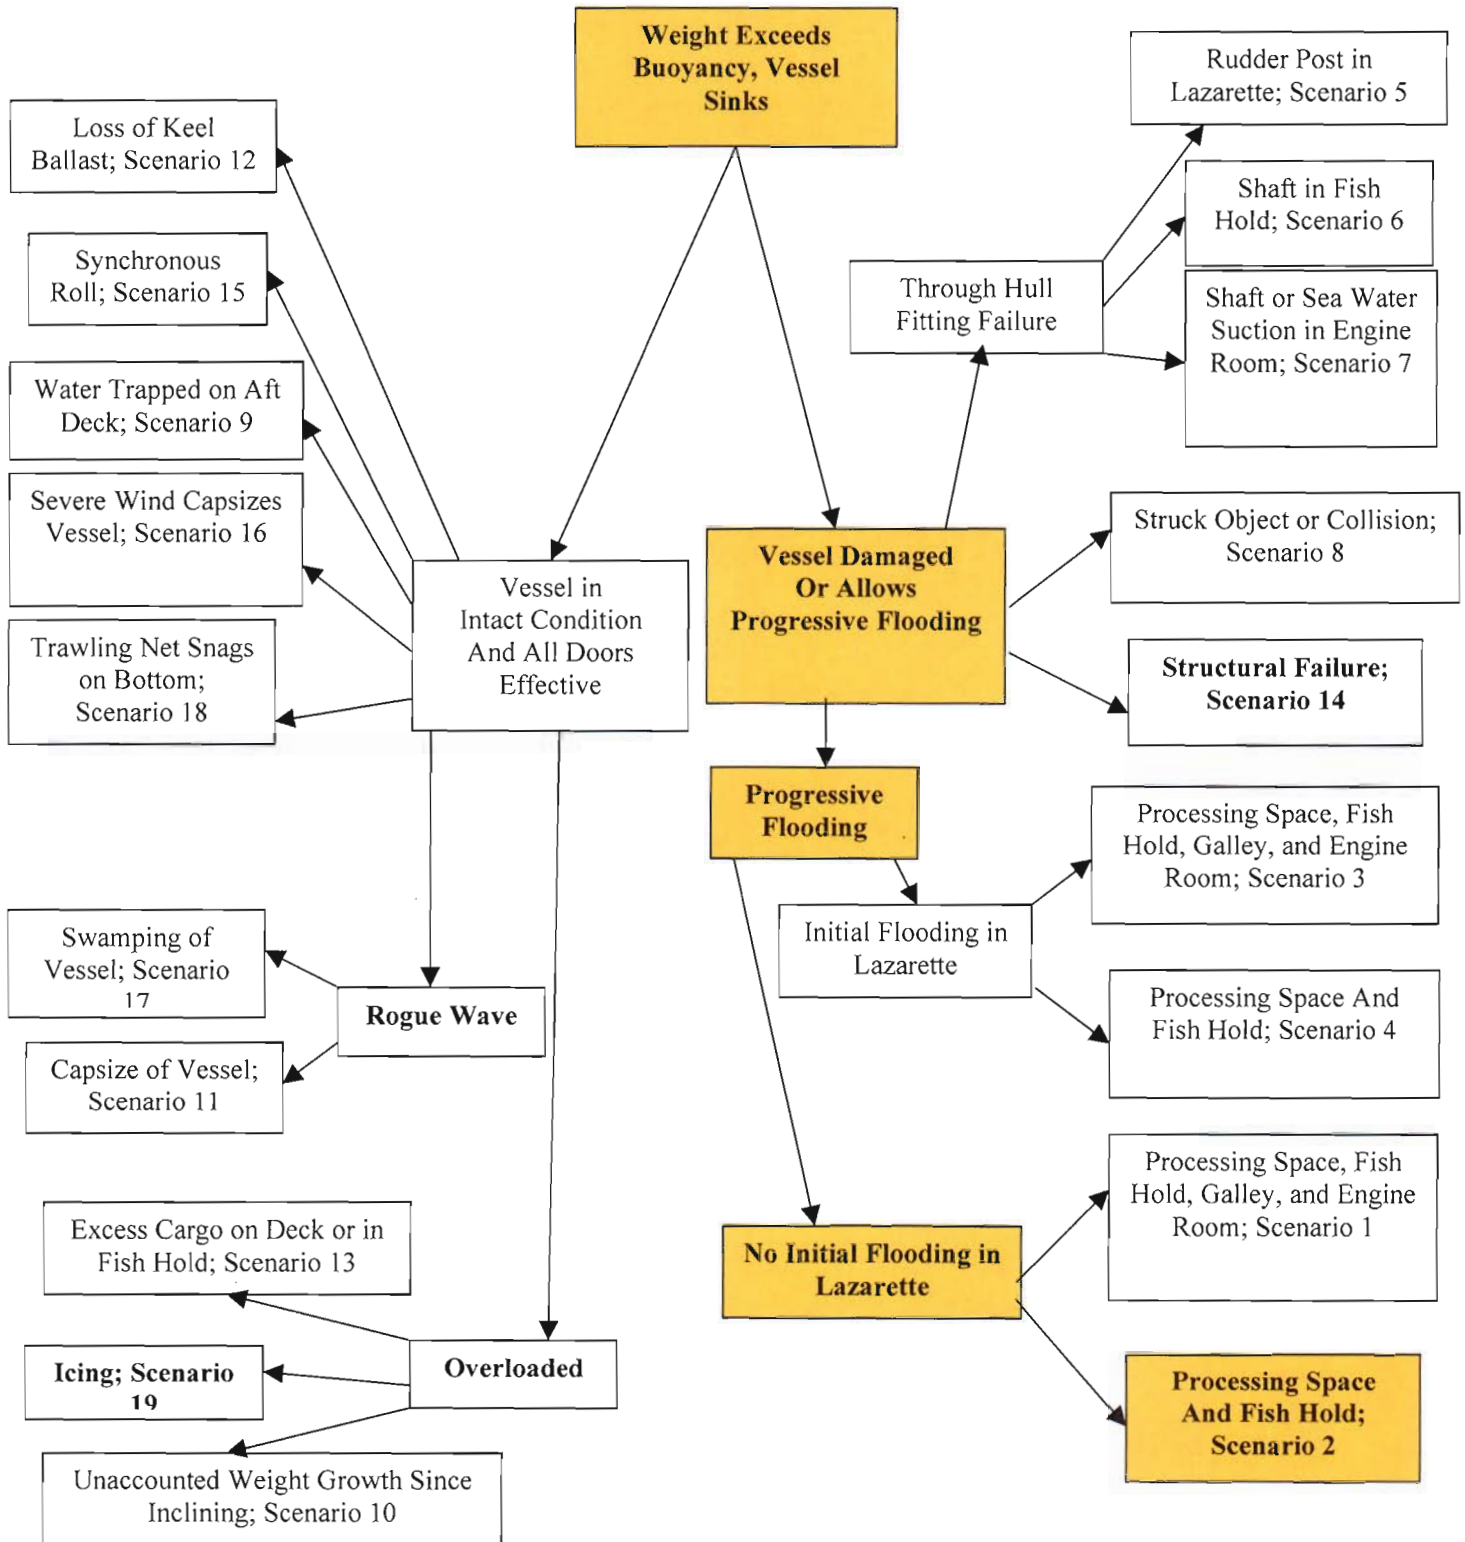
## SCENARIO 2

### PROGRESSIVE FLOODING INTO PROCESSING SPACE AND FISH HOLD

7. Based on the ARCTIC ROSE's rapid loss of positive stability and reserve buoyancy, the ROV video showing the aft door to the processing space open, testimony on the lack of watertight integrity above the main deck, and the arrangement of the vessel, it is likely that progressive flooding of the processing space and fish hold could have caused the loss of the ARCTIC ROSE. However, progressive flooding of the processing space and fish hold only is not the most likely scenario, because the non-weather-tight doors leading into the changing room, engine room, and galley would have had to prevent any water entry. Testimony provided to the Marine Board indicated this weather-tight door from the processing space to the mudroom was always open. The loss of reserve buoyancy of the processing space and fish hold alone would probably not be enough to sink the vessel.

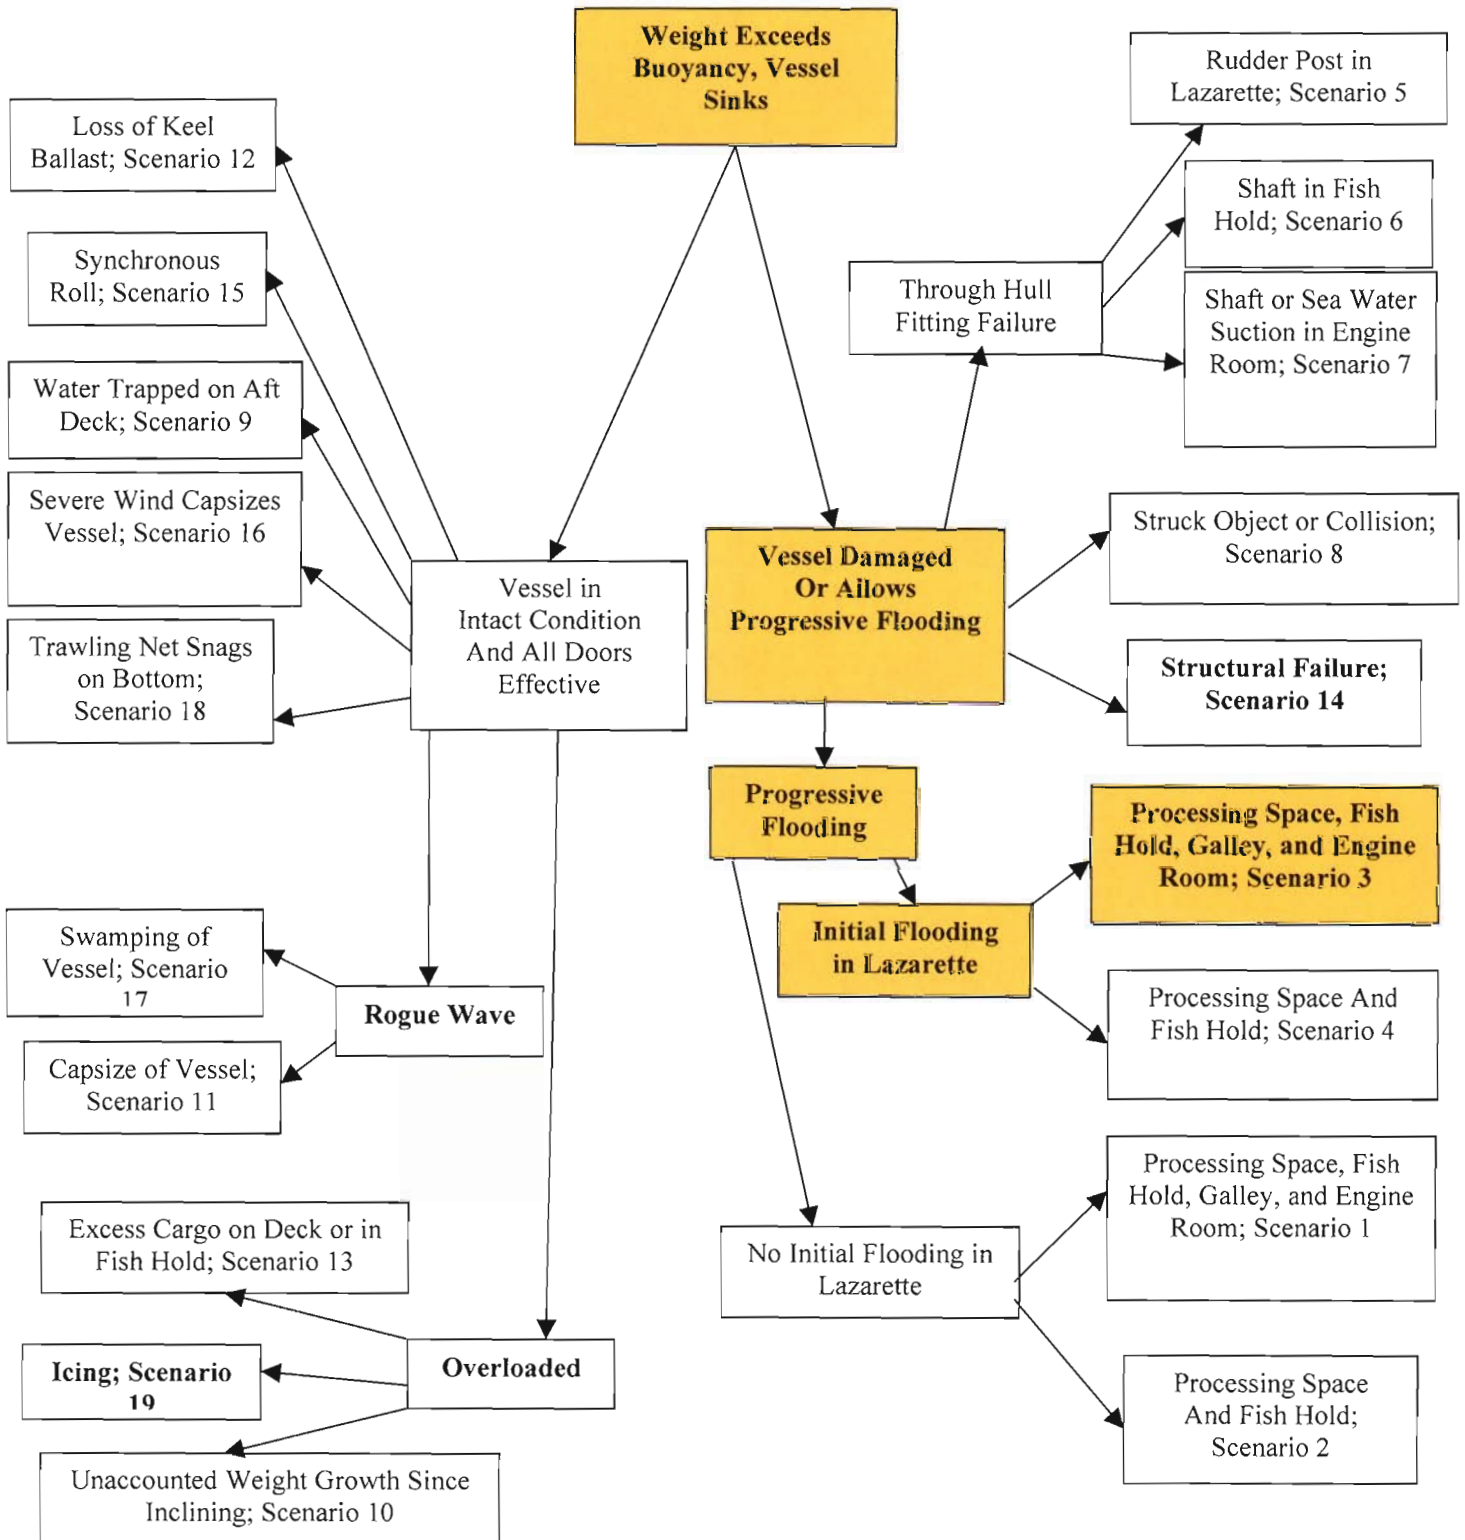
## SCENARIO 3

### PROGRESSIVE FLOODING INTO PROCESSING SPACE, FISH HOLD, GALLEY, AND ENGINE ROOM WITH LAZARETTE FLOODED TO EQUILIBRIUM

8. Based on the ARCTIC ROSE's rapid loss of positive stability and reserve buoyancy, the ROV video showing the aft door to the processing space open, testimony on the lack of watertight integrity above the main deck, and the arrangement of the vessel, it is possible that progressive flooding of the processing space, fish hold, engine room, and galley after the lazarette flooded to equilibrium was the cause of the loss of the ARCTIC ROSE. However, based on the lack of evidence the lazarette was flooded at the time of the casualty, it is not the most likely scenario analyzed.

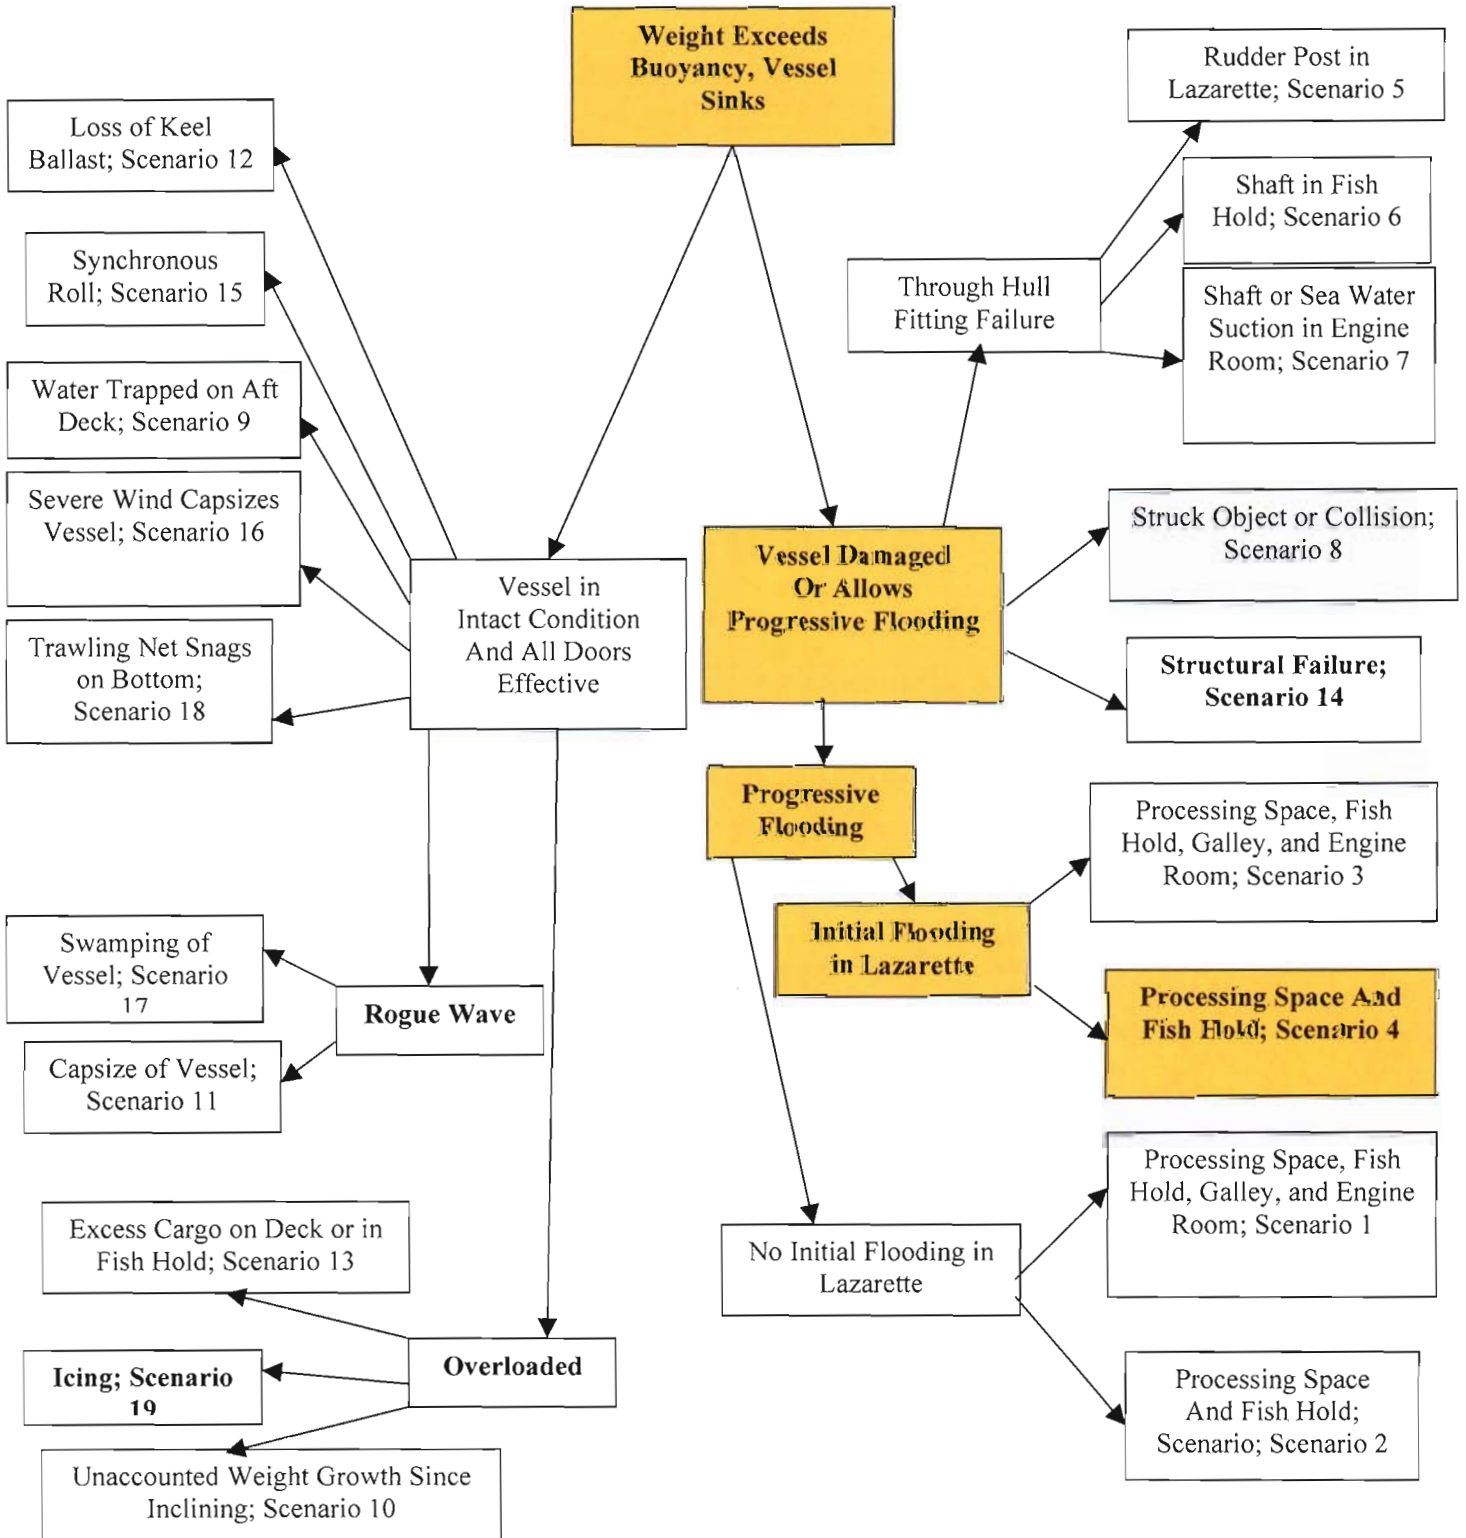
## SCENARIO 4

### PROGRESSIVE FLOODING INTO PROCESSING SPACE AND FISH HOLD WITH LAZARETTE FLOODED TO EQUILIBRIUM

8. Based on the ARCTIC ROSE's rapid loss of positive stability and reserve buoyancy, the ROV video showing the aft door to the processing space open, testimony on the lack of watertight integrity above the main deck, and the arrangement of the vessel, it is possible that progressive flooding of the processing space and fish hold after the lazarette flooded to equilibrium was the cause of the loss of the ARCTIC ROSE. However, based on the lack of evidence the lazarette was flooded at the time of the casualty, and the necessity for other spaces to eventually flood, it is not the most likely scenario analyzed.

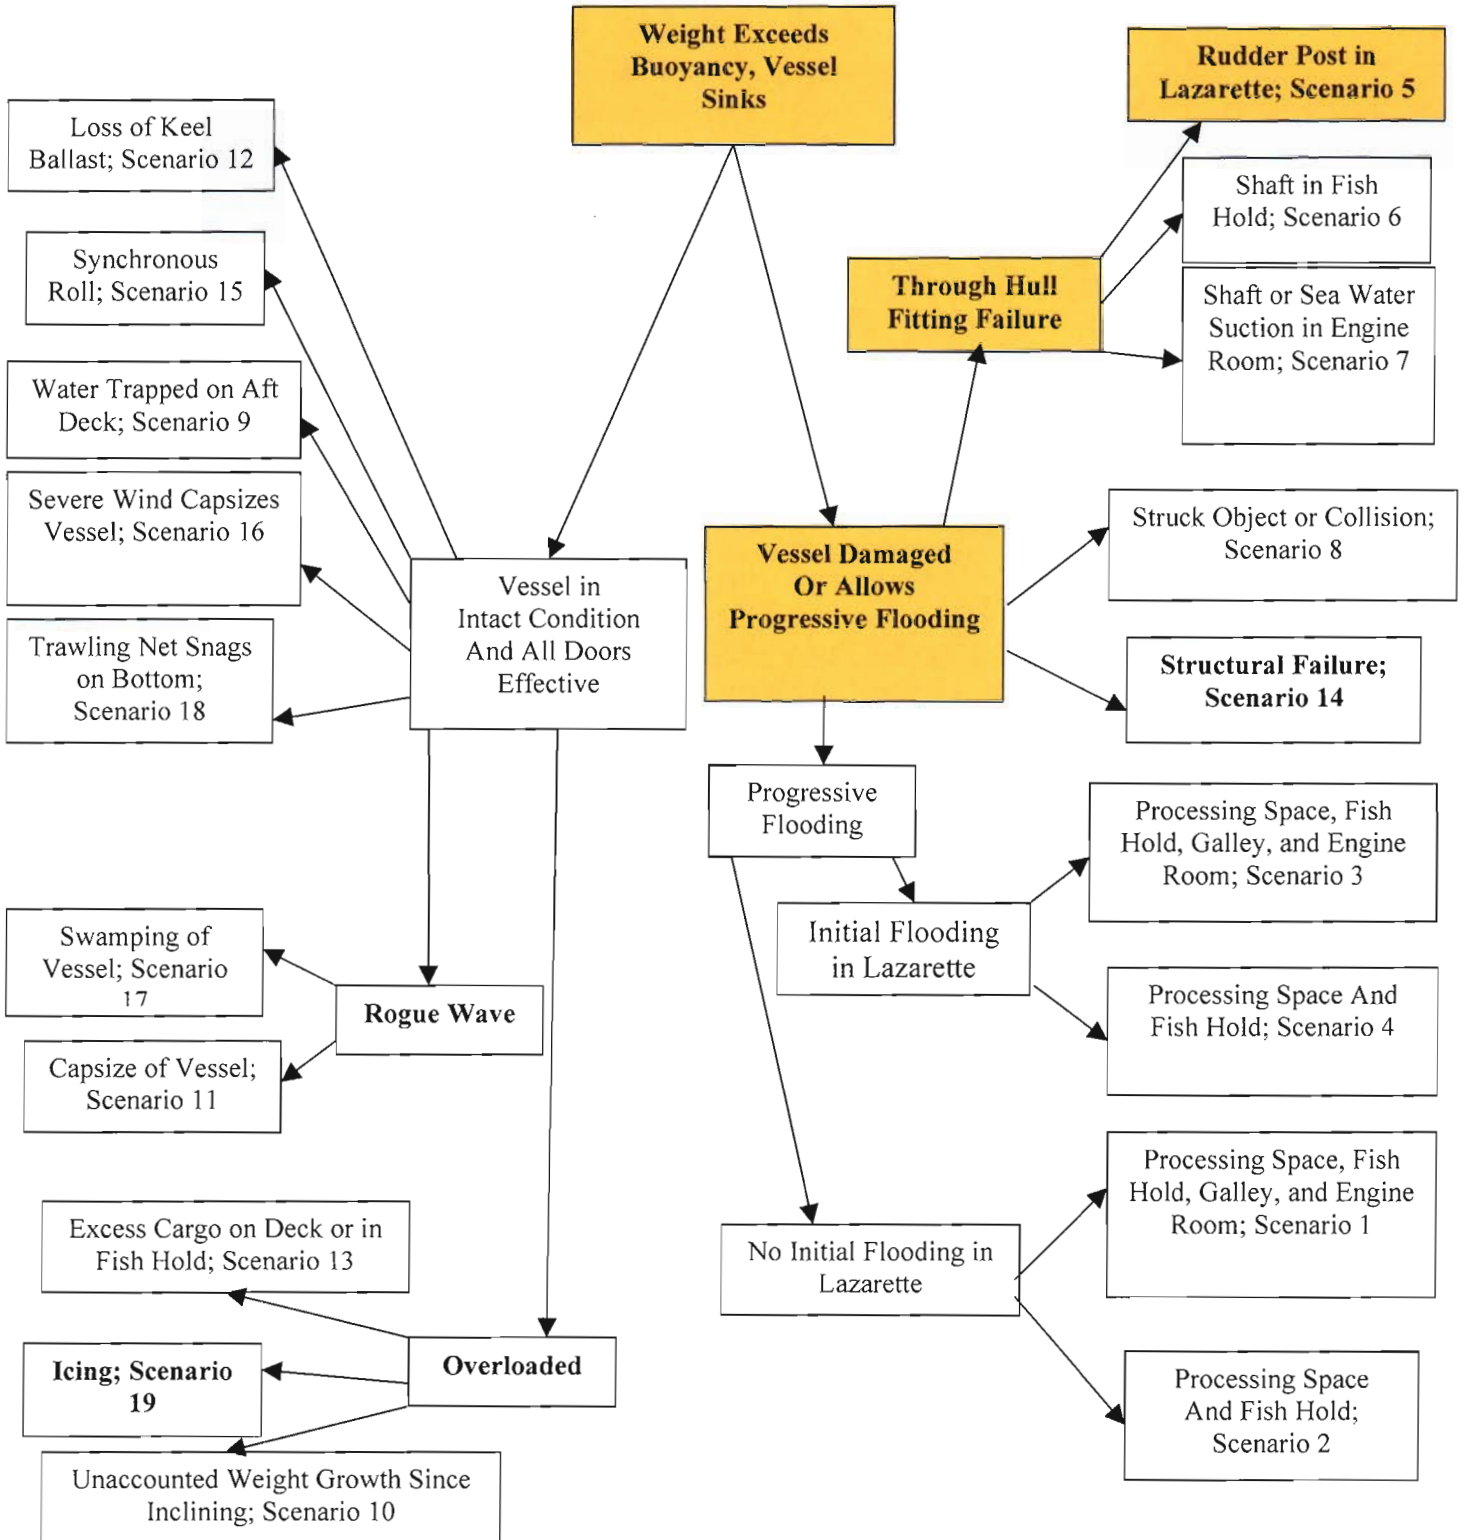
## SCENARIO 5

### THROUGH HULL FITTING FAILURE: RUDDER POST IN LAZARETTE AND DRY HOLD

5. Based on the ARCTIC ROSE's stability characteristics with the lazarette and dry stores spaces flooded and the lack of evidence of structural damage around the rudder post, it is unlikely that the loss of the ARCTIC ROSE was due to failure of a through hull fitting in the lazarette and dry store spaces.

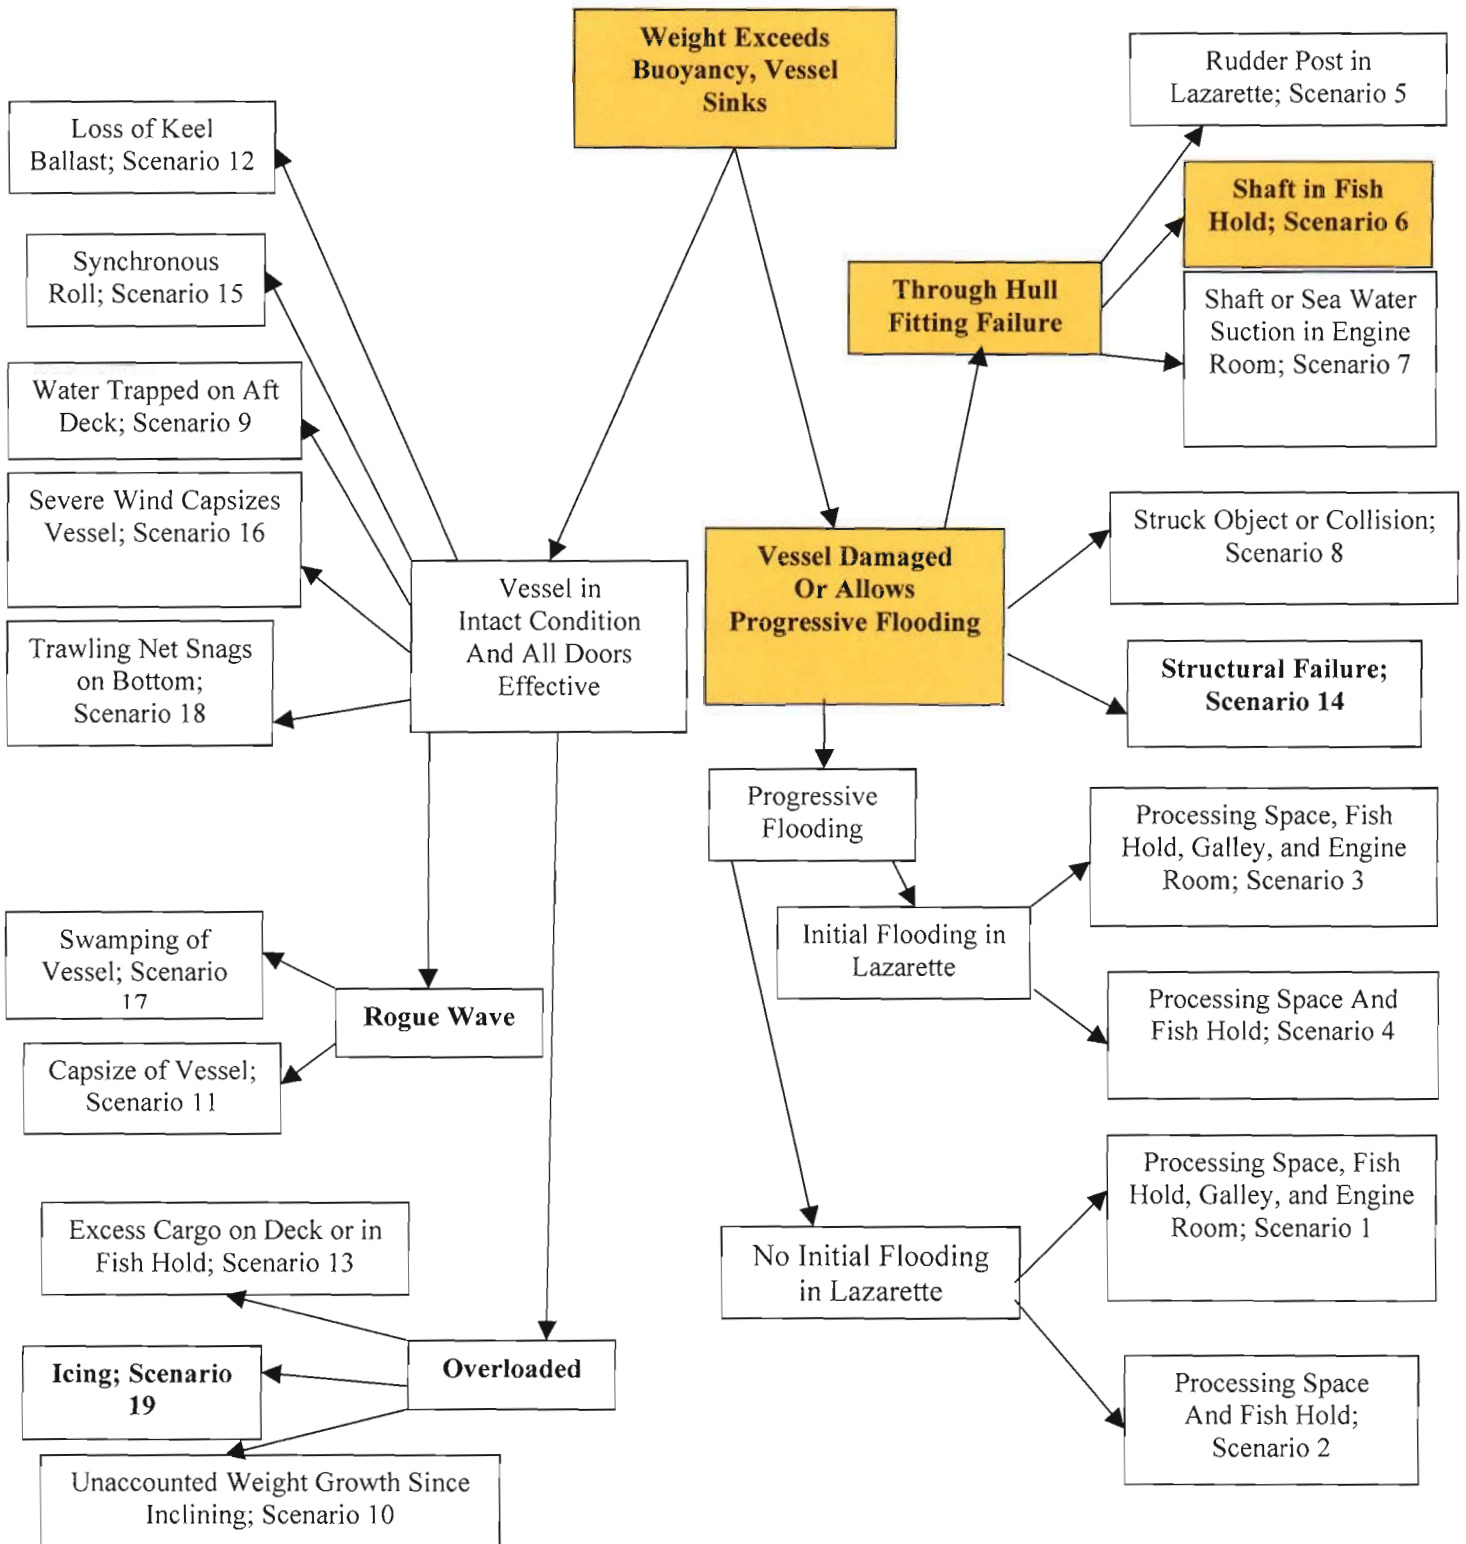
## SCENARIO 6

### THROUGH HULL FITTING FAILURE: SHAFT IN FISH HOLD

4. Based on the ARCTIC ROSE's stability characteristics with the fish hold space flooded and the lack of evidence of structural damage at a through hull fitting, it is unlikely that the loss of the ARCTIC ROSE was due to failure of a through hull fitting in the fish hold.

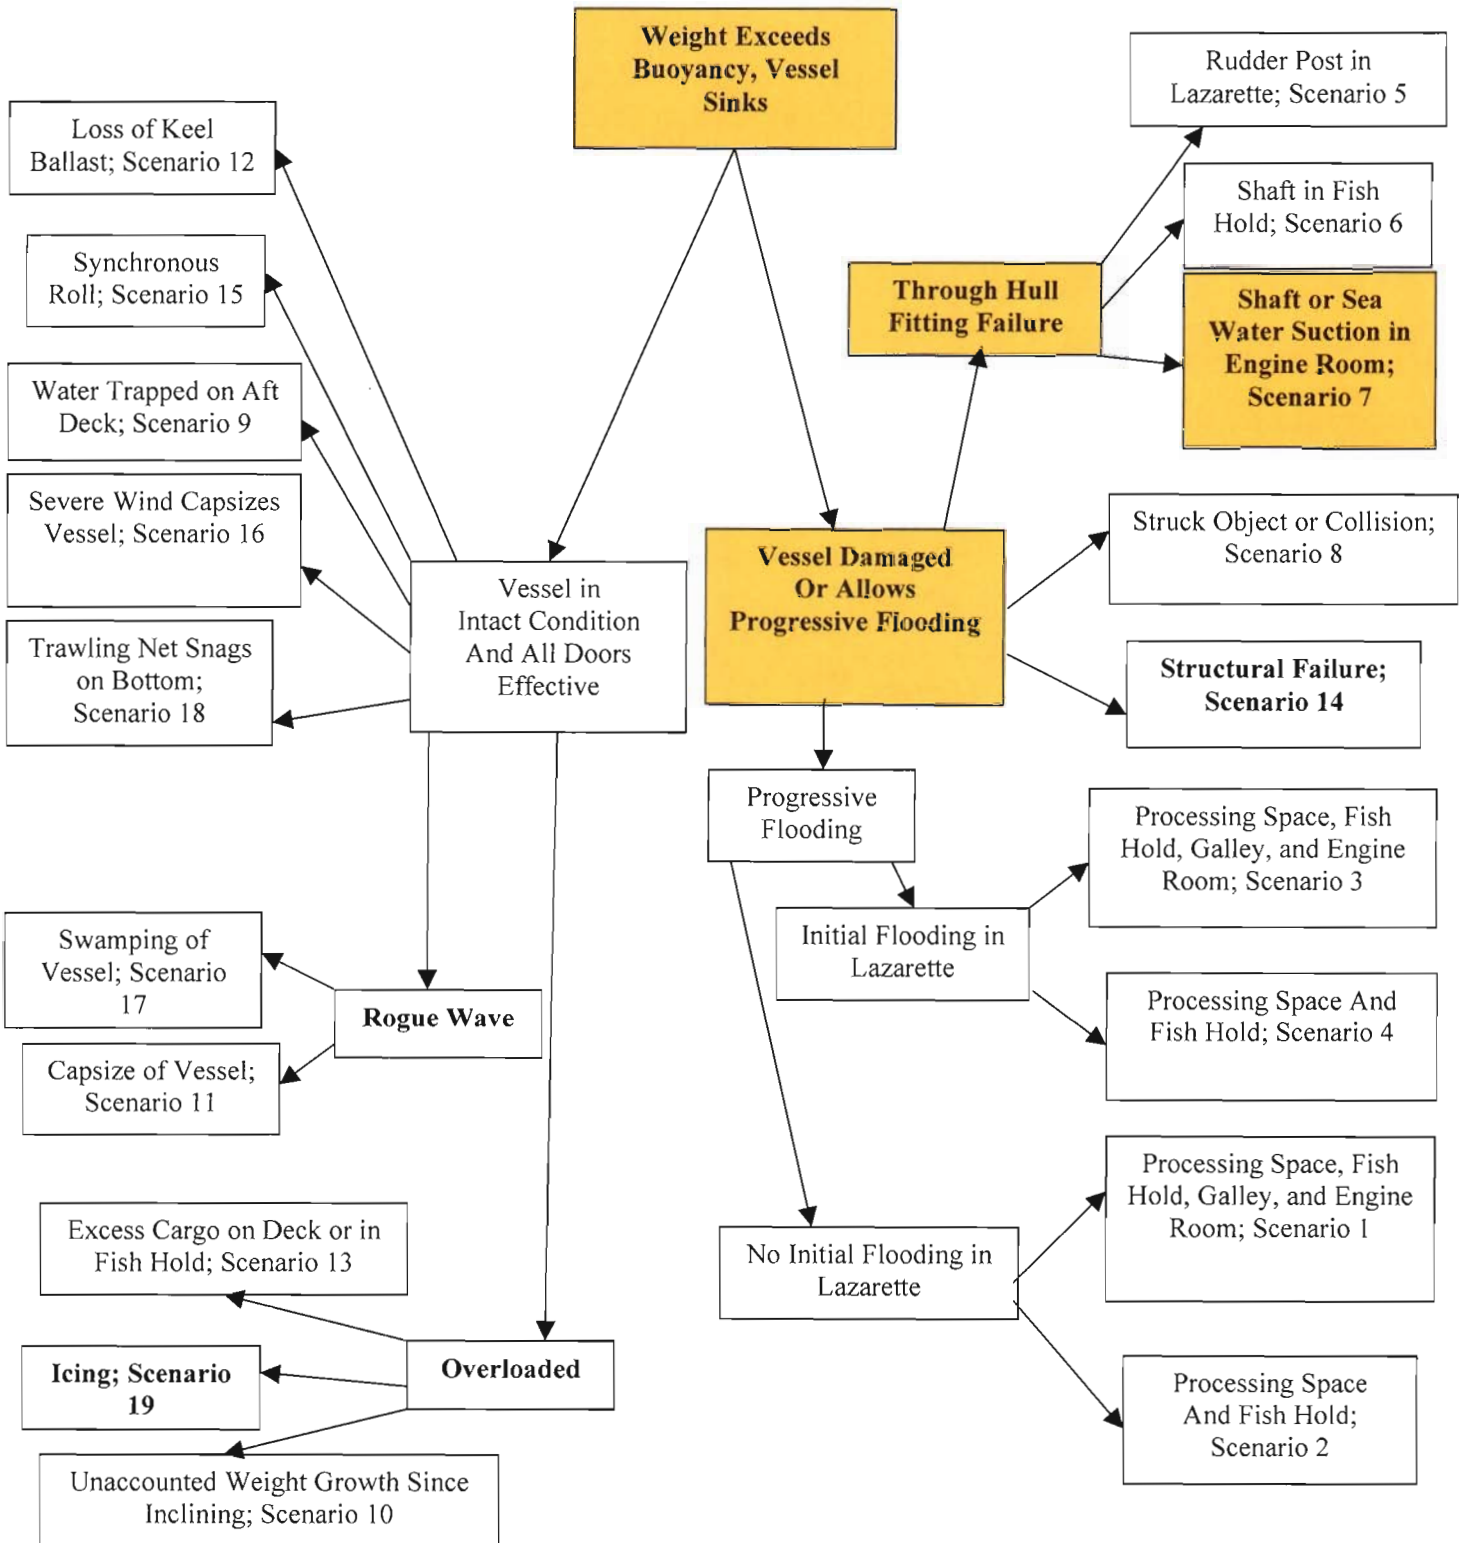
## SCENARIO 7

### THROUGH HULL FITTING FAILURE: SHAFT OR SEA SUCTION IN ENGINE ROOM AND MACHINERY SPACE

5. Based on the ARCTIC ROSE's stability characteristics with the engine room and machinery space flooded and the lack of evidence of structural damage around the engine room, it is unlikely that the loss of the ARCTIC ROSE was due to failure of a through hull fitting in the engine room or machinery space.
