INVESTIGATION INTO THE CIRCUMSTANCES  
SURROUNDING THE SINKING OF THE  
UNINSPECTED FISHING VESSEL

## ARCTIC ROSE

OFFICIAL NUMBER 931446, IN THE BERING SEA ON  
APRIL 2, 2001, WITH ONE PERSON DECEASED AND  
FOURTEEN PERSONS MISSING AND PRESUMED DEAD

Amended 05/20/2004

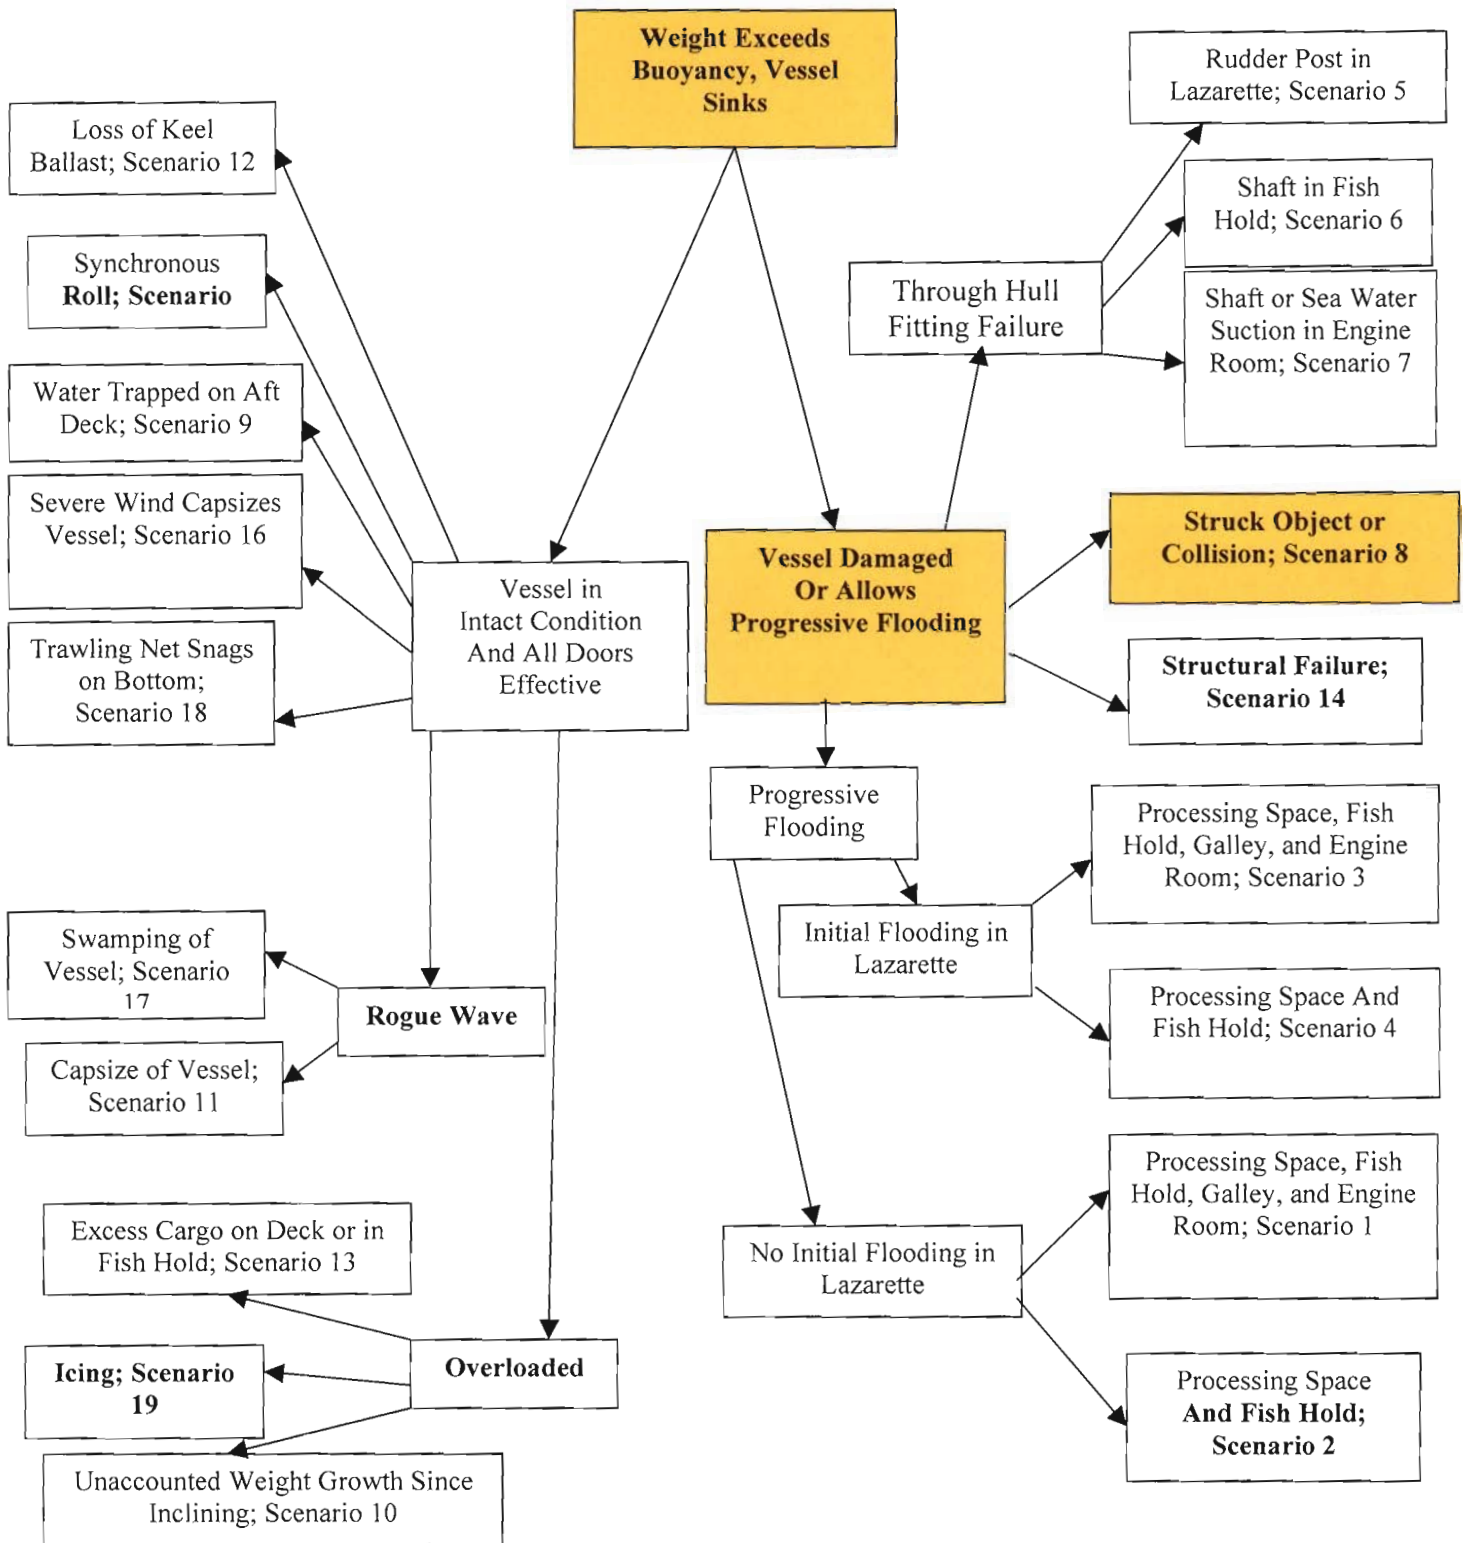
## SCENARIO 8

### STRUCK OBJECT OR COLLISION

6. Based on the ARCTIC ROSE's stability characteristics with either the fuel oil wing tanks or the forepeak compartment flooded, and the lack of evidence of structural damage on the outside of the vessel, it is unlikely that the loss of the ARCTIC ROSE was due to striking a submerged object or colliding with an object.

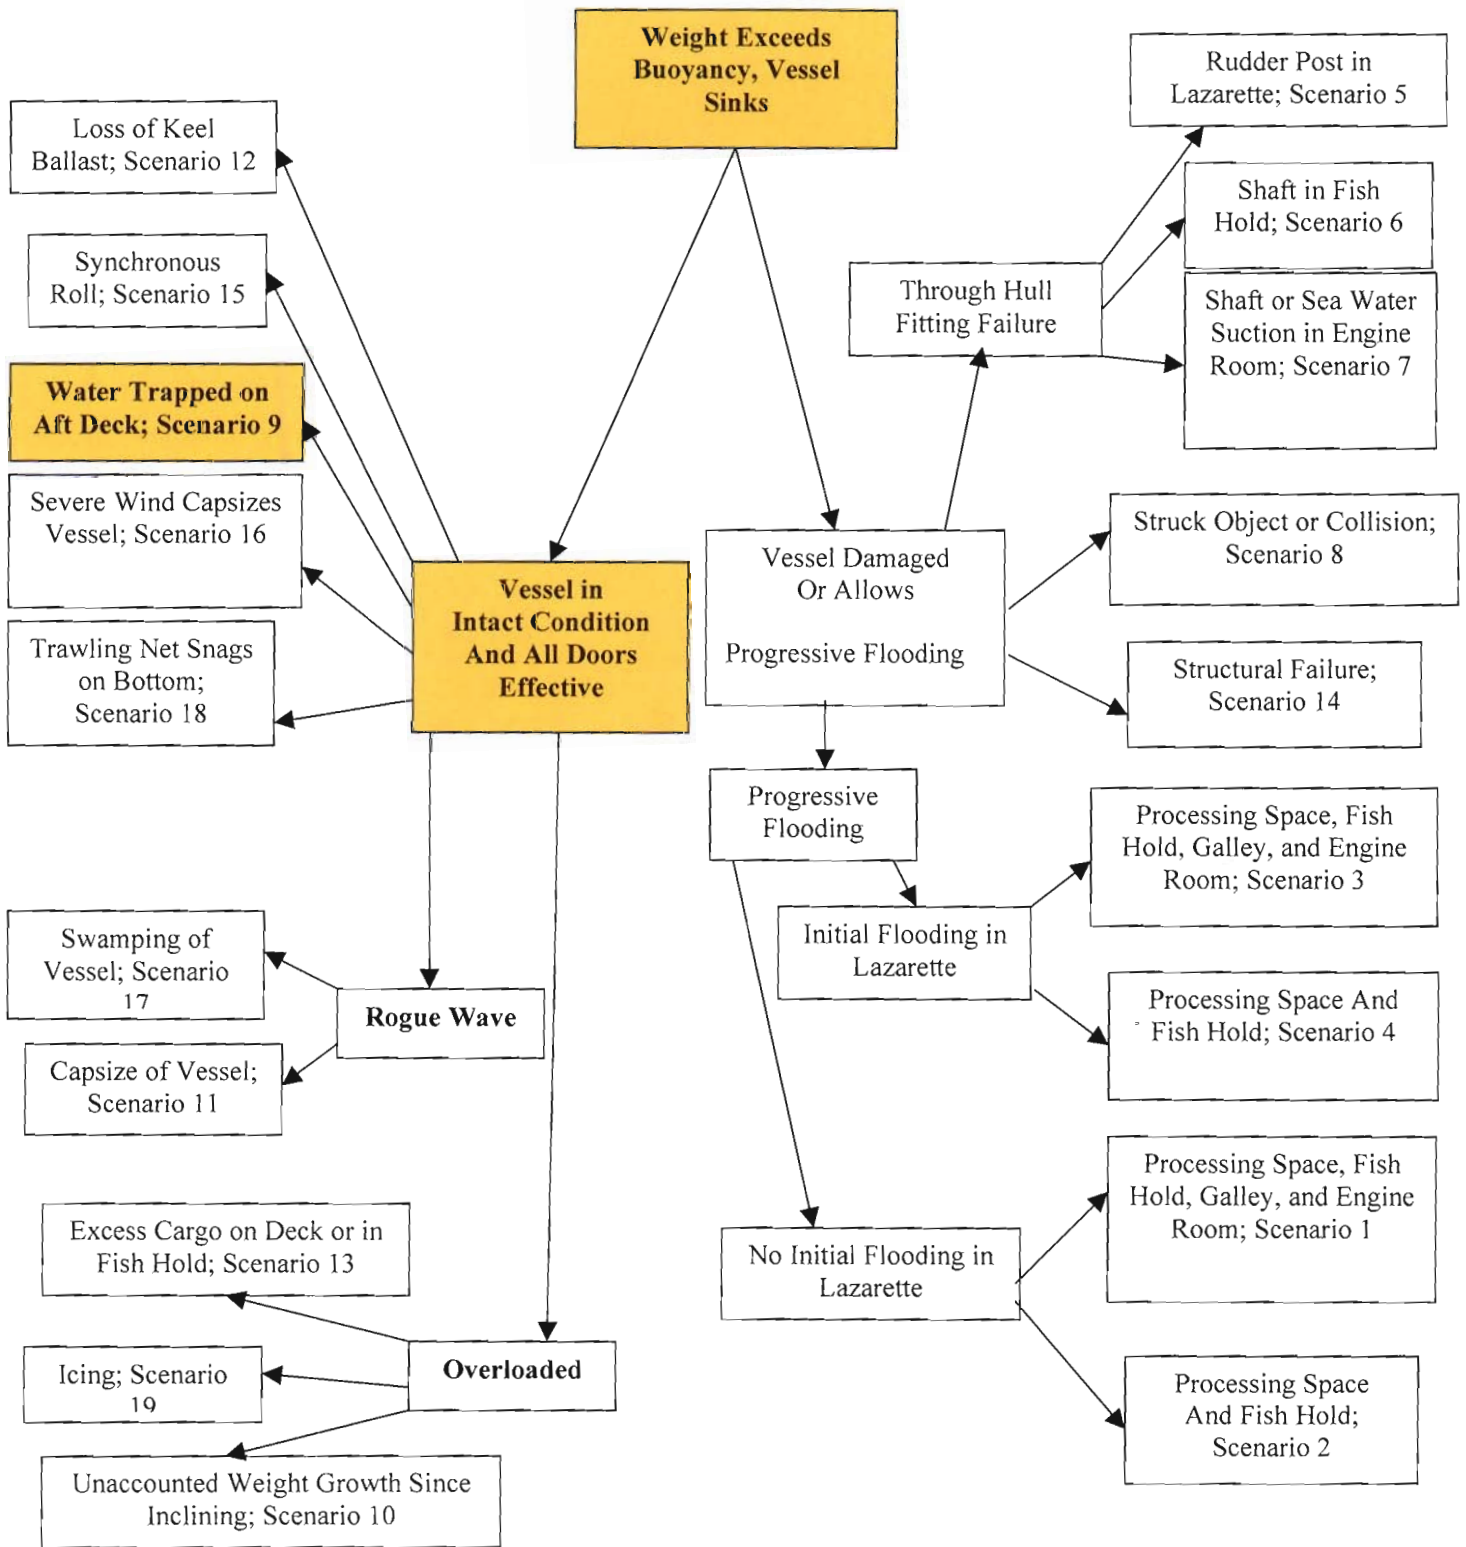
## SCENARIO 9

### WATER TRAPPED ON AFT DECK

4. Although the ARCTIC ROSE's stability would be reduced by water trapped on the after deck, the large range of stability, large reserve buoyancy of the vessel, and lack of evidence that water could gather and remain trapped on deck make it unlikely that the loss of the ARCTIC ROSE was due solely to water trapped on the after deck.

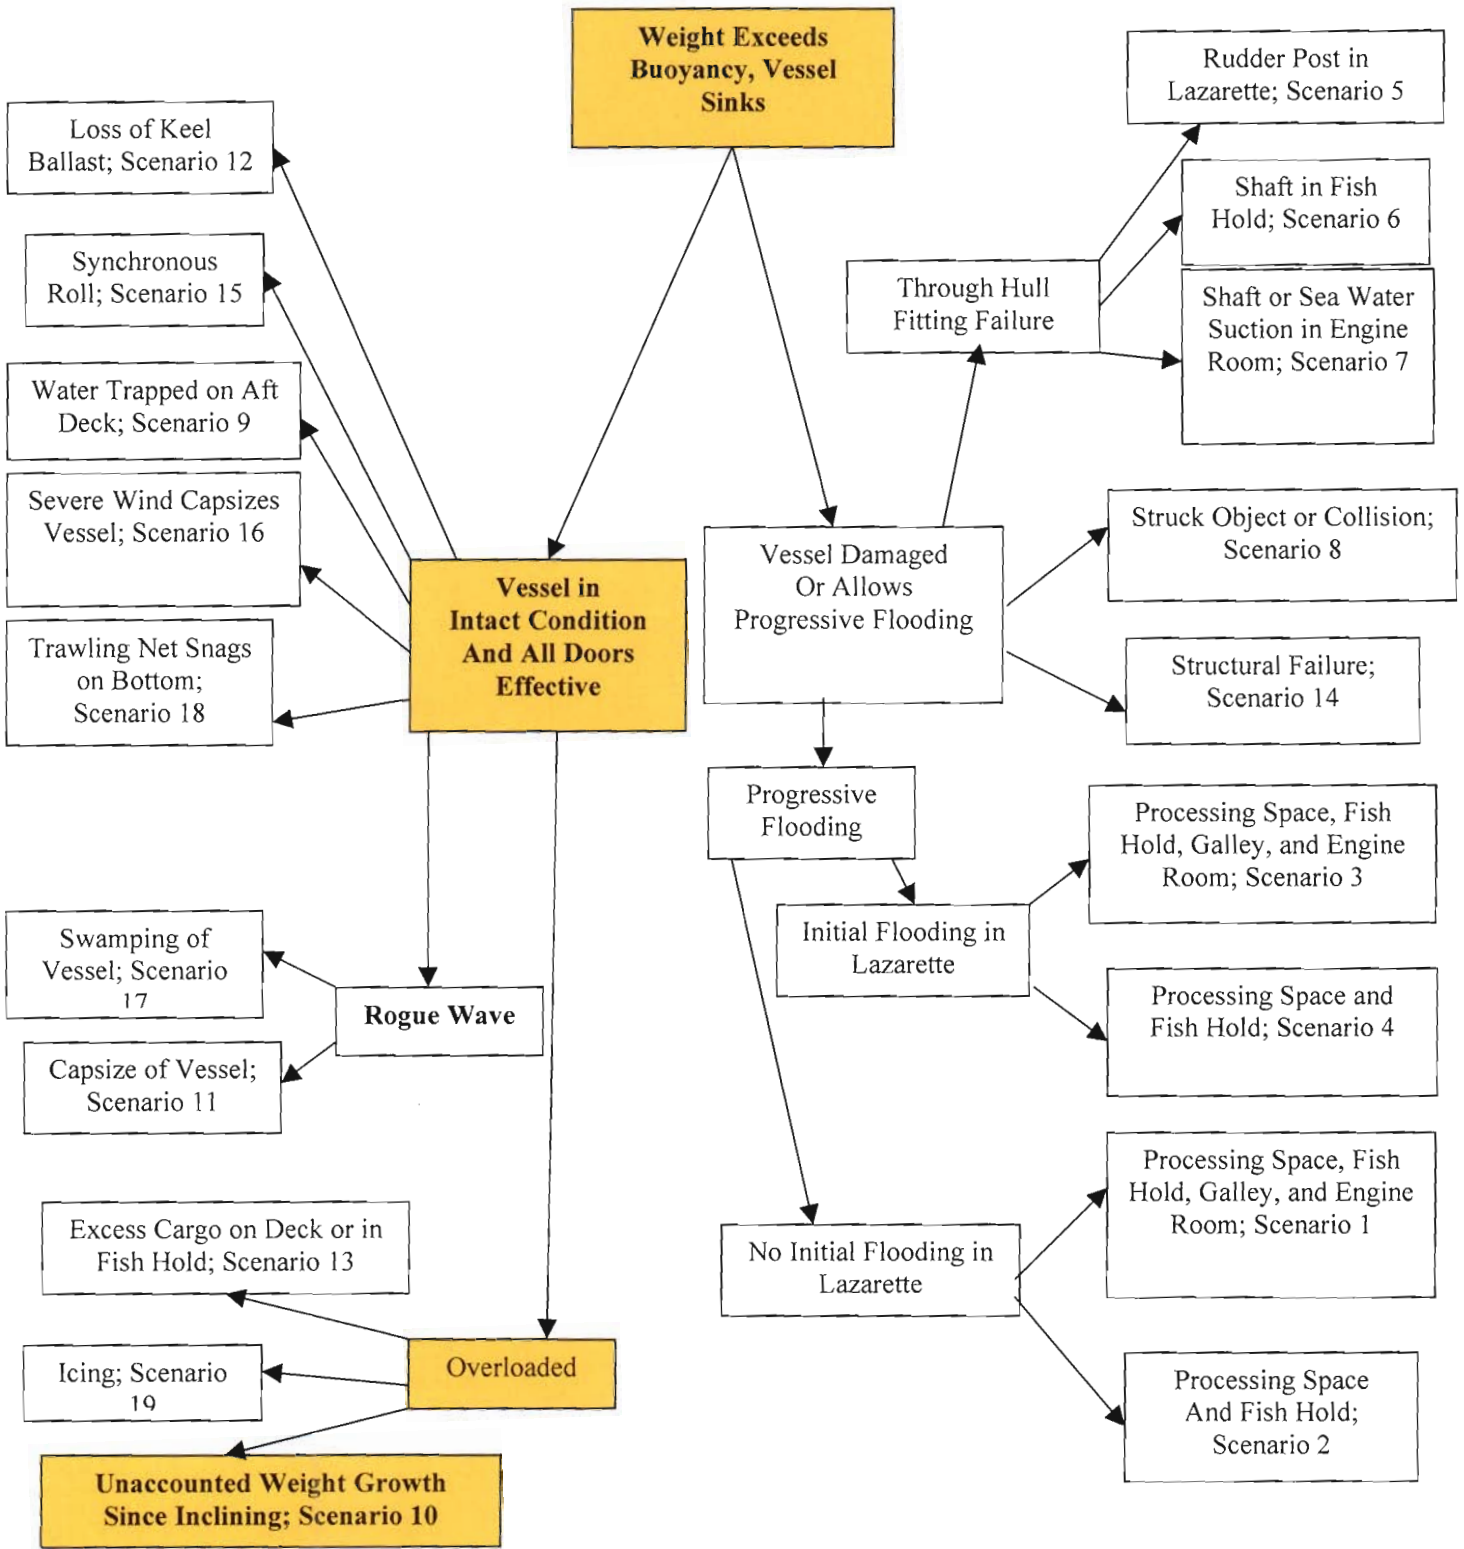
## SCENARIO 10

### UNACCOUNTED FOR WEIGHT GROWTH SINCE INCLINING

3. Based on the accurate correlation between the list of weights added, removed, or moved provided by Jensen Maritime Consultants and the testimony collected by the Marine Board, the ARCTIC ROSE' stability was very likely not severely affected by unaccounted for weight growth.

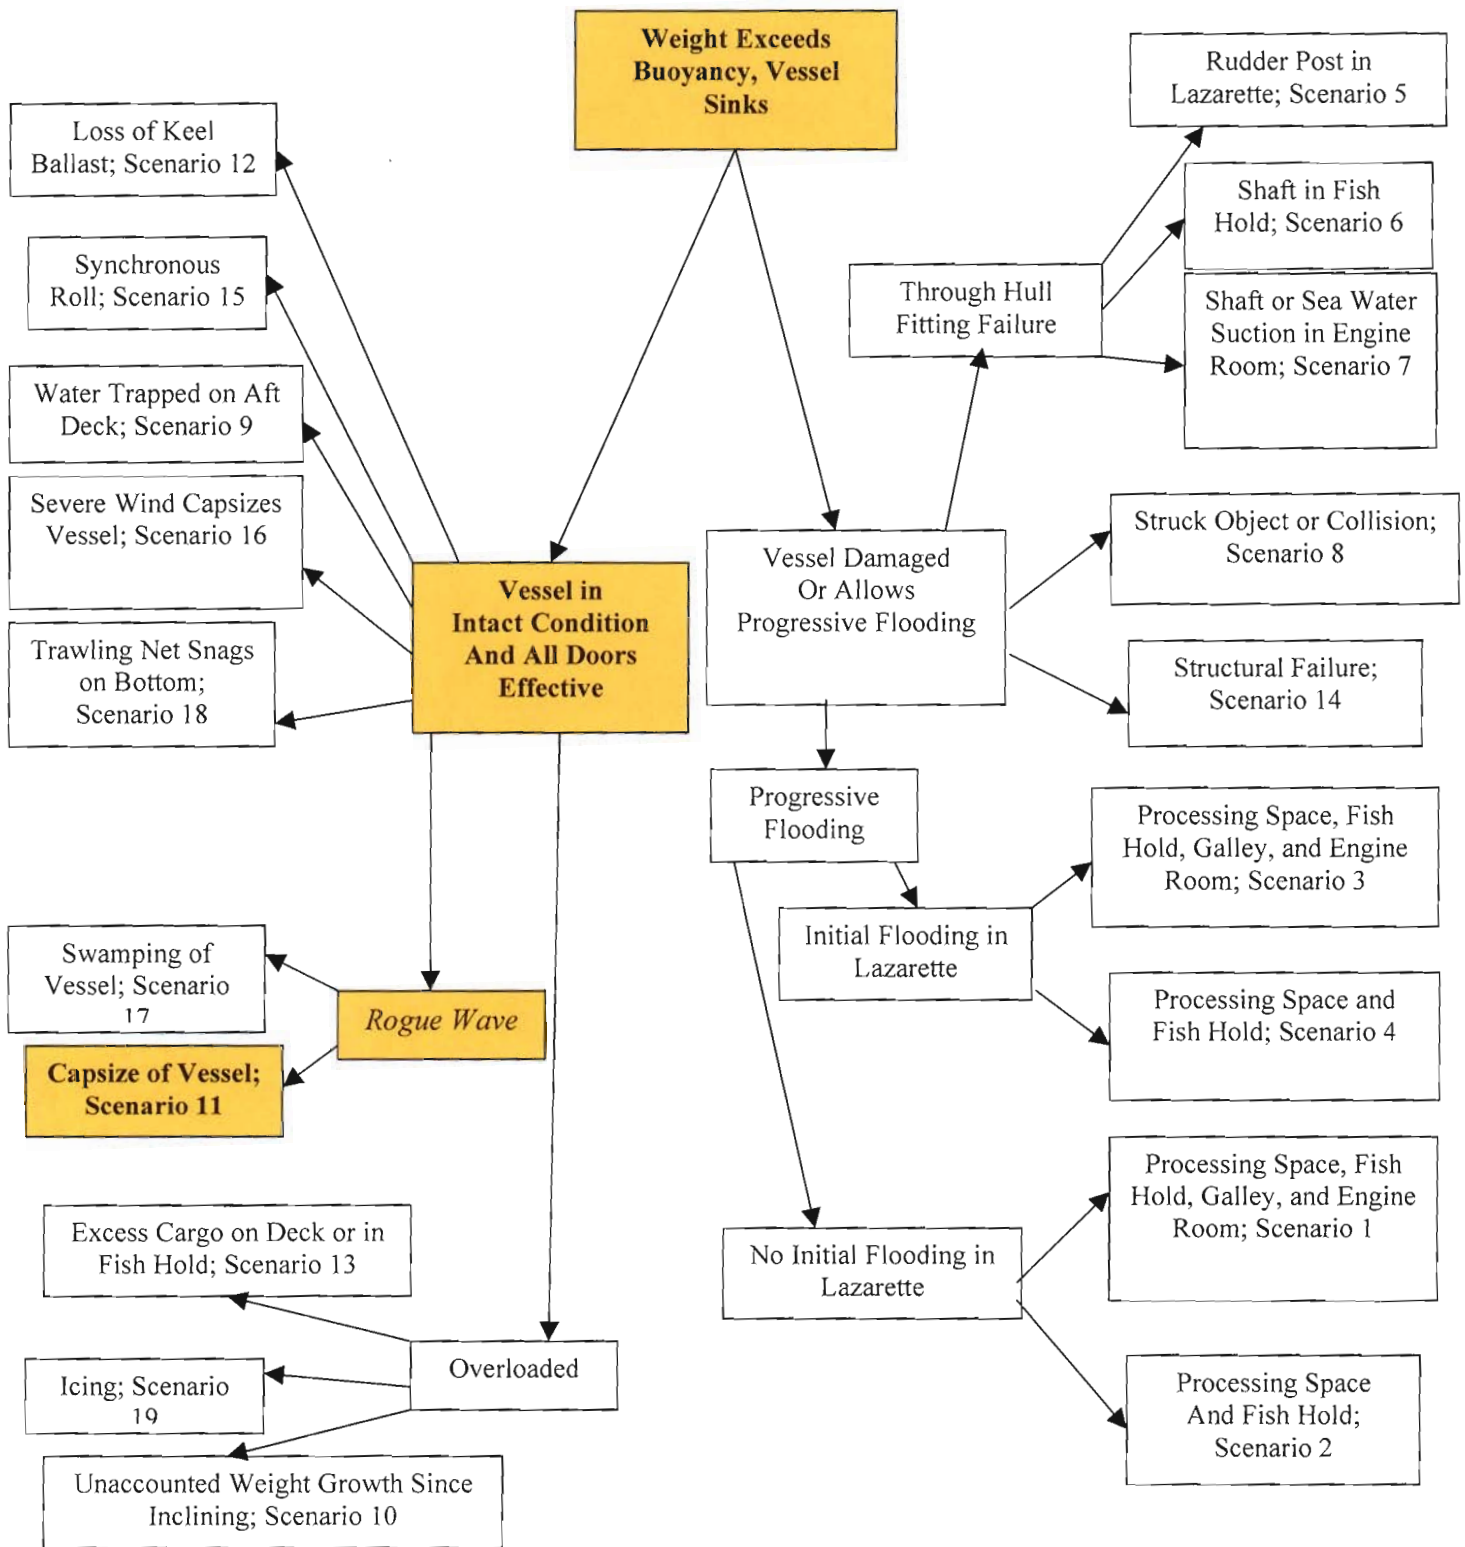
## SCENARIO 11

### CAPSIZING OF VESSEL DUE TO ROGUE WAVE

5. Based on the extremely large wave height calculated as necessary to cause the capsize of the ARCTIC ROSE, and the size of the seas on the night of the casualty, it is very unlikely that the loss of the vessel was due to a rogue wave.

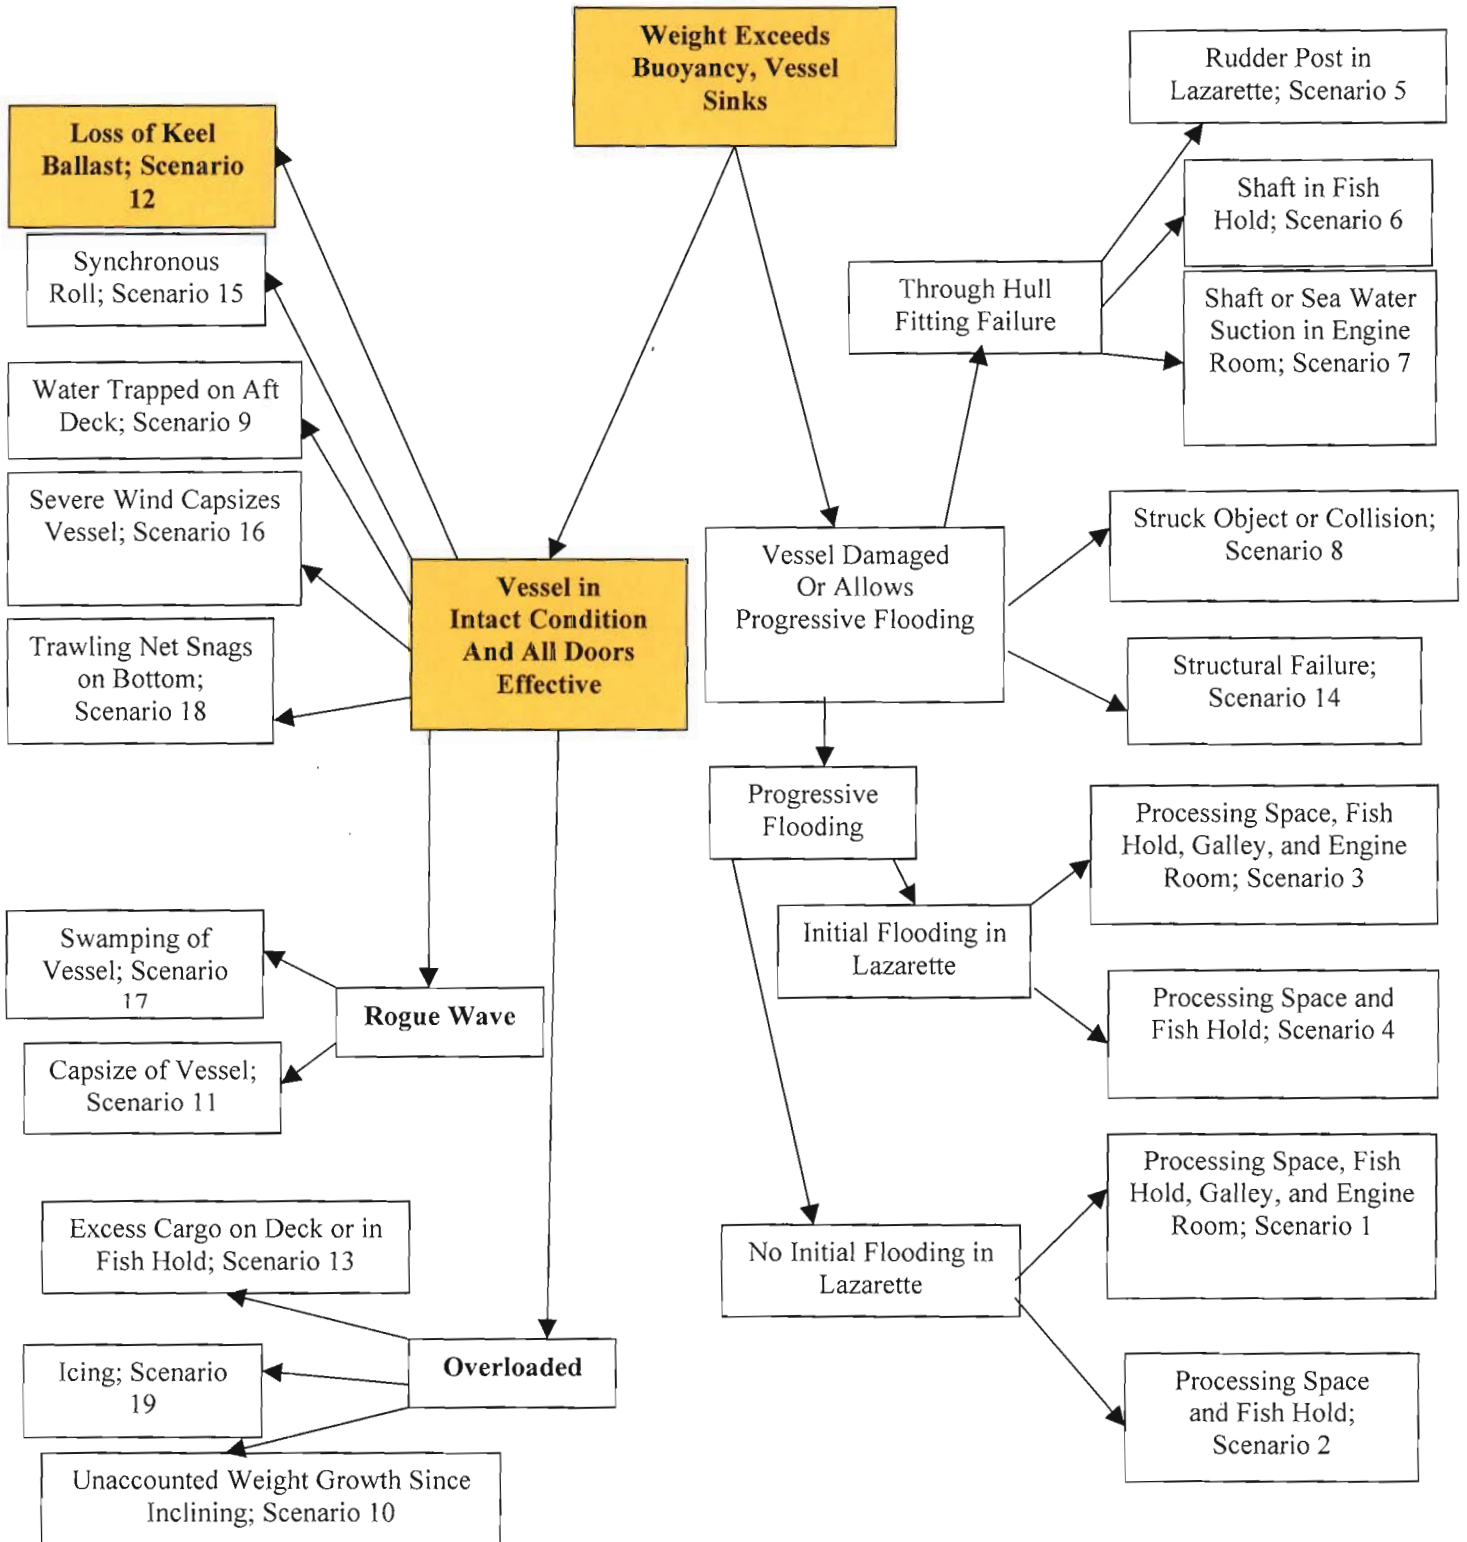
## SCENARIO 12

### LOSS OF KEEL BALLAST

4. Based on the ARCTIC ROSE's stability characteristics without the keel ballast and the fact there was no evidence of structural damage around the keel area, it is unlikely that the loss of the ARCTIC ROSE was due to the loss of the keel ballast.

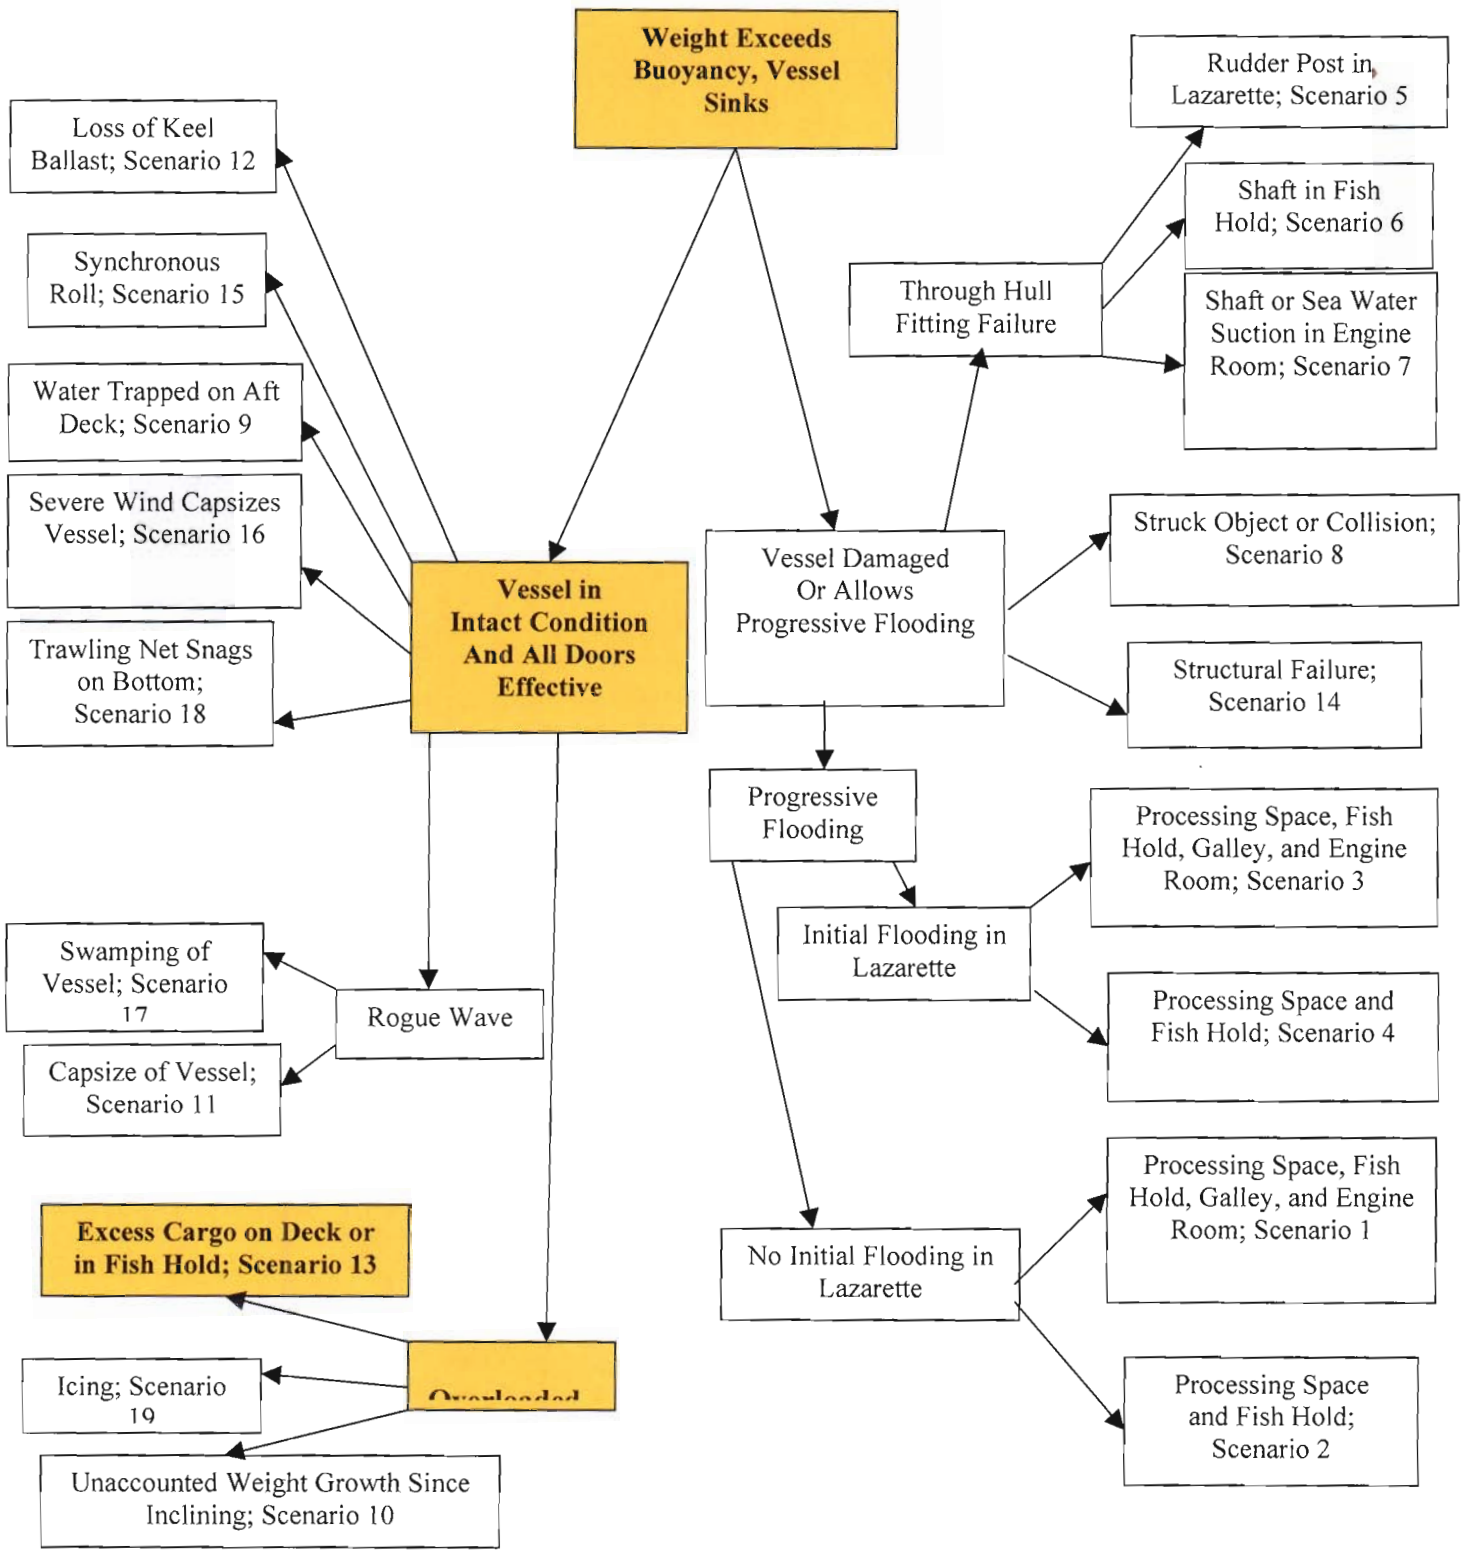
## SCENARIO 13

### OVERLOADED WITH EXCESS CARGO ON DECK OR IN FISH HOLD

3. Based on the cargo loads provided to the Coast Guard by the Marine Board of Investigation and the ROV video, it is very unlikely the loss of the ARCTIC ROSE was due to the vessel being overloaded with excess cargo on deck or in the fish hold.

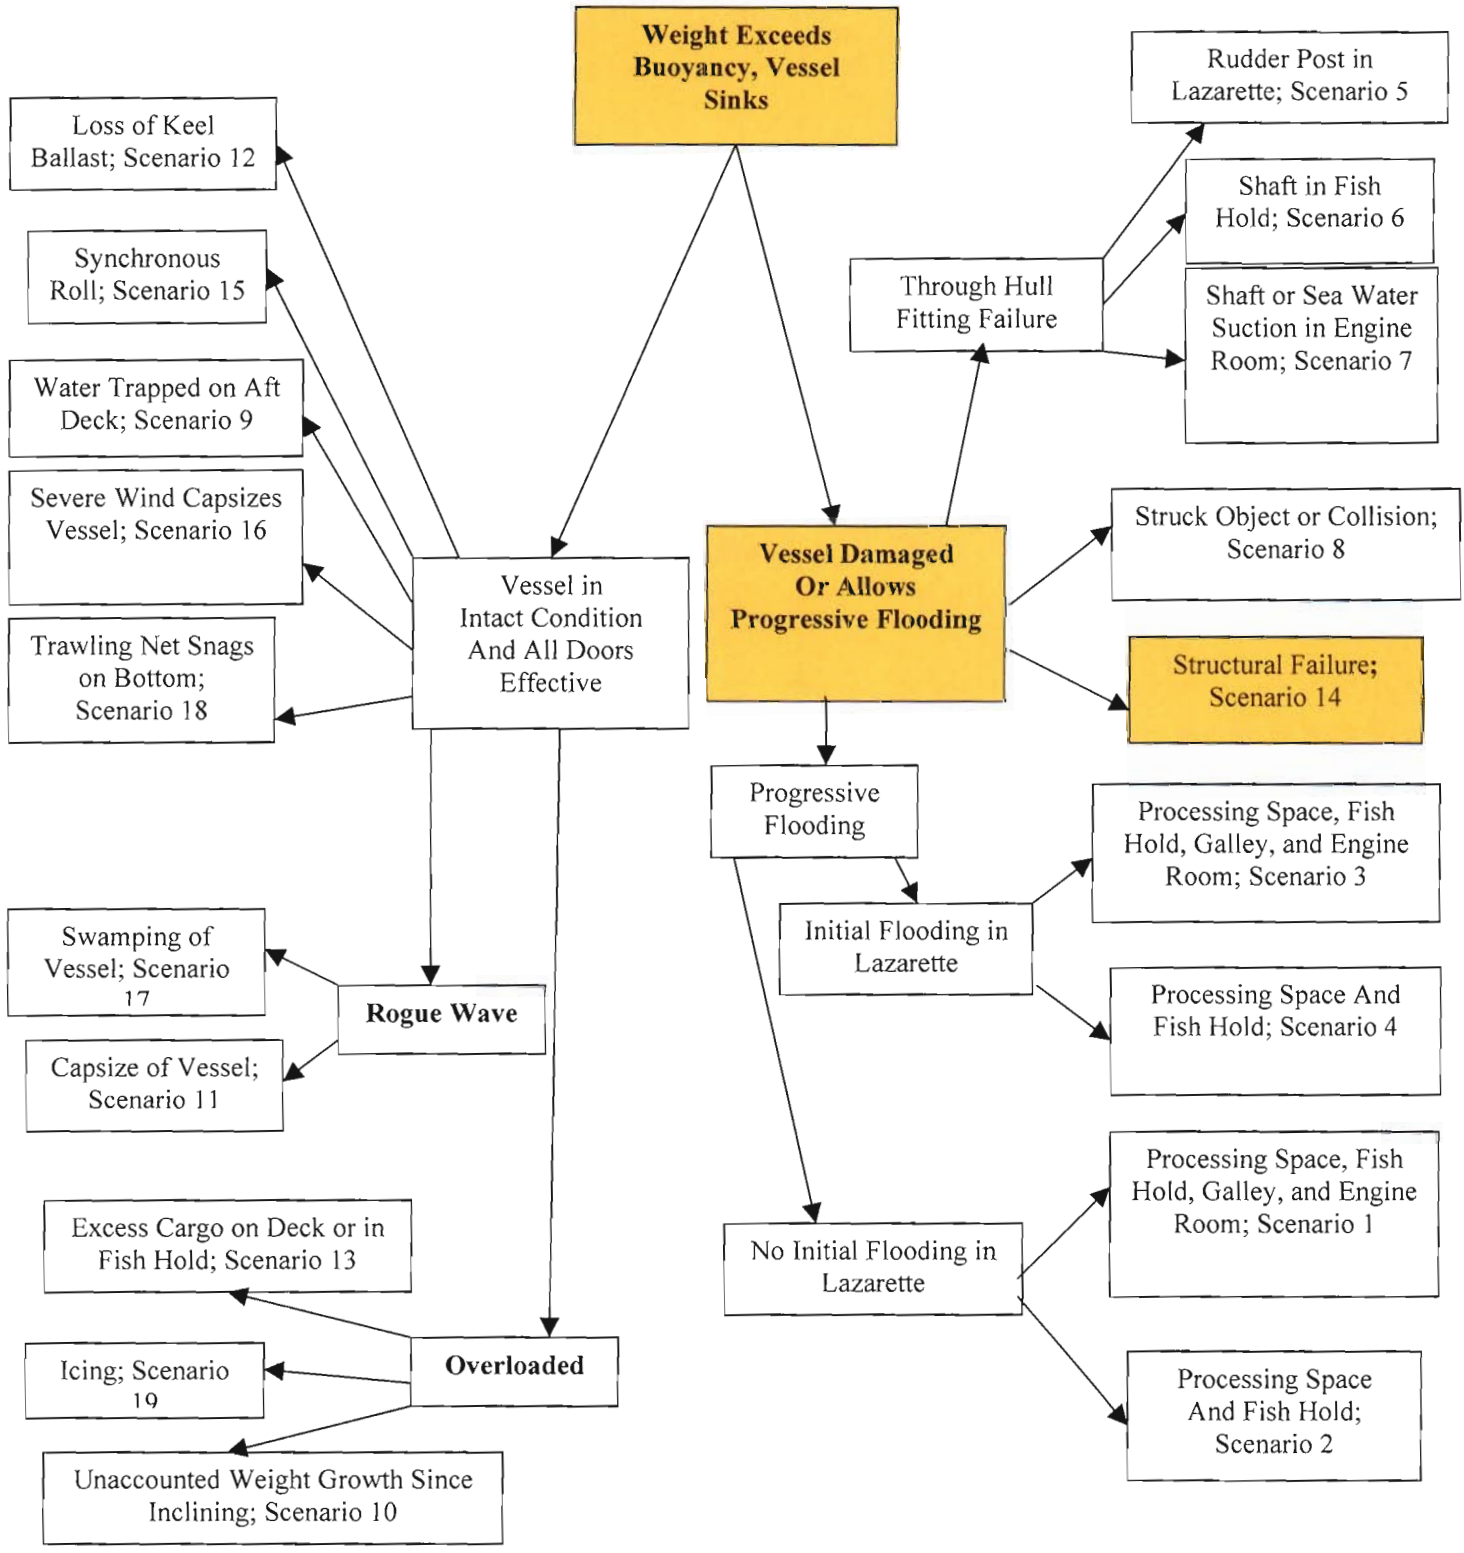
## SCENARIO 14

### STRUCTURAL FAILURE

4. Based on the ROV video of the ARCTIC ROSE side shell, deck plating, and bottom plating, it is very unlikely that the vessel sank due to a global structural failure.

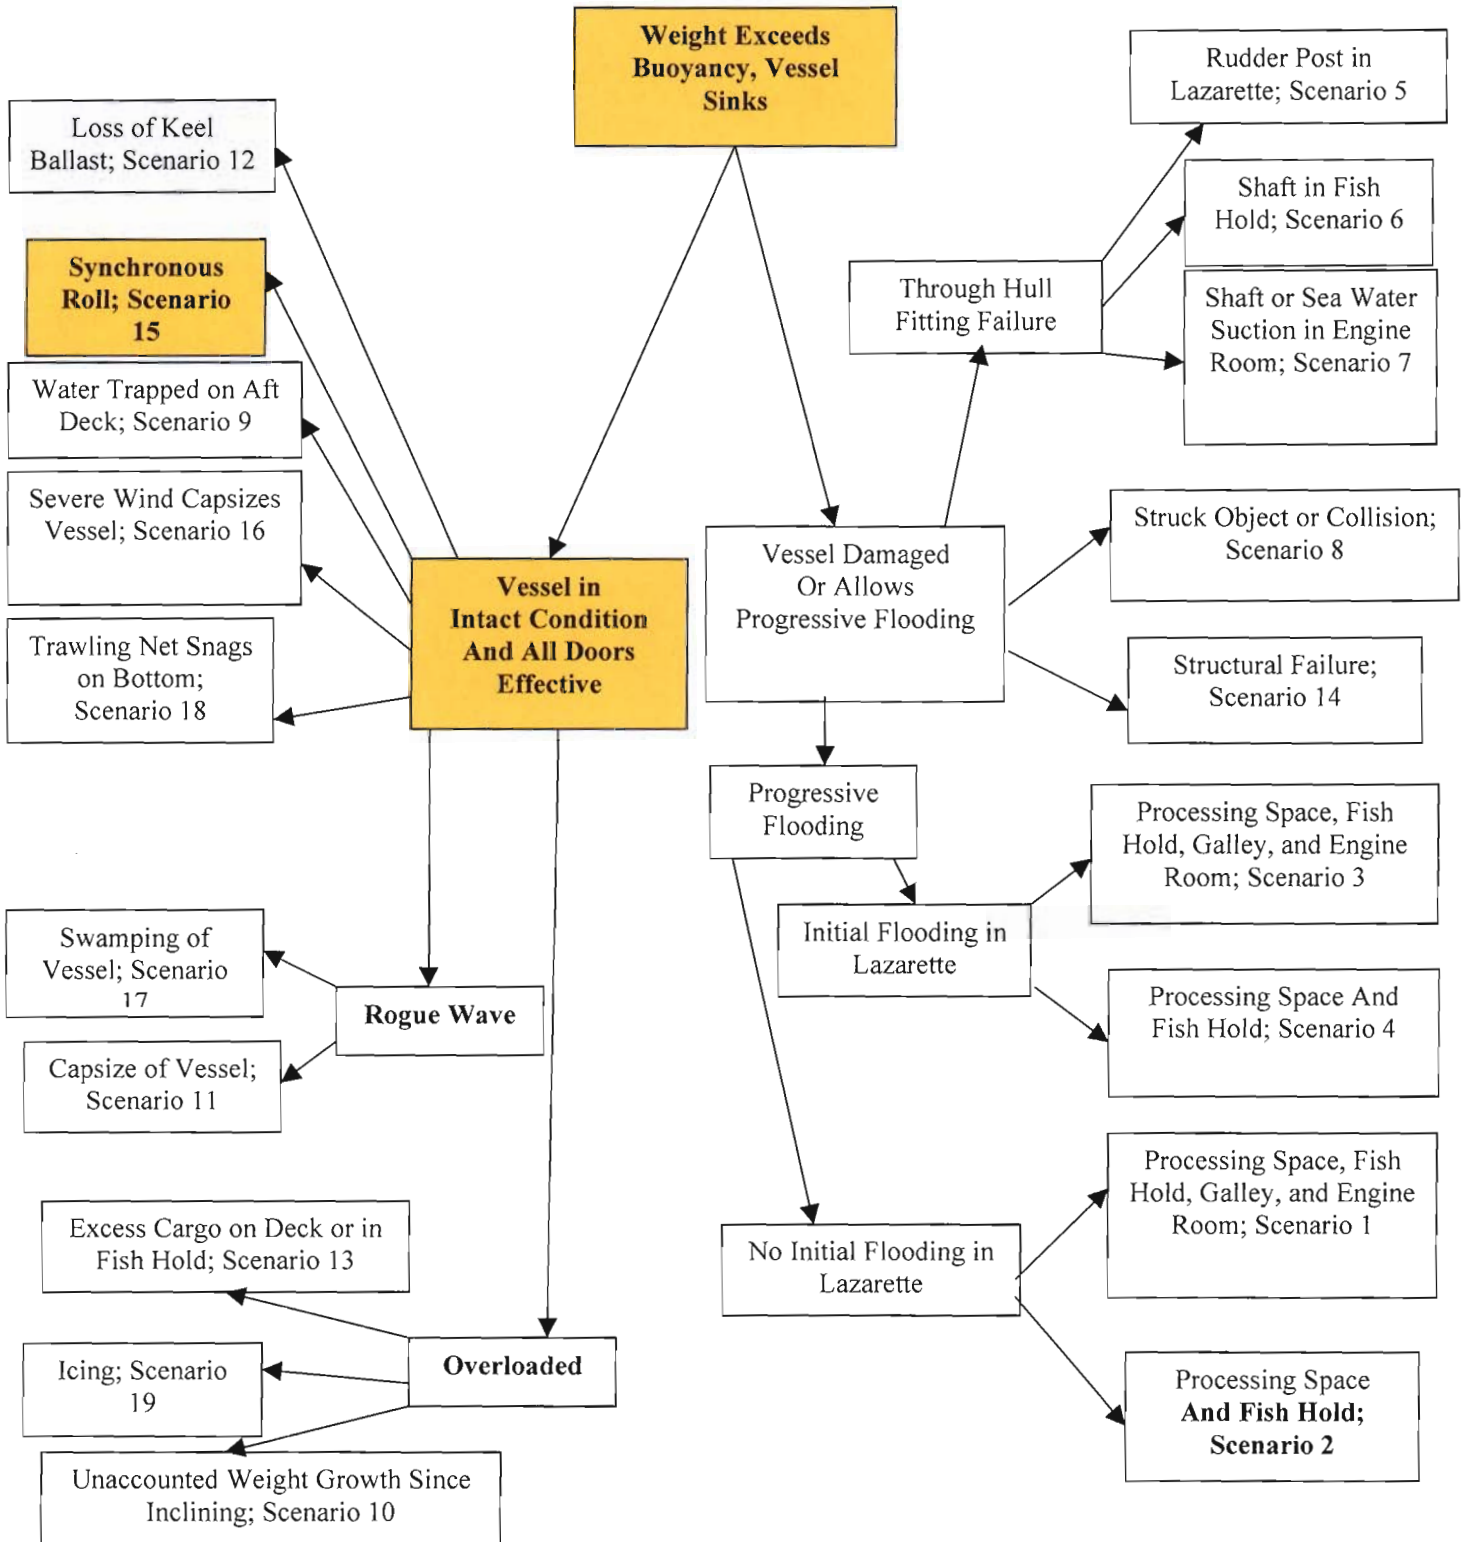
## SCENARIO 15

### SYNCHRONOUS ROLL

4. Based on the roll characteristics of the ARCTIC ROSE, the weather conditions the night of the vessel's loss, and the probable speed of the vessel, it is very unlikely that the loss of the ARCTIC ROSE was due to synchronous roll.

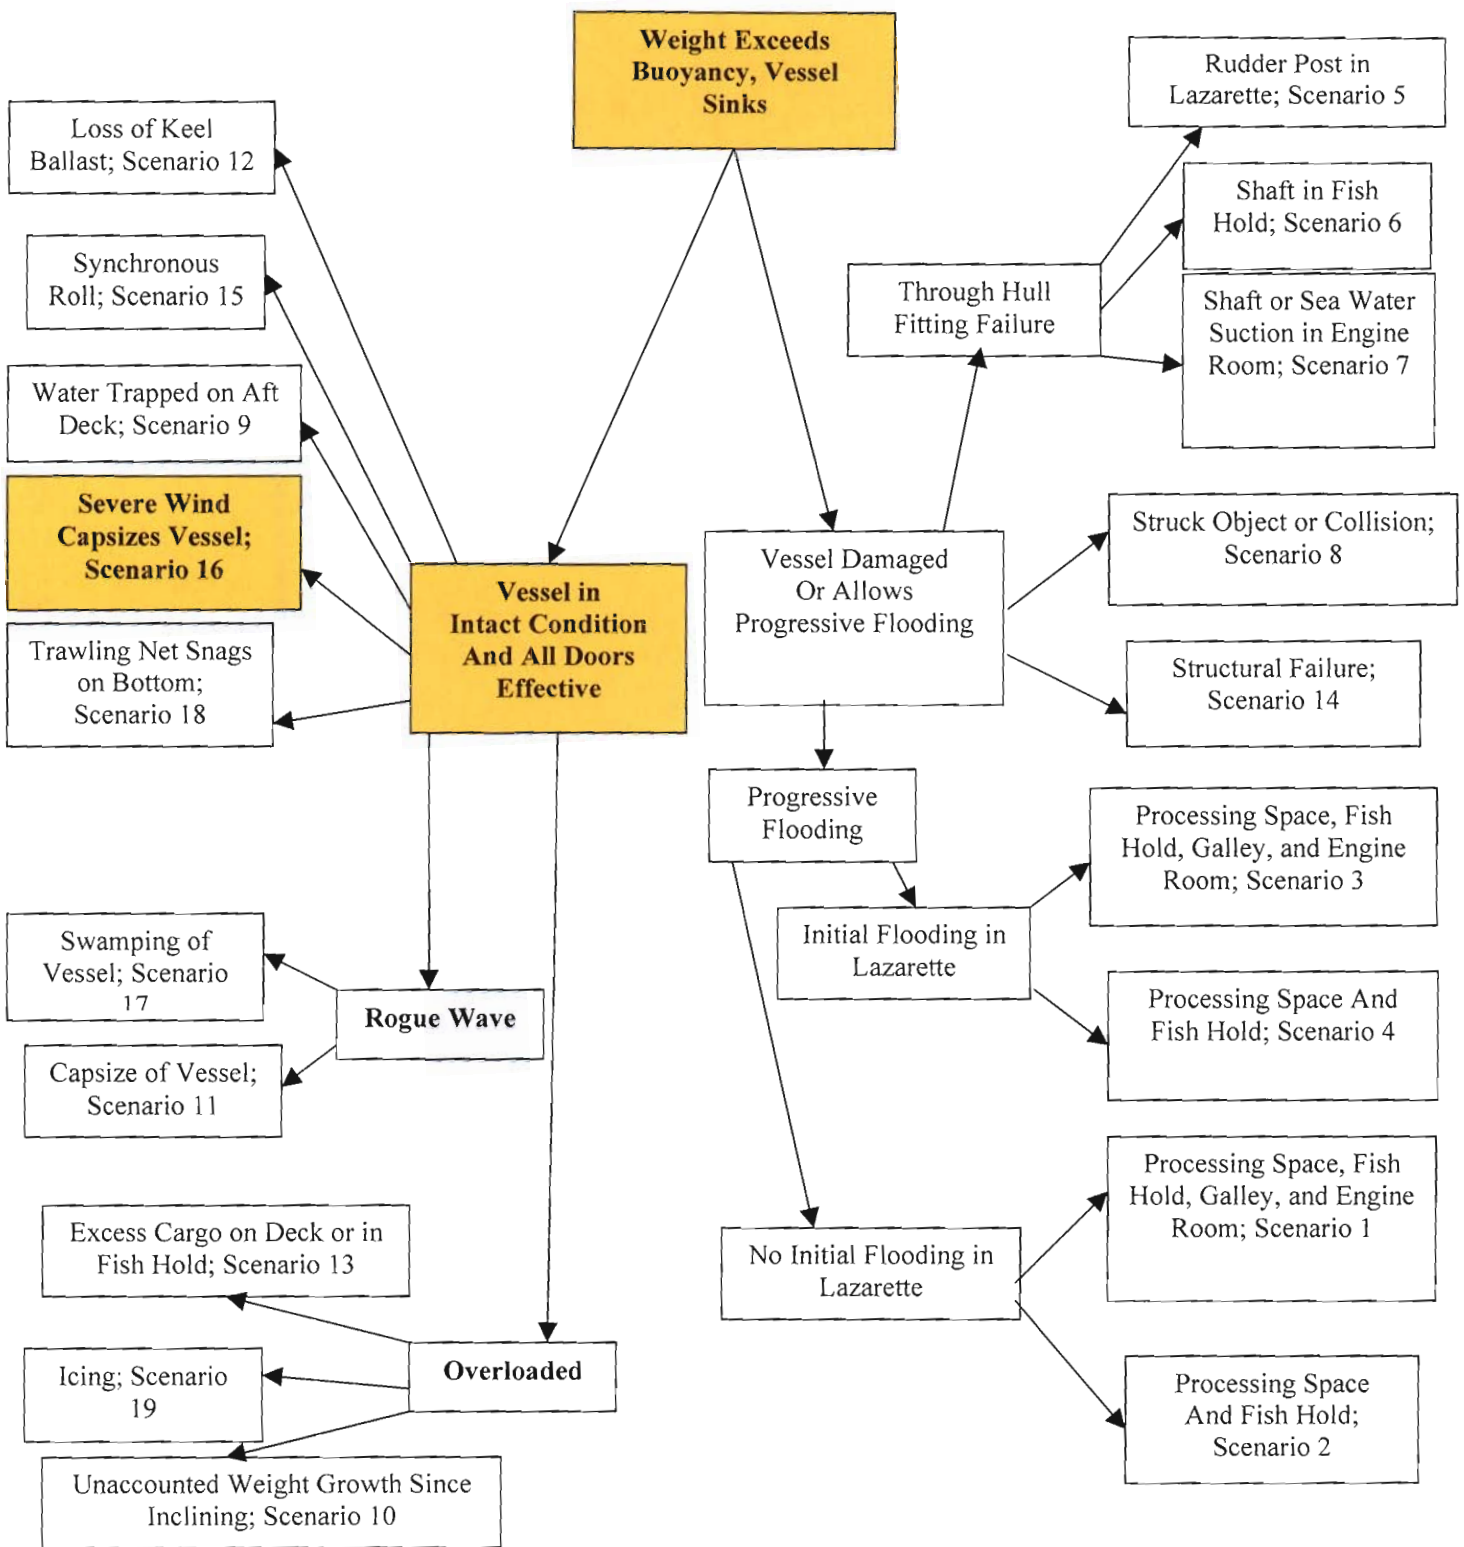
## SCENARIO 16

### SEVERE WIND CAPSIZES VESSEL

4. Based on the ARCTIC ROSE's stability characteristics when a 100 knot wind was applied, it is very unlikely that a severe wind would heel the vessel past its angle of vanishing stability and capsize the vessel.
