INVESTIGATION INTO THE CIRCUMSTANCES  
SURROUNDING THE SINKING OF THE  
UNINSPECTED FISHING VESSEL

## ARCTIC ROSE

OFFICIAL NUMBER 931446, IN THE BERING SEA ON  
APRIL 2, 2001, WITH ONE PERSON DECEASED AND  
FOURTEEN PERSONS MISSING AND PRESUMED DEAD

Amended 05/20/2004

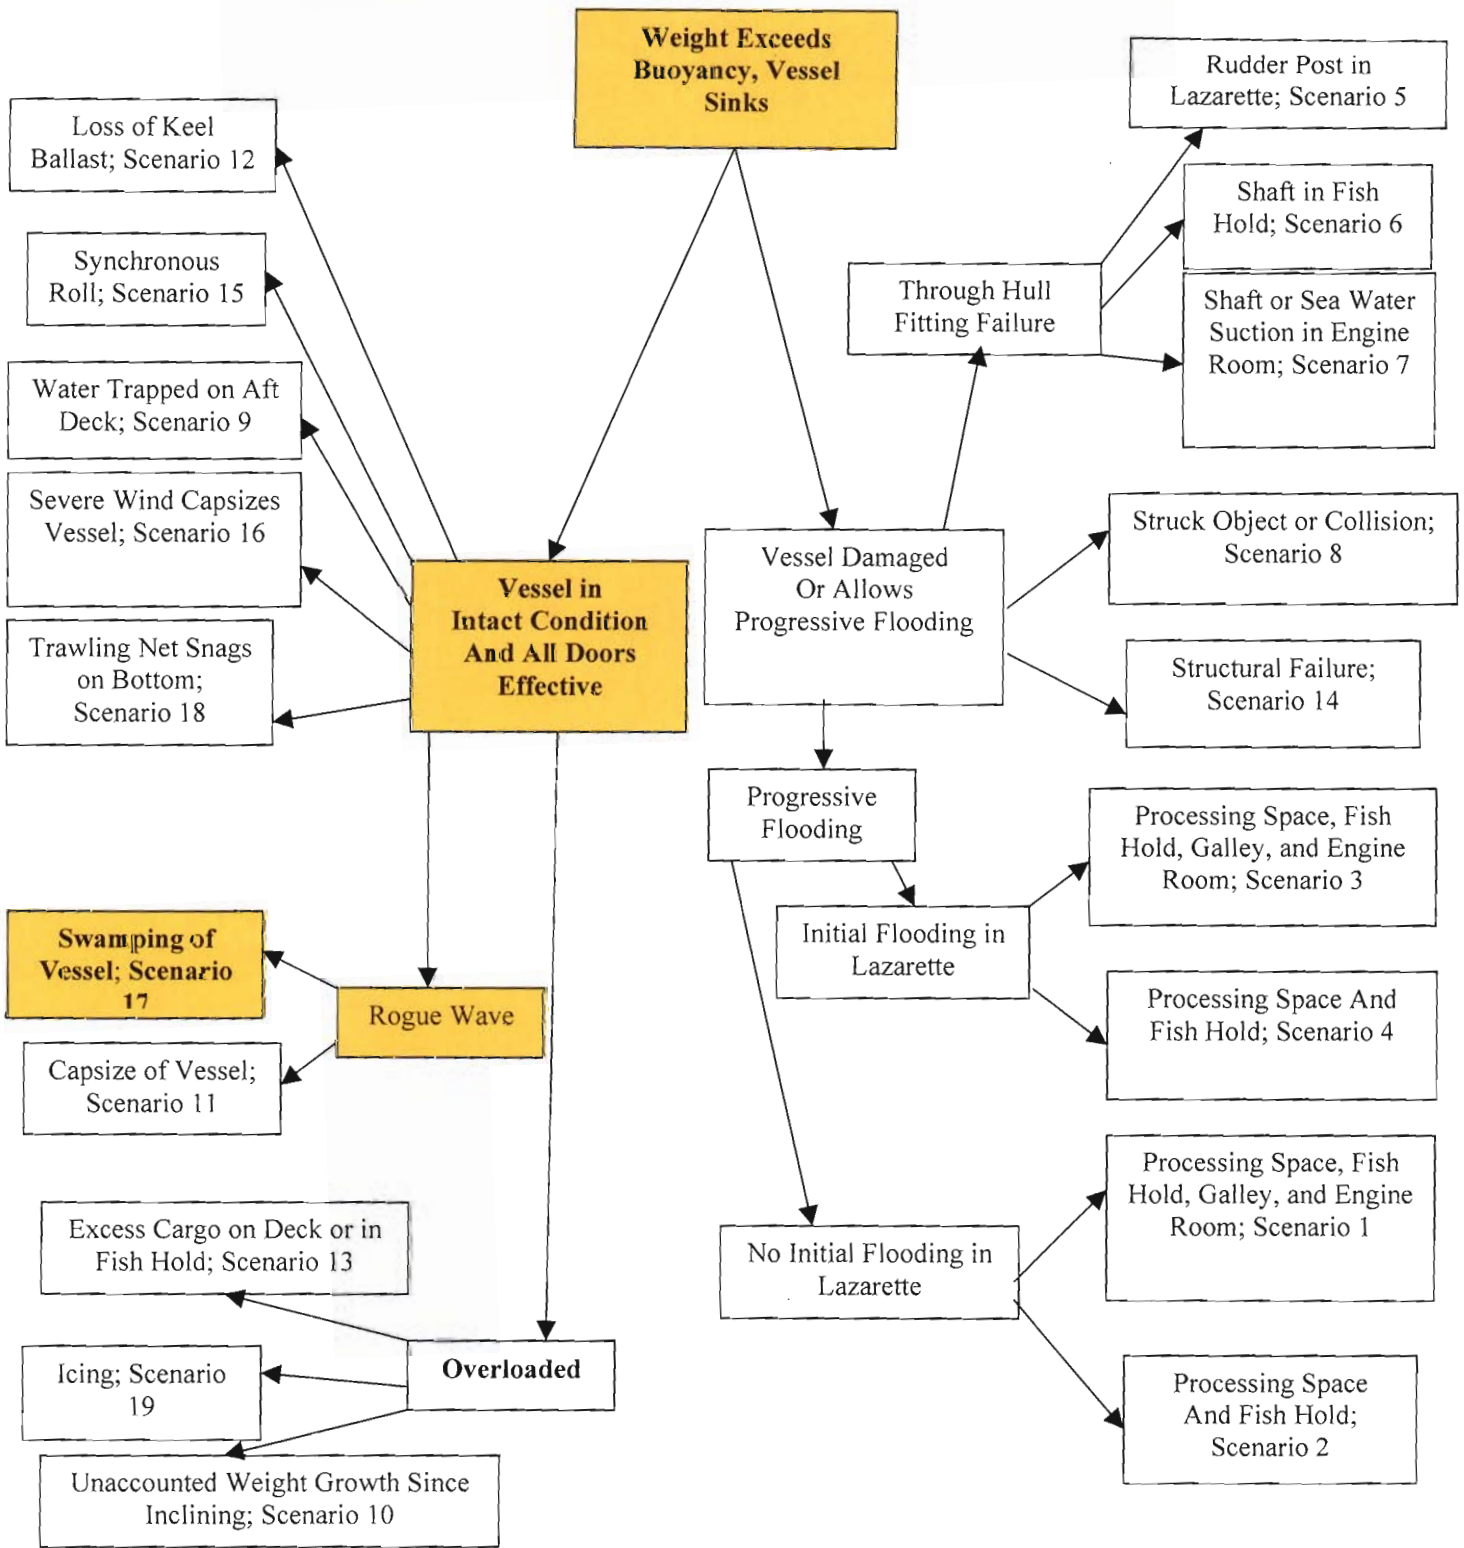
## SCENARIO 17

### SWAMPING OF VESSEL DUE TO ROGUE WAVE

3. Based on the extremely large volume of water that would be needed to swamp the ARCTIC ROSE, the small aft deck area, and the relatively small door opening through which water could enter the processing space, it is very unlikely that a rogue wave swamped the vessel and caused it to sink.

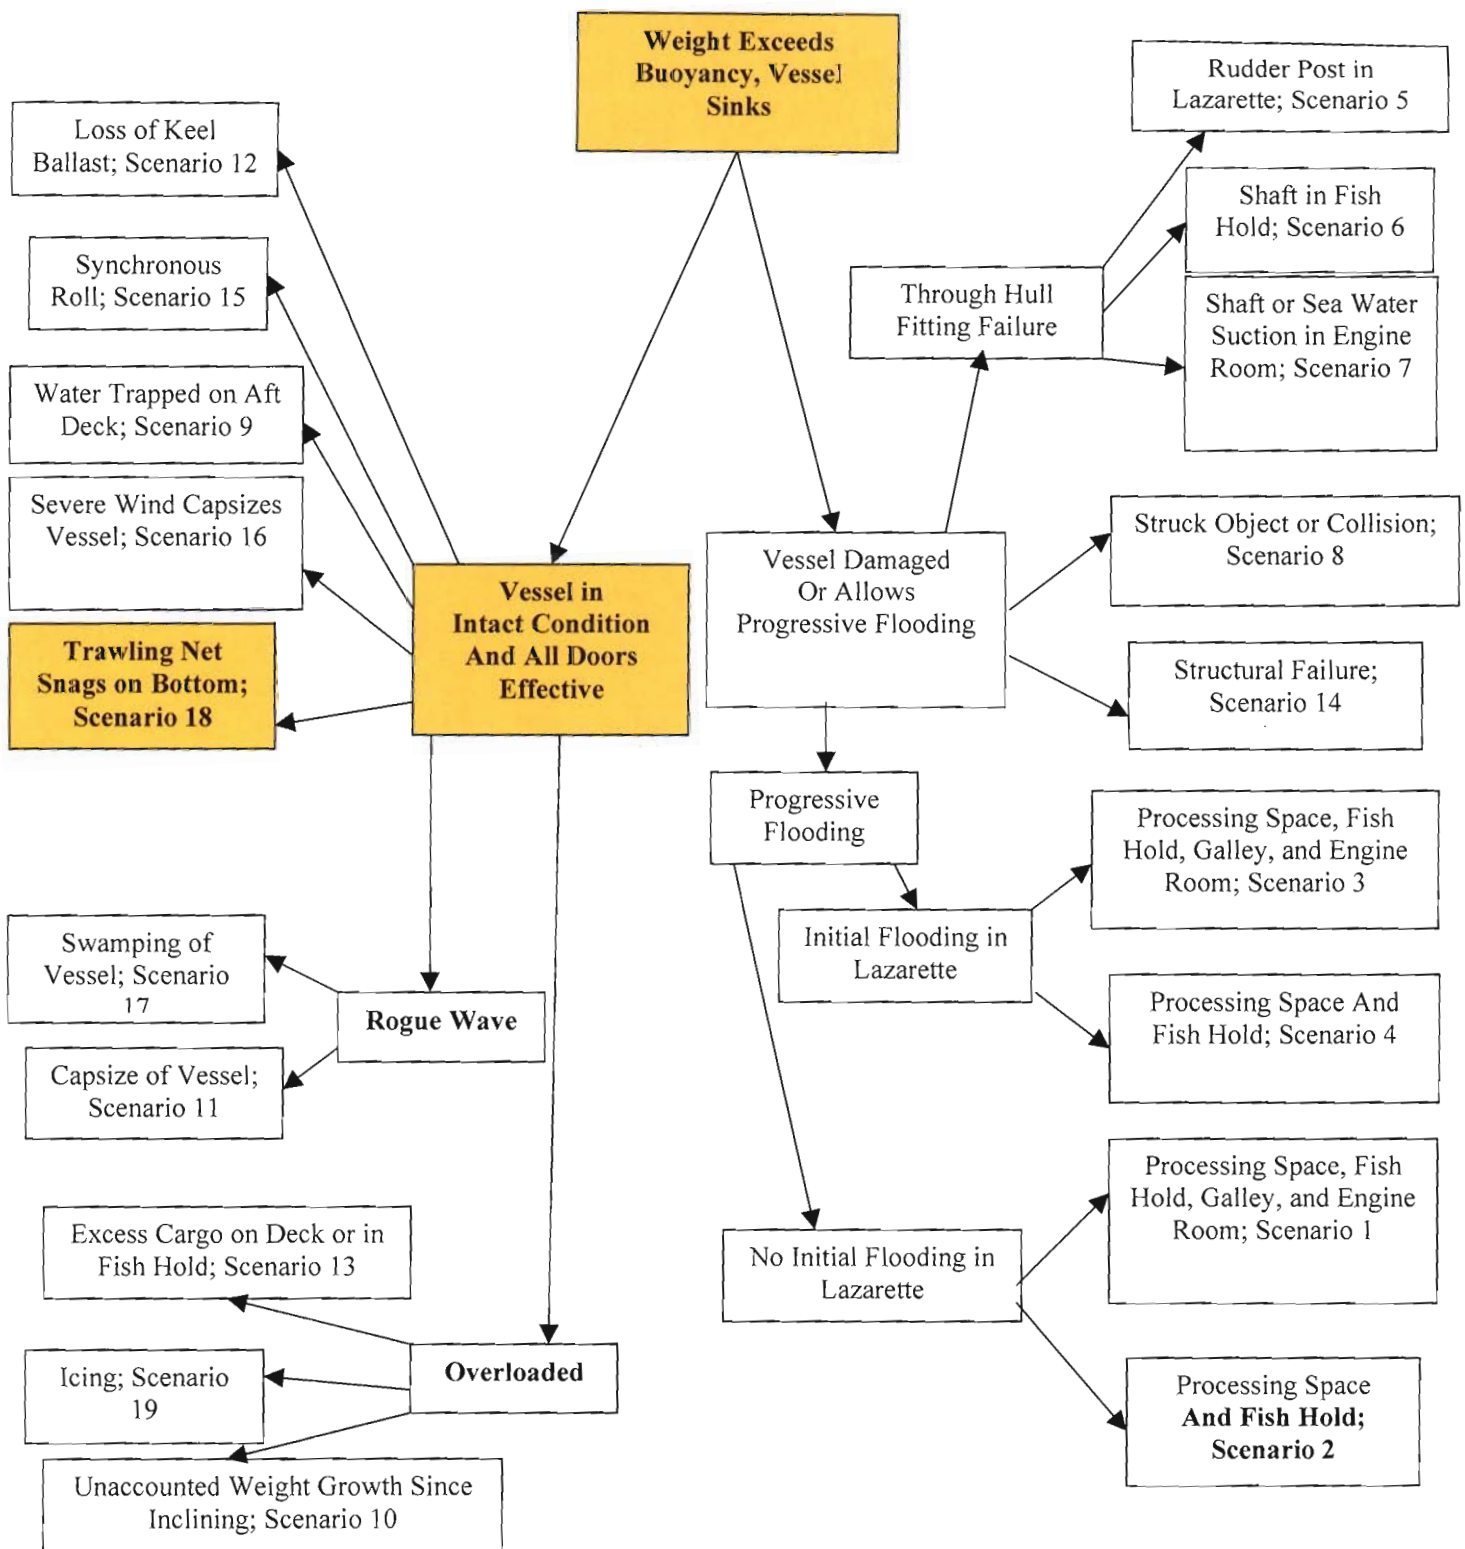
## SCENARIO 18

### TRAWLING NET SNAGS ON BOTTOM

3. Based on the ROV video which shows the trawling net stowed on the aft reel, it is very unlikely that the ARCTIC ROSE sank due to the trawling net snagging the bottom and dragging the aft end of the vessel down.

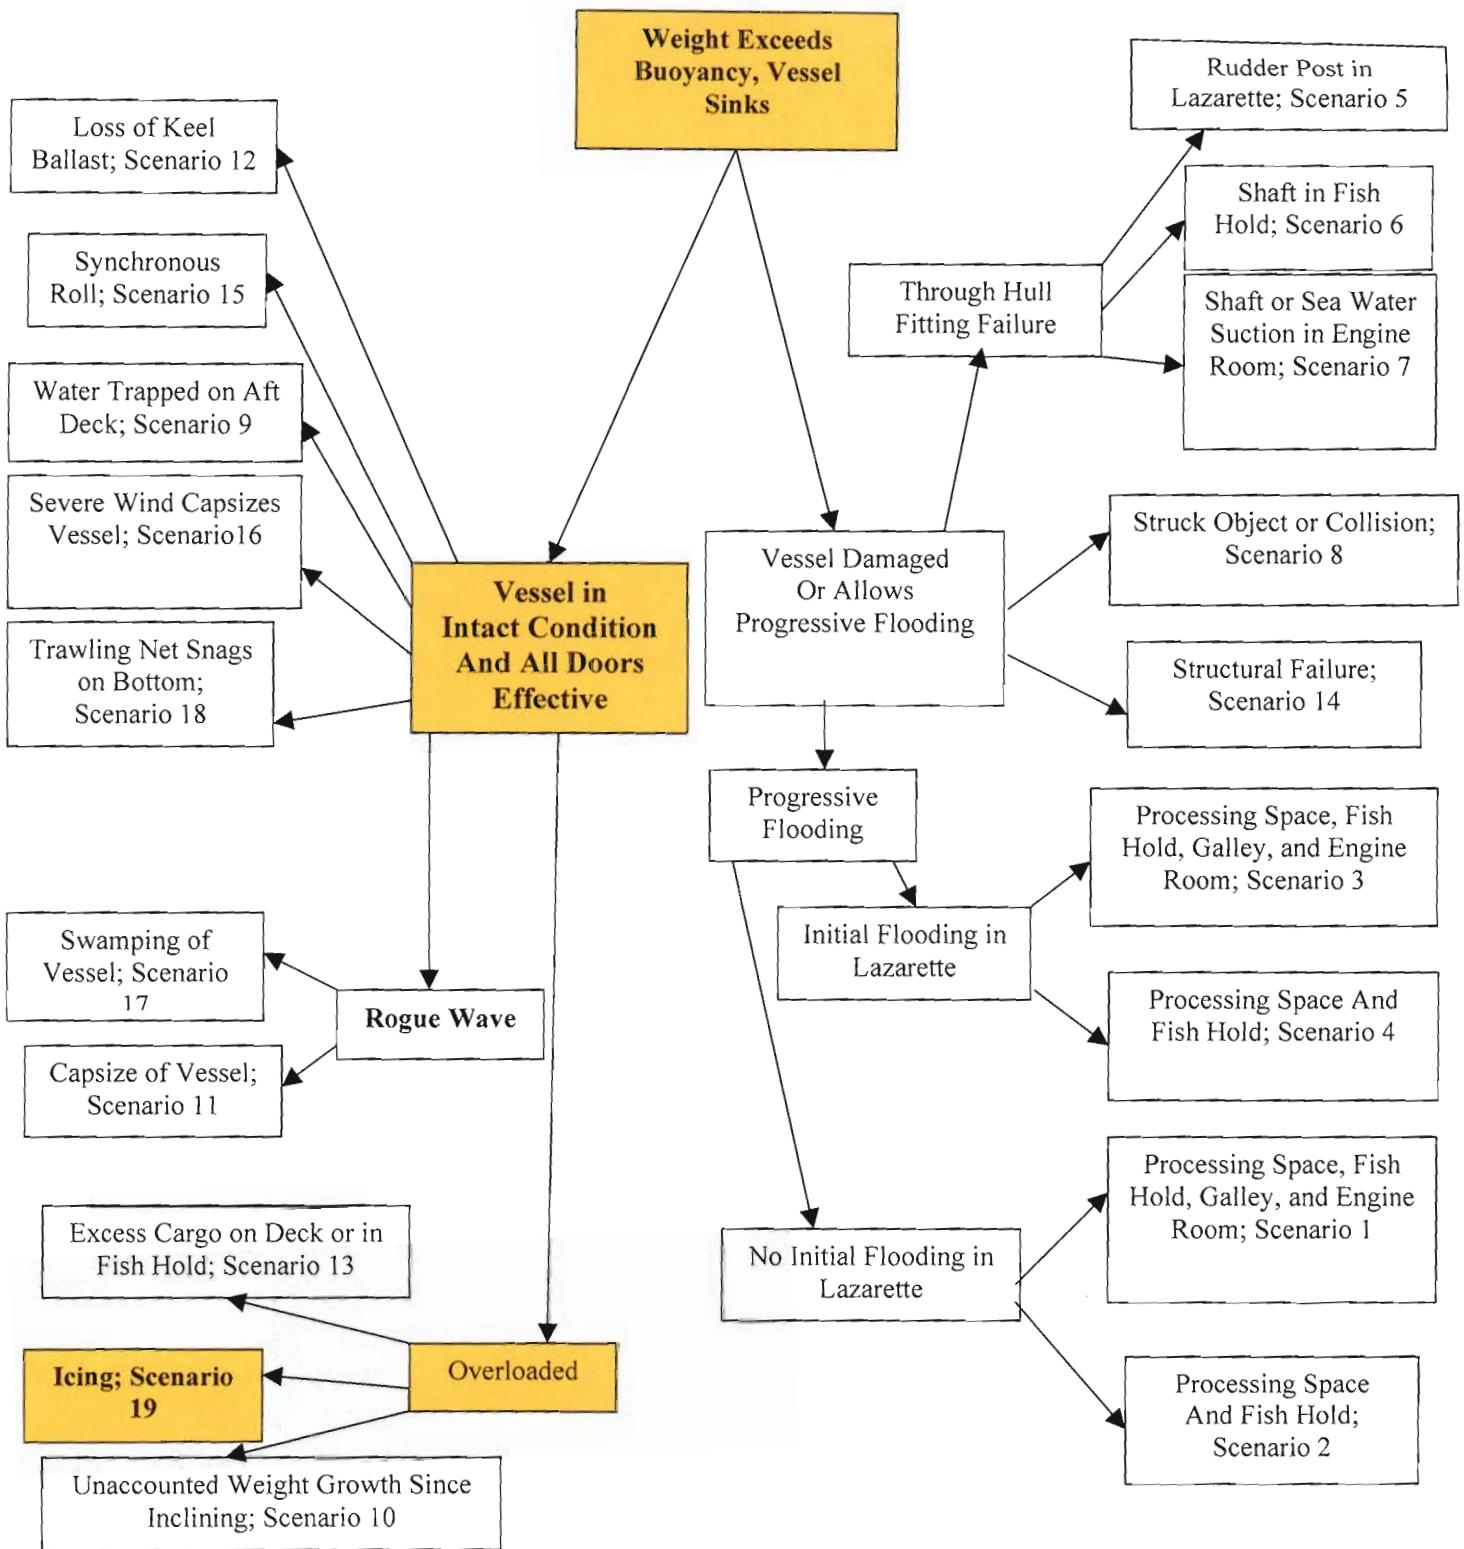
## SCENARIO 19

### OVERLOADED DUE TO ICING
