UNITED STATES COAST GUARD

INVESTIGATION INTO THE CIRCUMSTANCES
SURROUNDING THE SINKING OF THE
UNINSPECTED FISH PROCESSING VESSEL

ALASKA RANGER

OFFICIAL NUMBER 550138, IN THE BERING SEA ON
23 MARCH 2008 WITH THE LOSS OF FOUR LIVES AND
ONE PERSON MISSING AND PRESUMED DEAD

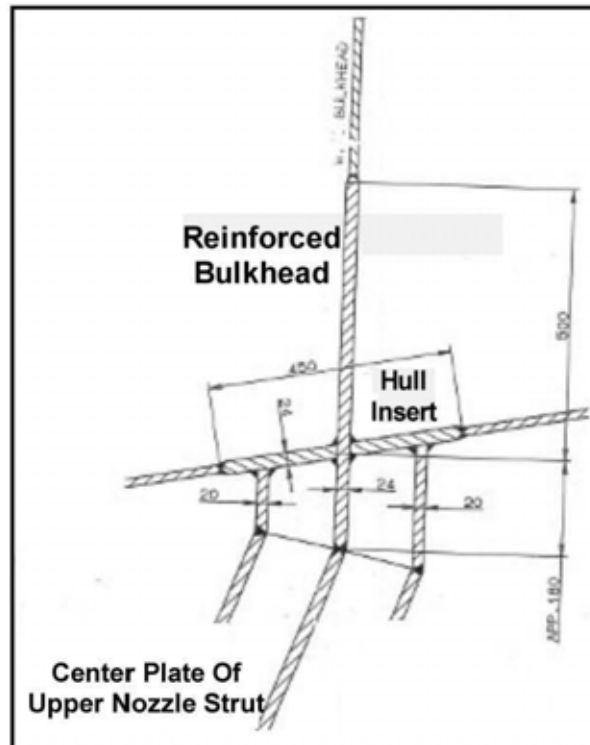
Figure 23: Portion of nozzle manufacturer's installation drawing

As shown in Figure 23, an excerpt from the MAN B&W installation plans, the center plates of the upper nozzle struts were to extend through the hull and join directly to a reinforced longitudinal bulkhead, which was to be 24mm thick and extend from frame 56 to frame 58. The existing 12 mm hull plating in way of the nozzle strut attachment was to be removed and replaced with hull plating twice as thick. The two plates inboard and outboard of the center plate of the upper nozzle supports were to be welded to the 24 mm hull plating insert.

This design transferred the weight of the Kort nozzles to the internal framing of the vessel, which is the recommended practice. According to Ship Design and Construction (██████████, Editor, 1980, published by Society of Naval Architects and Marine Engineers), “the inboard ends of shaft struts are usually carried through the shell and attached to special framing arranged to distribute the load from the arms to a sufficiently broad and rigid structure to eliminate any likelihood of local vibration. The hole in the shell plating is closed by heavy plate around the strut arm.”

The Kort nozzles were supposed to be installed in November 1991 while the ALASKA RANGER was at Yamanishi Ship Building & Iron Works, Ishinomaki City, Japan. While in the shipyard, TMPS discovered the actual structural arrangements of the vessel were different from that assumed during development of the installation plans. Correspondence between a TMPS employee with the vessel in the shipyard and the owner of TMPS states the potable water tanks had “no swash bulkheads or framing” and details of the cofferdams and #4 fuel oil tanks differed from what was shown in the MAN B&W installation plans.

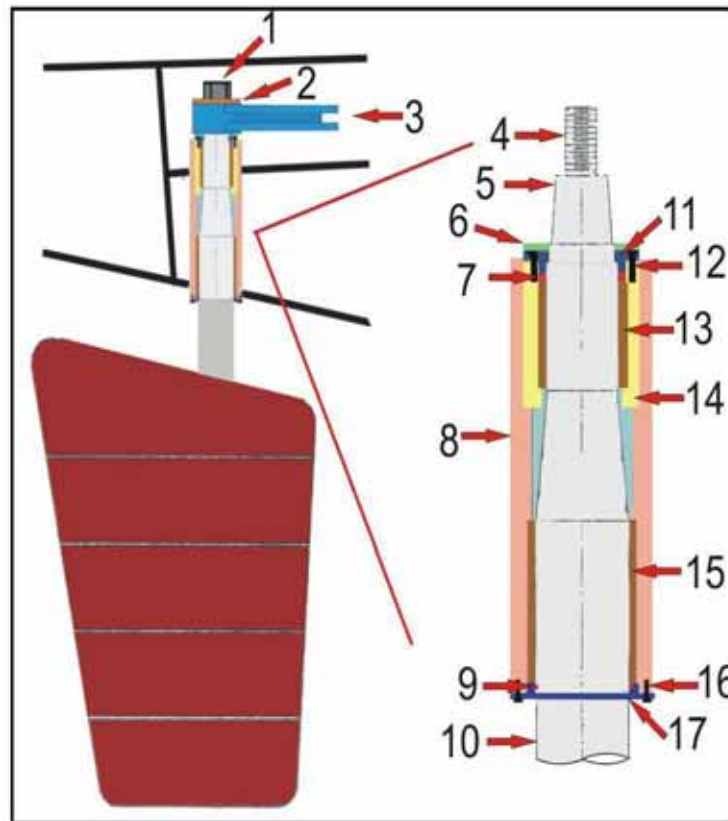
Figure 29: Rudder configuration

The ALASKA RANGER was equipped with two semi-balanced spade rudders. Each rudder blade was approximately nine feet high and is estimated to have weighed about 7,250 lbs.

The threaded section of the rudder stock accepted a 4 inch diameter, 4 threads per inch, national coarse rudder nut (1). A washer (2) was placed between the rudder arm and the nut. A steel keeper plate, not shown in Figure 29, was fitted on top of the steel nut and served as a locking device. It was welded to the top of the rudder stock and to both sides of the nut, and locked the entire assembly in place to prevent the nut from coming loose.

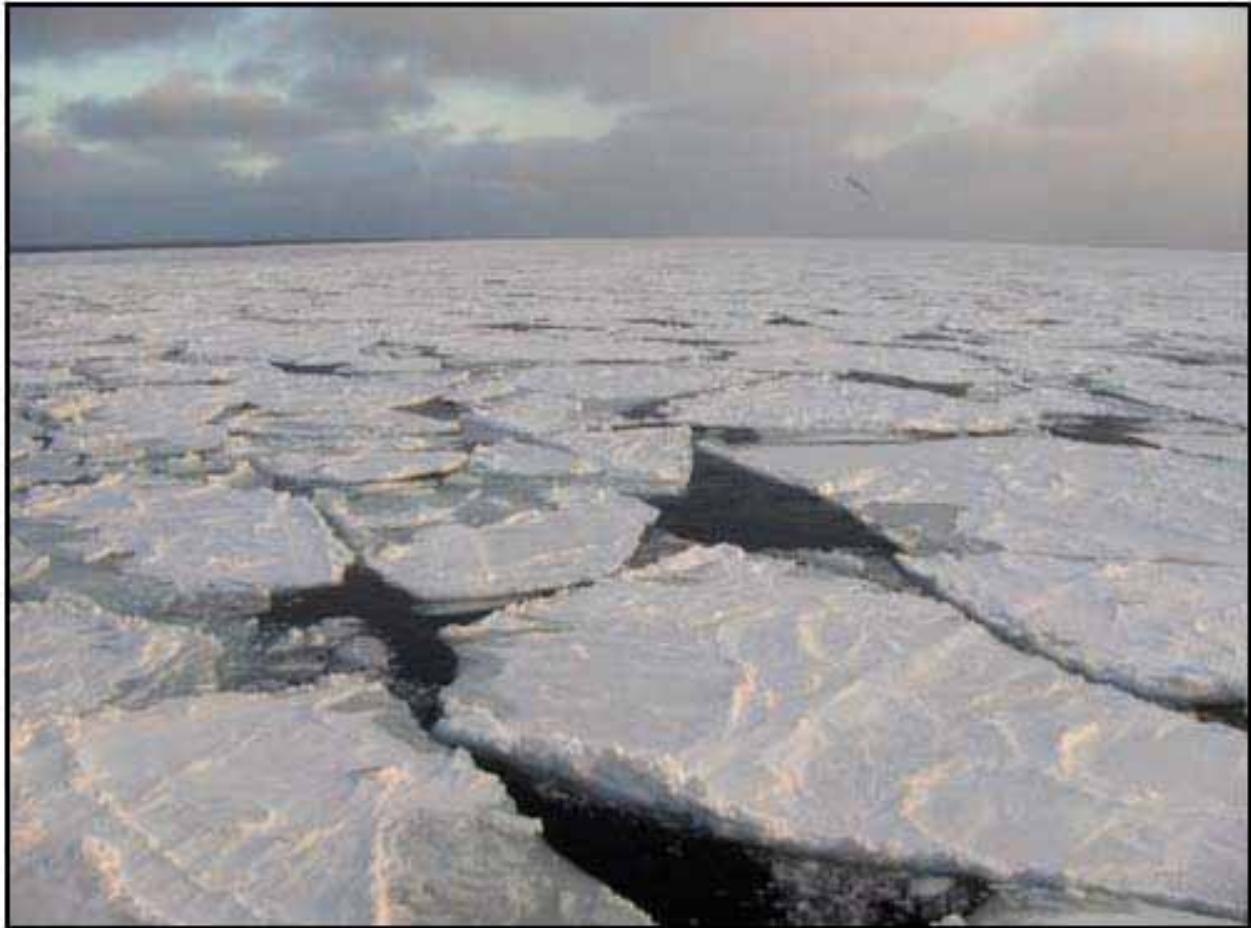
Figure 31: Photograph of ice encountered by the ALASKA RANGER in February 2008

The previous Captain also explained that the ALASKA RANGER “didn’t fish through the ice per se.” They would only fish during daylight, when they could find clearings in the ice. This

The MBI consulted with the naval architects at the USCG Engineering Logistics Command, which provides engineering design, support and repair assistance to USCG cutters, including the USCG's fleet of ice breakers. They reviewed the evidence and testimony, and indicated ALASKA RANGER would not likely have sustained severe damage to the stern appendages of the vessel. Though vessels operating in ice sometimes experience damage to the stern, it normally occurs when vessels make large turns or back down in ice.

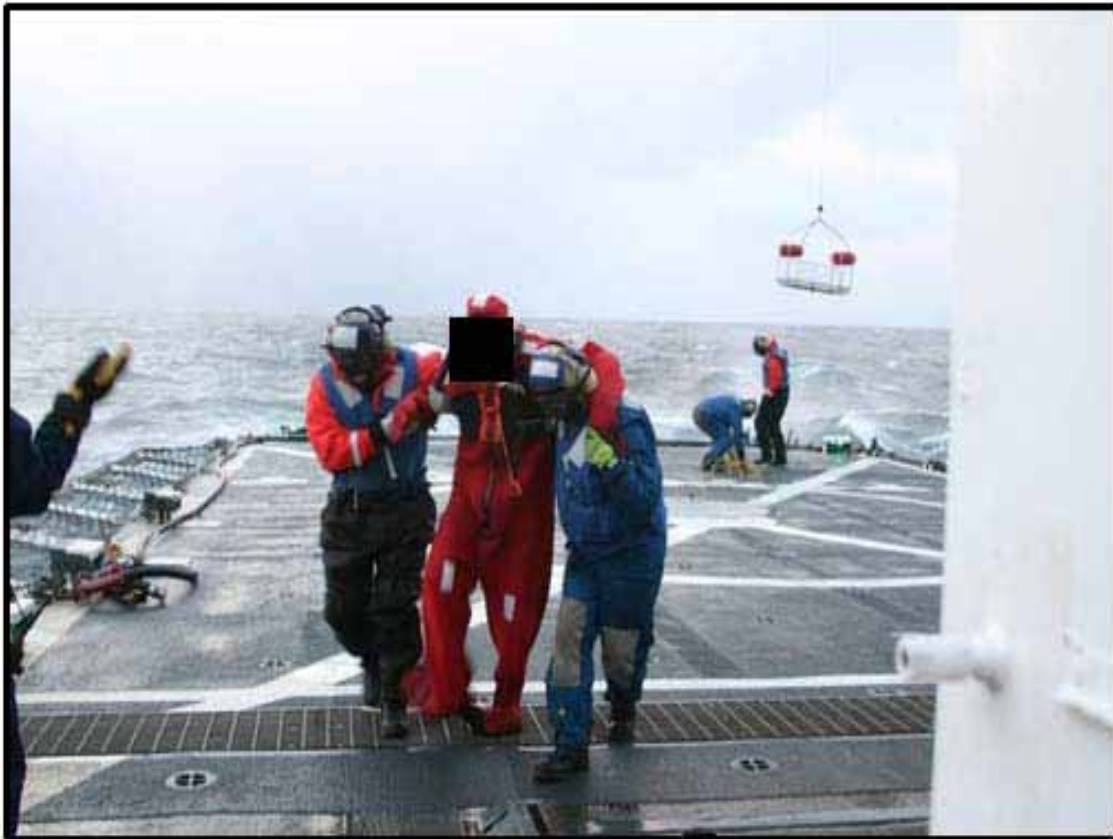
Figure 32: Photograph of rescued ALASKA RANGER crew member in survival suit

to get him into the helicopter. Personnel on the ALASKA WARRIOR had to cut the suit of another crew member in order to recover the man. In Figure 32, the midsection and legs of the survival suit of one survivor are much too large and his right foot does not reach the survival suit boot.

The water in these survival suits might be attributed to being in the ocean under conditions other than flat calm seas. Alternatively, the survival suits may not have fit correctly, may not have been donned properly, or may have leaked through seams or holes in the suits. Water may have also gotten into the survival suits due to the activities of crew member while in the water (e.g. swimming).

Two crew members testified their suits contained water and/or were damaged before they donned them. The MBI inspected the suits after the casualty and generally found the suits in acceptable condition. The tears, cuts, and areas of worn material on the suits could not be conclusively linked to the condition of the suit before the casualty.

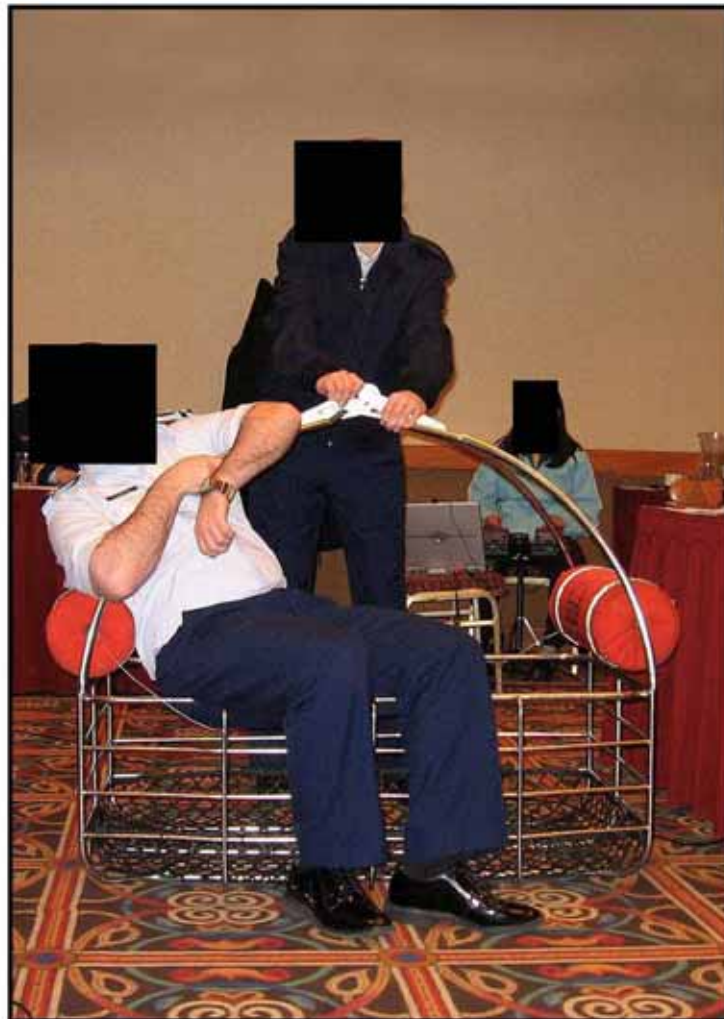
Figure 33: Photograph of LTJG [REDACTED] demonstrating position of Crew Member A

As the basket came out of the water, Crew Member A's legs were outside of the basket, and he appeared to be sitting on the top rail along the length of the basket, with his head and shoulders through the triangle formed by the lifting bale, as illustrated in Figure 33. As the hoist began, Crew Member A looked stable to the Flight Mechanic and the Rescue Swimmer began swimming to the next survivor to be hoisted.

The pilot of the HH-65 spotted Crew Member A face down in the water, but was unsuccessful in his attempts to alert the Rescue Swimmer and have him return to Crew Member A.

Crew Member A would later be recovered by the ALASKA WARRIOR and declared dead. The personnel who attempted to revive Crew Member A stated they did not see any physical injuries on his body.

The Flight Mechanic deviated from written procedures in Commandant Instruction CGTO IH-65C-1, the H65 Flight Manual, and began to hoist before the rescue swimmer provided the “ready to be hoisted” signal. The Flight Mechanic’s decision to commence the hoist was based on several factors including the on scene weather conditions, sea state, Crew Member A’s difficulty getting into the basket, the limited time left on scene due to the helicopter’s dwindling fuel supply, and an awareness that there were still more survivors at risk.

Crew Member A was alive when the HH-65 attempted to rescue him. Because an autopsy was not conducted, it is unknown whether the fall caused any injuries. In addition, the MBI could not determine if Crew Member A would have survived the exposure and conditions he had endured while in the water.

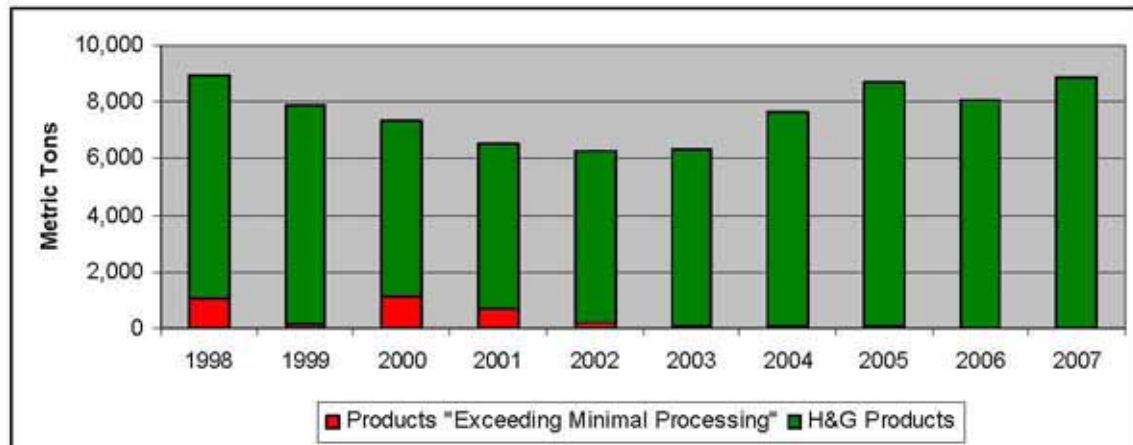
Figure 35: ALASKA RANGER Catch Sorted by ACSA Product Code

The ALASKA RANGER consistently produced NMFS product codes 10 and 14, “Headed & gutted, Tail Removed” and “Roe” respectively, which are both defined as “Exceeding Minimal Processing.” As shown in Figure 35, products defined by ACSA as “Exceeding Minimal Processing” have accounted for less than 1% of the total annual product produced on the ALASKA RANGER since 2002. However, in order to continue producing these products, the ALASKA RANGER had to enroll into ACSA or meet classification and load line requirements.

The application requirements in the ACSA Agreement were not followed for the ALASKA RANGER. On 5 April 2006, more than 10 weeks before the issuance of the ACSA Agreement and D13 Instruction, FCA submitted an application to enroll the ALASKA RANGER and six other vessels into ACSA. In a letter sent 22 months later, D13 told FCA the application for exemption from the requirements to be classed by the ABS or a similarly qualified organization and the load line requirements “constituted acknowledgement that the subject vessel operates as a fish processing vessel as defined in 46 CFR Part 28.”

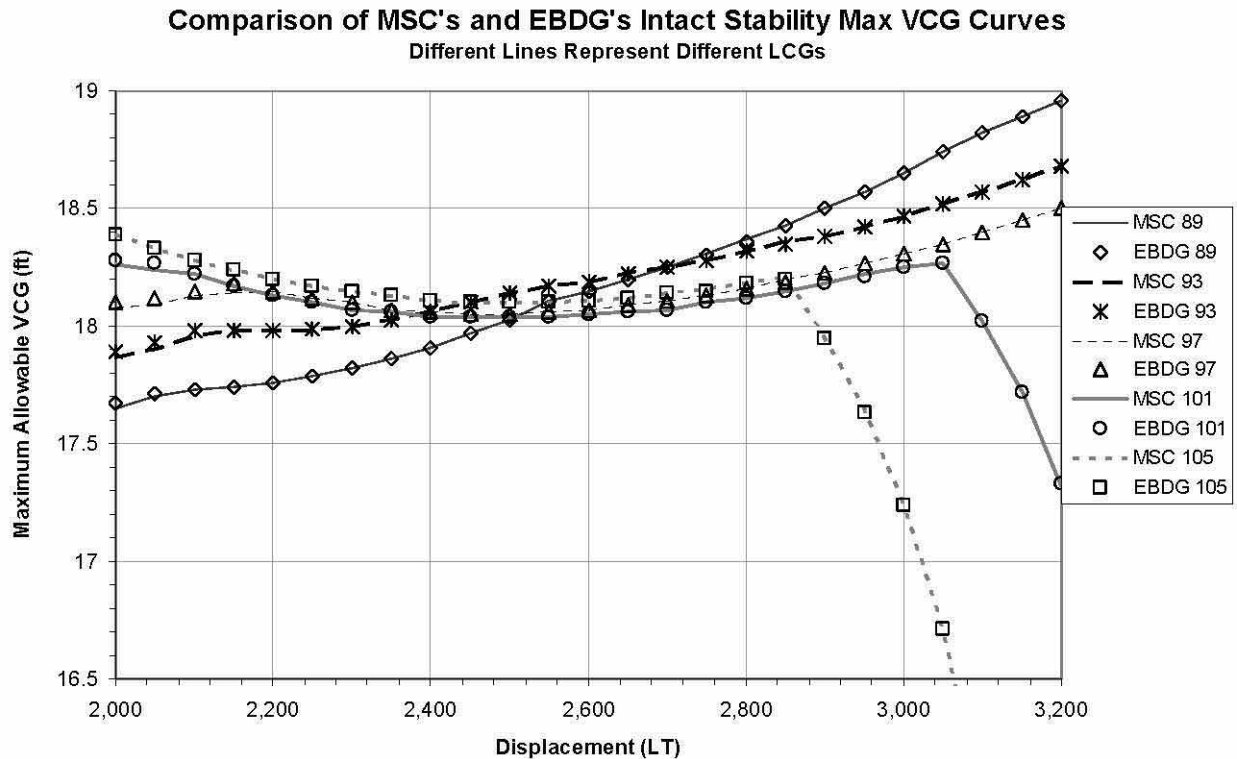
Figure 1: Comparison of Max VCG Curves

The loading guidance provided to the vessel’s master is based upon the use of maximum VCG curves. A maximum VCG curve, like those shown in Figure 1, shows maximum allowable VCG for the entire vessel over a range of displacements. Because the shape of maximum VCG curves is dependent on trim, separate curves are generated for different longitudinal centers of gravity (LCG). In EBDG’s analysis, separate curves were generated for four of the applicable criteria:

In order to verify the loading guidance provided in the T&S book, an independent generation of the ALASKA RANGER's max VCG curves was undertaken. In our review, the maximum VCG was computed using the four criteria considered by EBDG as well as the water on deck criteria in 46 CFR 28.565. As seen in Figure 1, there was good correlation between EBDG's and MSC's intact stability analyses. Our review revealed that the water on deck criteria was not limiting in any case so EBDG's omission of this criteria from their maximum VCG curves did not impact the results.

In general, the limiting criteria were the Intact Righting Energy requirements contained in 46 CFR 28.570. Specifically, the GM requirement and righting energy between 30° and downflooding were the most restrictive. Since the lowest downflooding points were aft on the ALASKA RANGER, aft trim conditions at deeper drafts quickly reduced the allowable VCG as seen in Figure 1 on the LCG = 105 curve at displacements greater than 2900 LT.

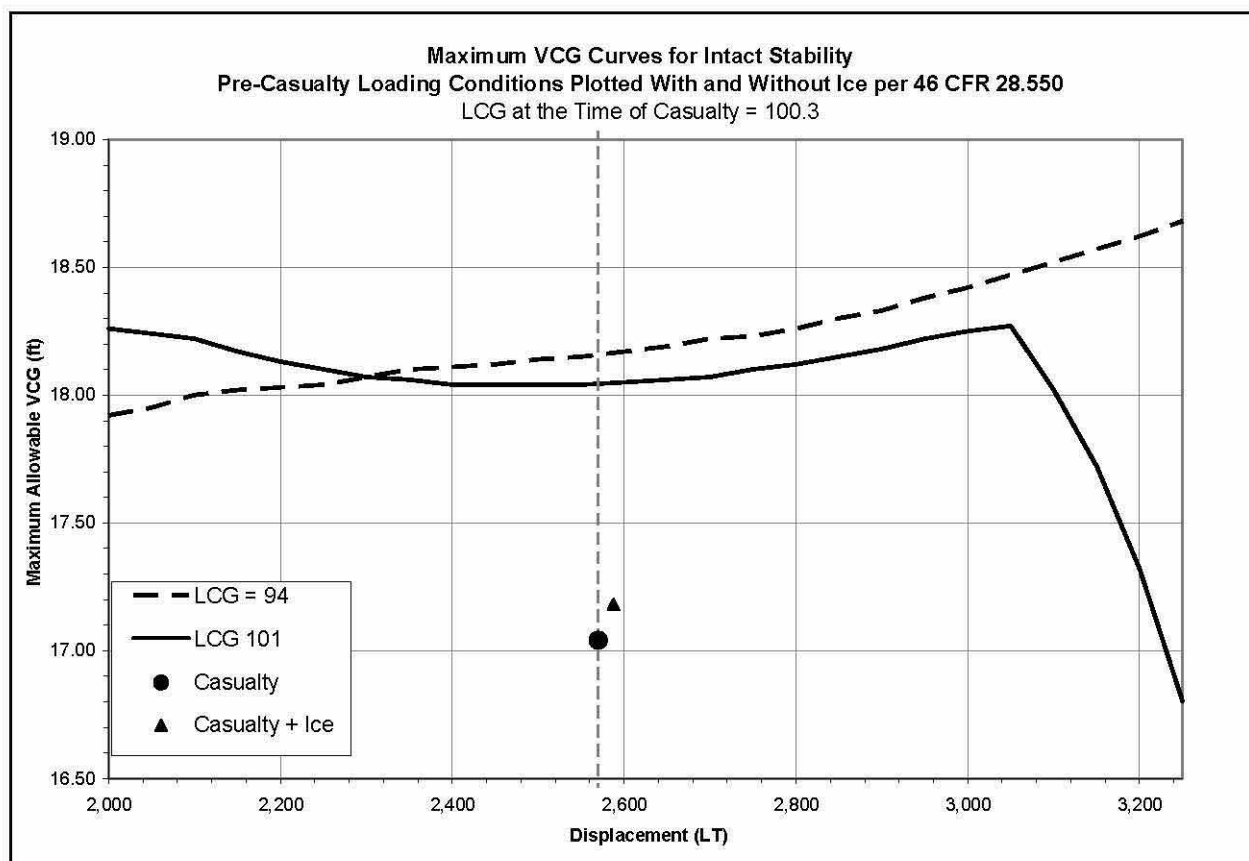
Figure 3: Range of Stability

Paragraph 2-e of reference (a) requested a determination of the maximum trim angles and displacements for which the ALASKA RANGER could pass the applicable intact and damaged stability requirements. Since the vessel did not meet the damage stability requirements of 46 CFR 28.580 in any of her conditions of loading, damage stability was excluded from this portion of the analysis. Based on the information provided, at the time of the casualty the ALASKA RANGER had a large intact stability margin for VCG, trim, and displacement. This large margin created many combinations of displacement and trim at which the vessel would meet intact stability requirements. Figure 3 displays the limiting KG curves over the range of displacements considered in the T&S booklet load cases. The dotted curve shows the forward most LCG considered among the load cases and corresponds to 2.9 feet of forward trim. The solid curve represents the aft most LCG corresponding to 3.5 feet of trim by the stern.

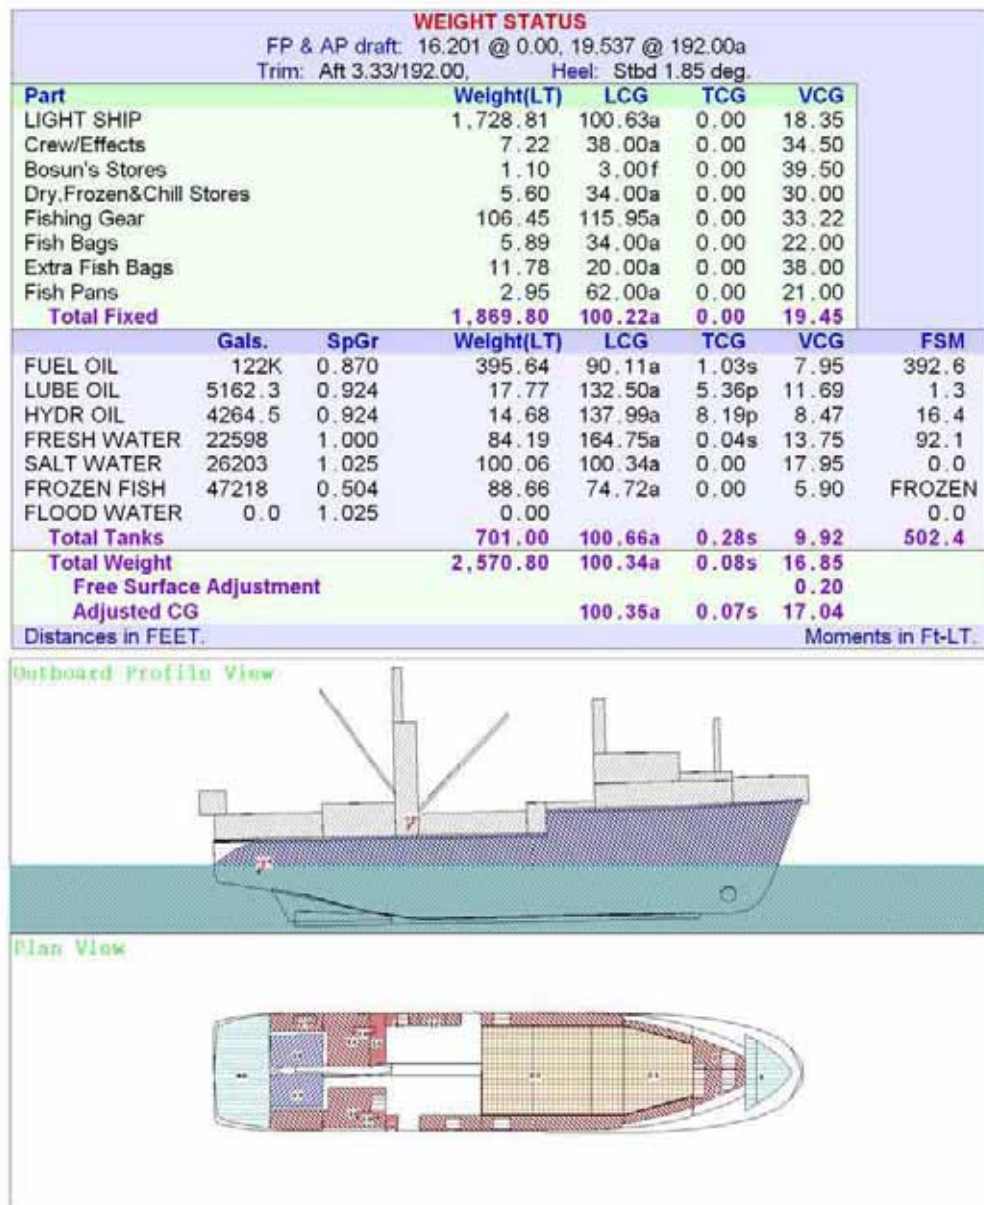
Figure 4: Summary of Pre-Casualty Load Condition

Based upon the information in the T&S booklet for full load departure as well as the additional modifications called out in paragraph 5-c of reference (a), an estimate of the pre-casualty loading condition was developed. This estimate is summarized in Figure 4. The 122,000 gallons of fuel

takes into account 12,000 gallons in the day tanks as well as 110,000 gallons in the fuel oil storage tanks.

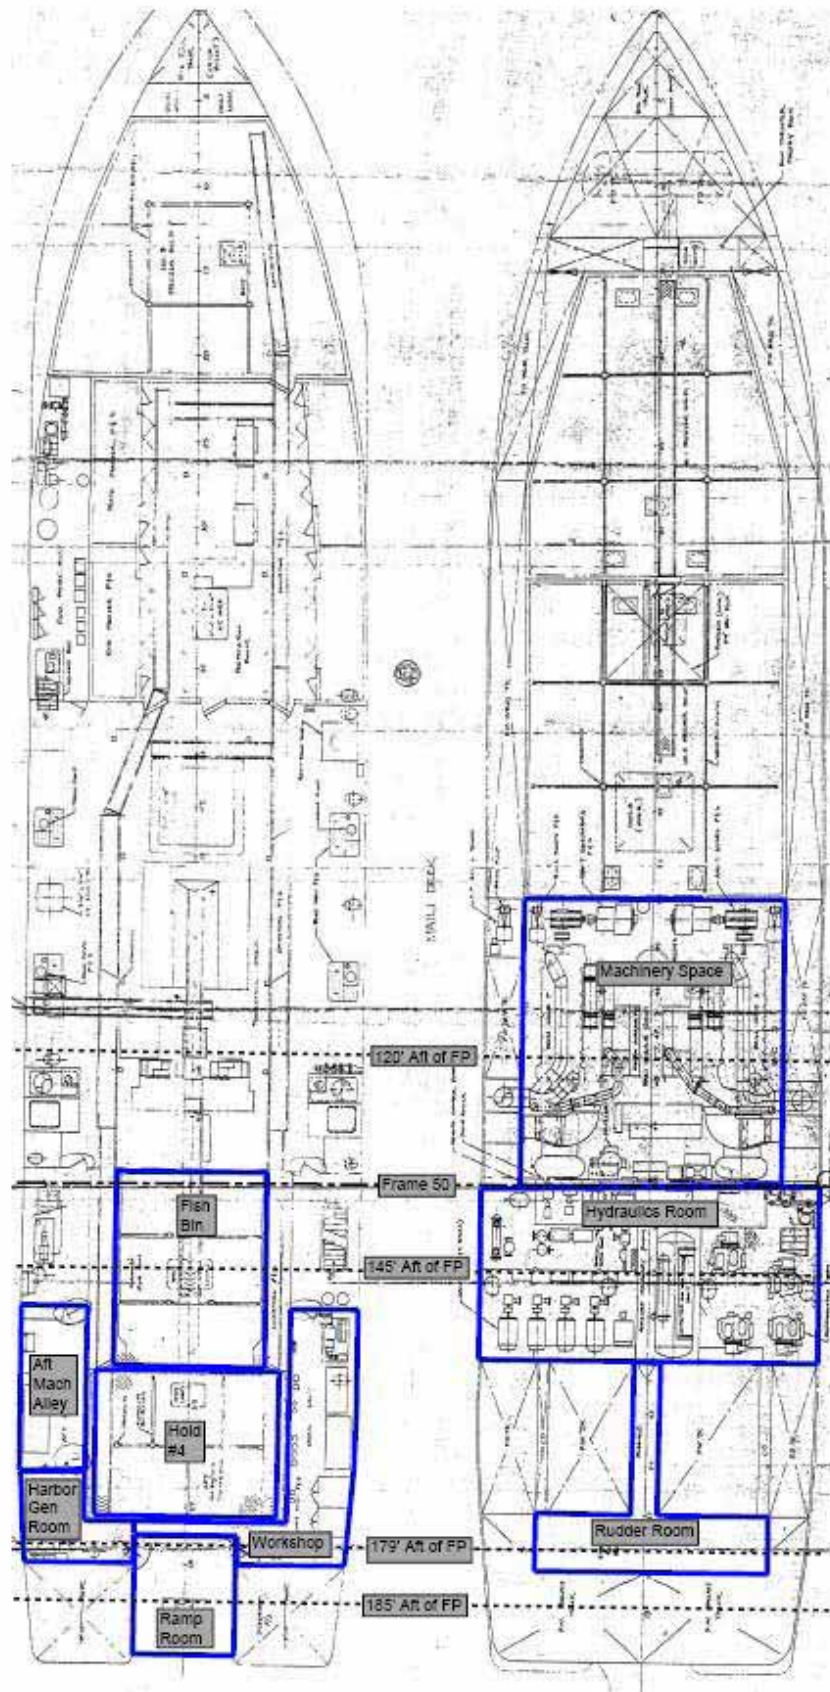
Figure 5: Plan View for the Main and Hold Decks Showing Relevant Compartments

Figure 5 is taken from the ALASKA RANGER's arrangement plans for the hold and main decks. All of the compartments discussed in the sinking scenarios are labeled. In addition, there are dotted lines showing the locations of the body plan cuts used in figures 7 through 15.

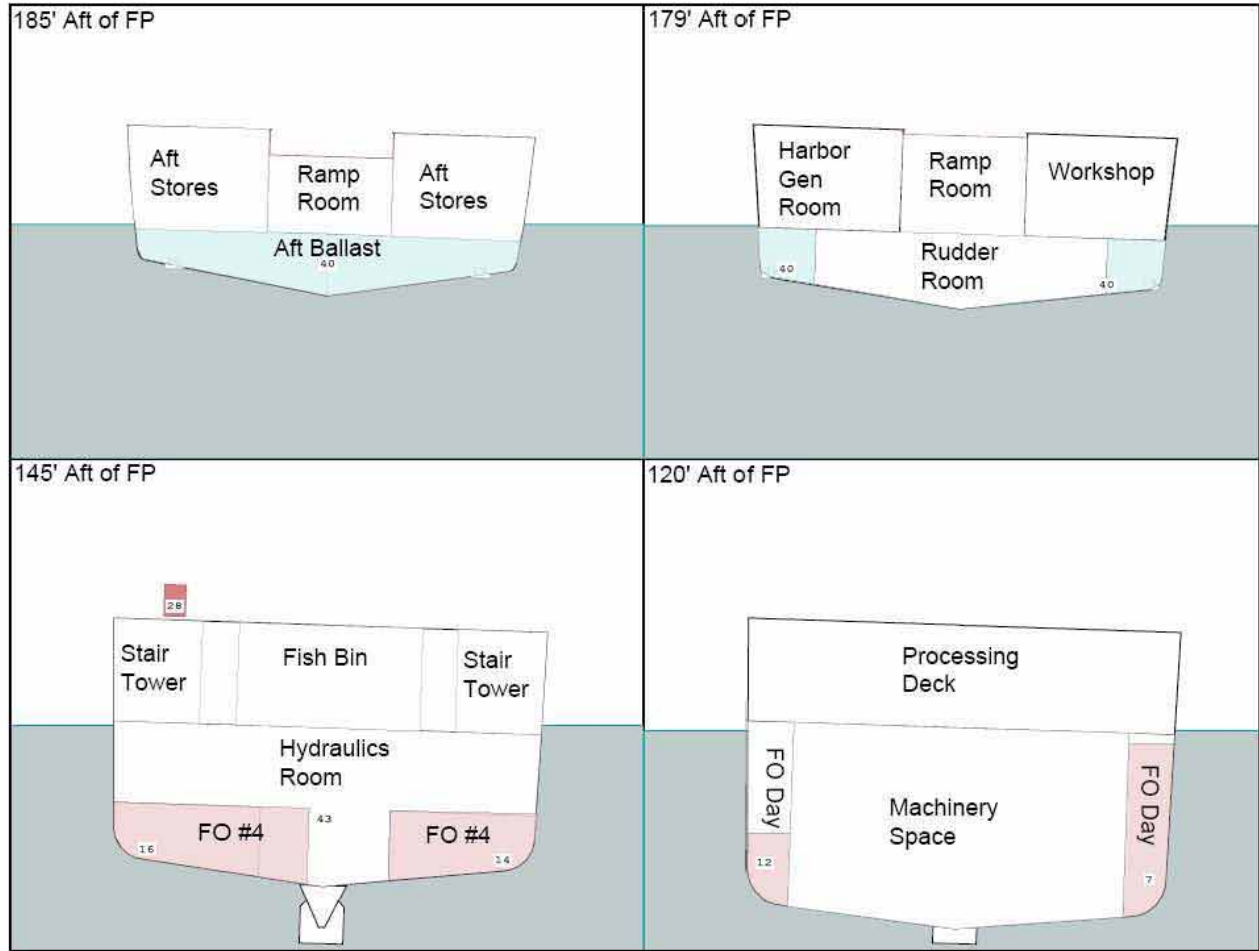
Figure 7: Body Plan Space Descriptions

Figure 7 labels the compartments on the body plan cuts used throughout the remainder of the analysis. The longitudinal location of each cut may be seen in Figure 5

Step	Compartments Freely Flooded	Heel Angle	Min Freeboard	Height of DF Point	Total Flooding
		(°)	(ft)	(ft)	(LT)
A	None	1.9	7.90	12.08	0
B	Rudder Rm	1.8	6.97	11.66	54
C	B+ Ramp, Harbor Gen Rm, Workshop, & Aft Mach Alley	4.2	5.48	10.61	97
D	C+ Engine Room	1.2	-3.07	5.74	904
E	D+ Fish Bin and Hold #4	29.0	-50.56	-9.10	1116

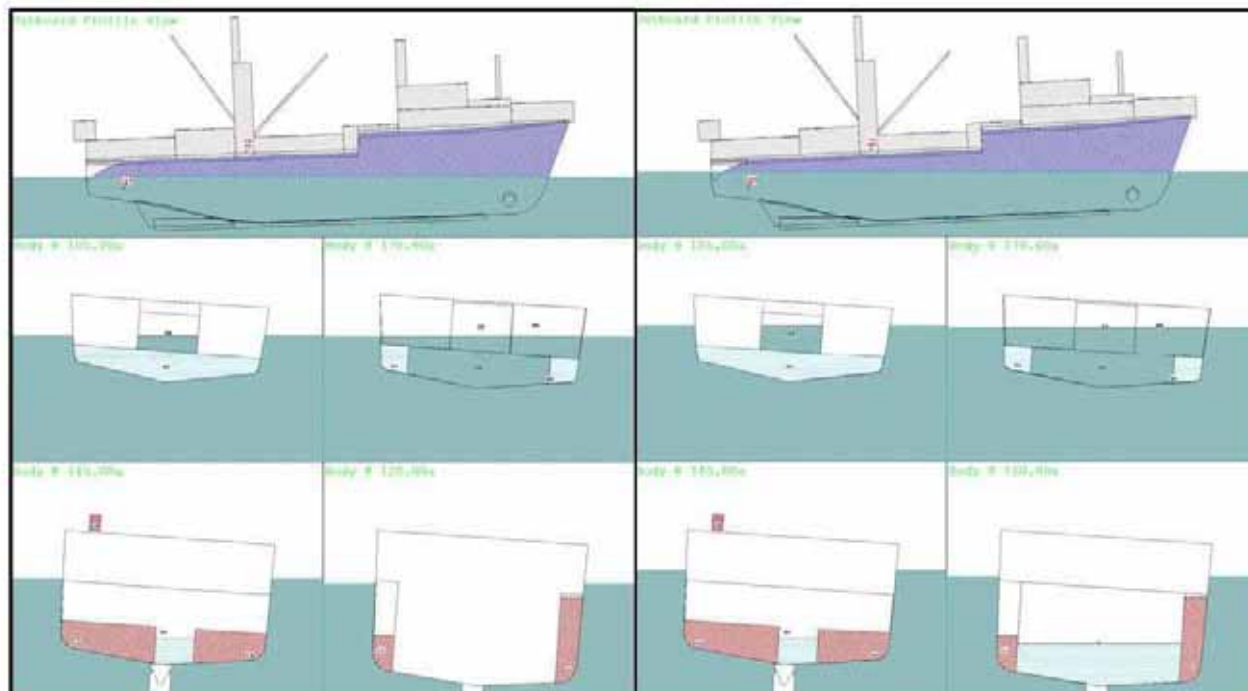
Figure 12: Step G in the 2nd Flooding Scenario

Reference (a) indicated that the vessel listed hard to starboard after losing power. There was little indication of asymmetric flooding and so the list would likely have been due to the large free surface effects associated with partially flooded compartments. Because the top of the model's engine room was below the static waterline, the compartment would flood solid rapidly and not allow for any free surface as depicted in Figure 9. In contrast to the free flooding considered in the previous scenario, the 2nd scenario assumed the model was loaded with sea water up to a particular height at frame 50 in order to include the effects of free surface.

The engine room aboard the ALASKA RANGER was assumed to be made up of two separate compartments until flood water reached the main engine shafts. Cutouts in the bulkhead at frame 50 were considered to be the point where flood water would begin spilling from the hydraulics space forward into the machinery space. This spilling would have begun when there was approximately 6.8 ft of water at the forward end of the hydraulics room. This corresponds to approximately 29.5 LT of seawater as shown in Figure 11. After the spilling occurred, the forward machinery portion of the engine room was filled until the level at the spill point matched that in the hydraulics space. This occurred on the model with approximately 182 LT of water in the forward machinery space as shown in Figure 12.

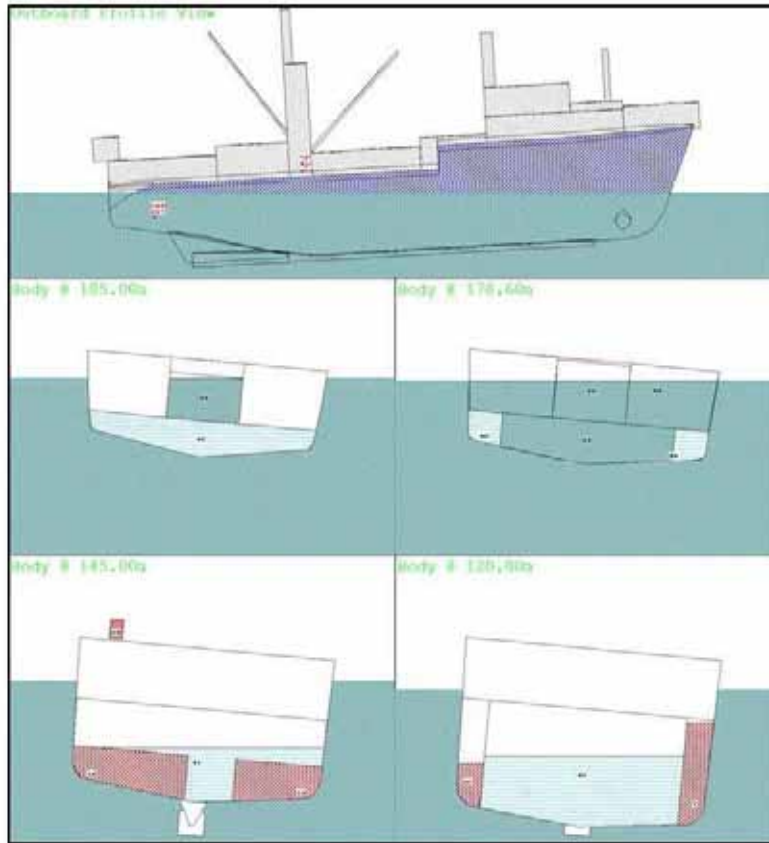
Figure 13: Step I in 2nd Progressive Flooding Scenario

Reference (a) also indicated that by 03:45, or 1 hour and 45 minutes after the initial report of flooding in the rudder room, the ALASKA RANGER had lost her generators and main diesel engines. It was assumed that the loss of the main engines corresponded to step I in the scenario where the engine rooms were flooded with 10 ft of water. Using the slowest flood rate in Table 2, the total 511 LT of flood water in all flooded compartments, would have taken approximately 50 minutes to ship through the rudder bearing. Presumably, the progressive flooding between compartments would occur more slowly than the initial flooding into the rudder room. However, this rough check verified that the flooding rates discussed in section 4.2 were not out of the question when compared with the timeline in reference (a).

As noted previously, the ALASKA RANGER reportedly listed hard to starboard after losing power (presumably due to flooding in the engine rooms). However, Table 4 shows only between 4° and 5° static starboard heel angle once the engine rooms are flooded. One plausible condition that would increase the free surface effect and create a greater heel angle is a small quantity of flood water on the processing deck. Limited flooding on the processing deck is a reasonable assumption considering the aft end of the trawl deck was nearly submerged in step I of the scenario. When only 15 LT of flood water was added to the processing deck, the model heeled sufficiently to put the starboard corner of the transom in the water as shown in Figure 14. With 50 LT of flood water on the processing deck, the heel angle doubled to 16°. At this point, our model indicated that the starboard side of the trawl deck was underwater from frame 47 to the transom.
